PAVEMENT DESIGN REPORT

Guelph Line

Derry Road to Steeles Avenue

Region of Halton Request PR-2385

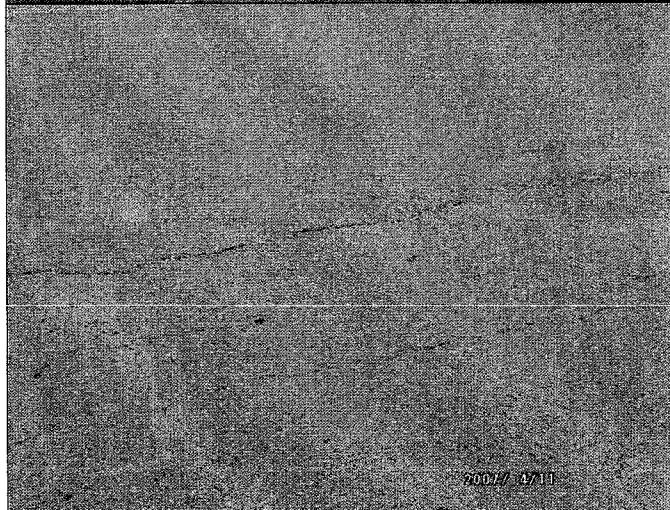
Typical longitudinal cracking.

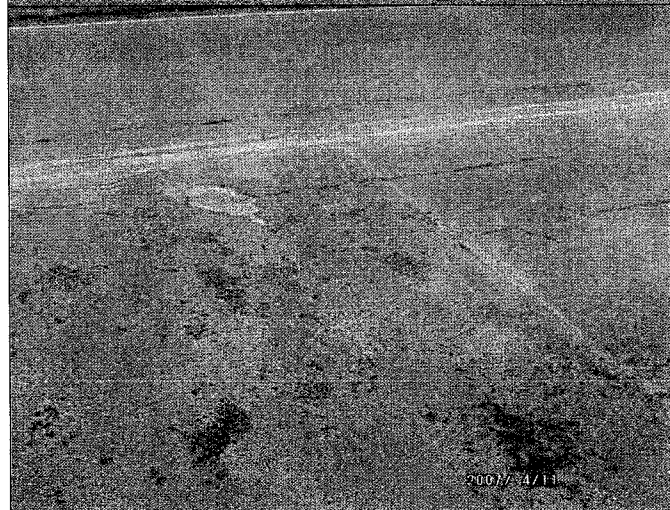
Distress area in northbound lane. Note delamination of overlay in upper right corner of patch.

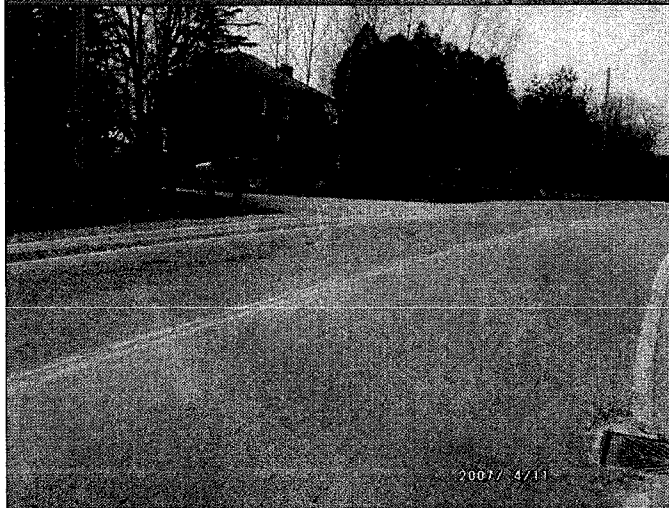
Areas of alligator cracking and patching in southbound lane

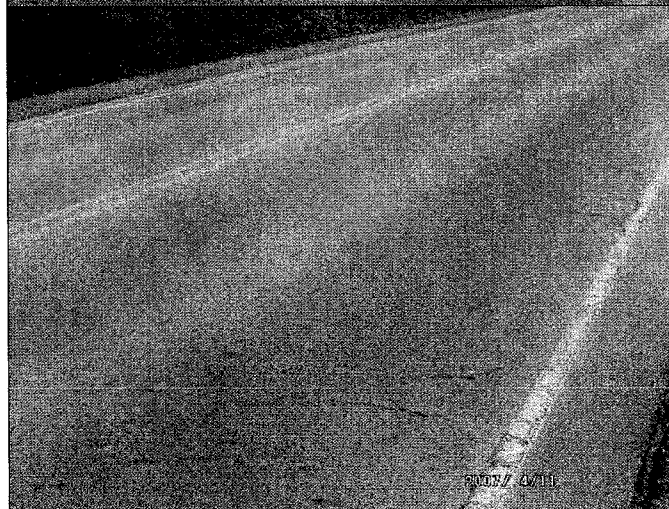
Cracking and rutting in both lanes.

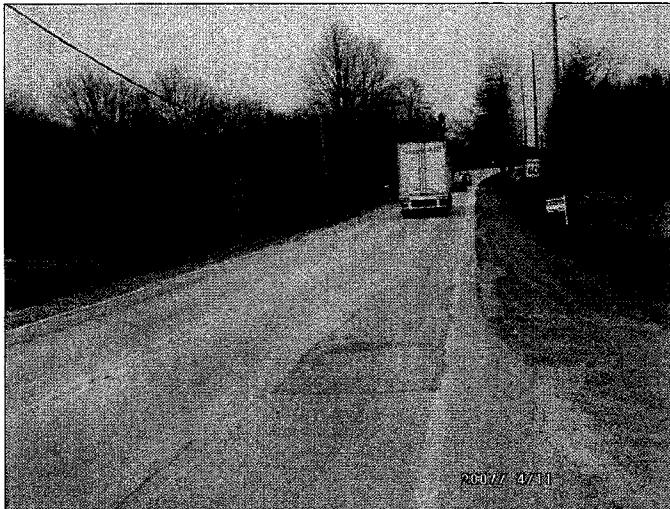
Typical patches in centre section of project.

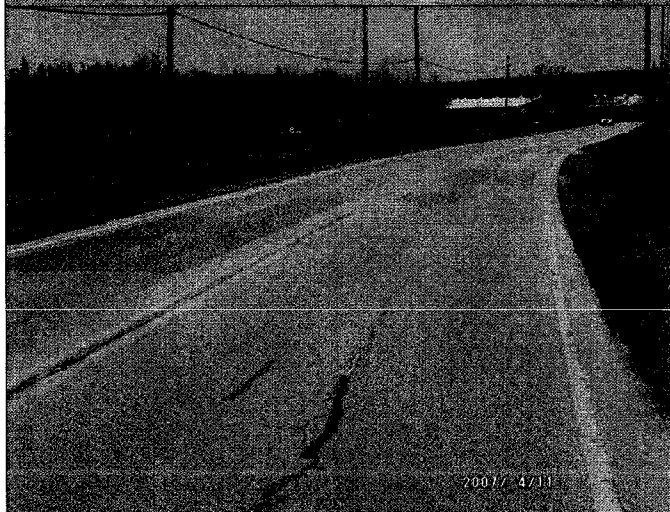
Typical patches and cracking in centre section of project.

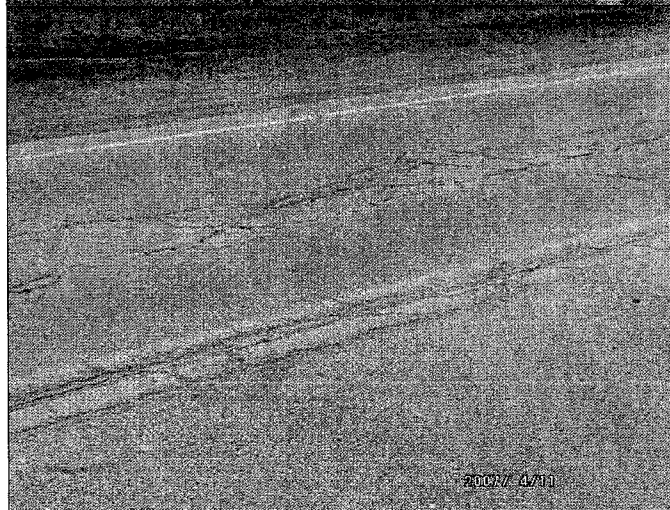
Distresses in southbound lane.

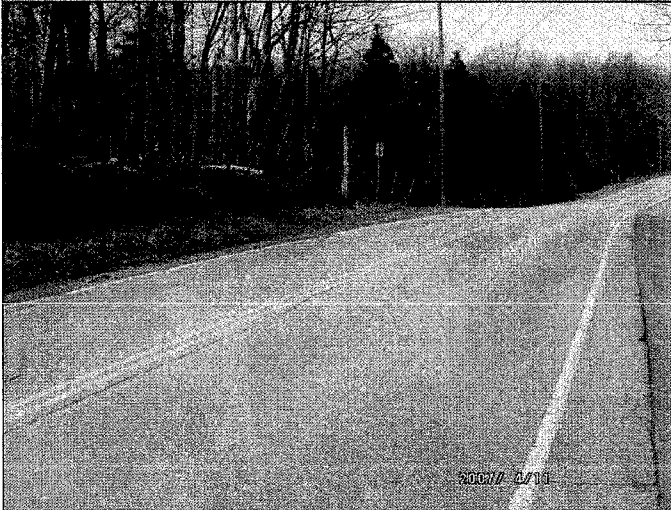
Typical longitudinal and transverse cracking in northern section of project.

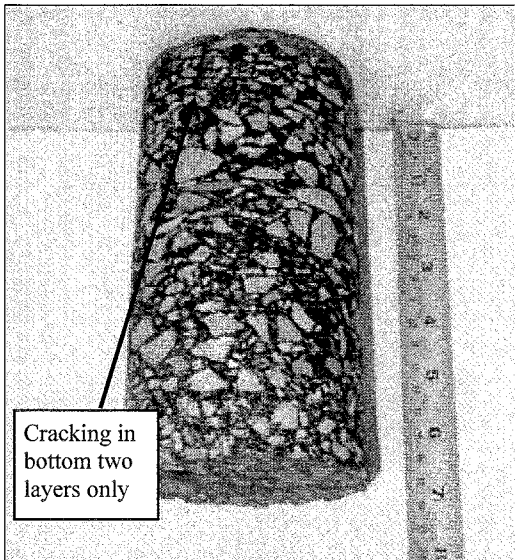
Examining the core extracted from Station 1+012, found that cracking was observed in the lower two layers of the asphaltic concrete. The cracking had not progressed to the surface course.

We note from examination of the core from Station 1+012, that cracking was observed in the lower two layers of the asphaltic concrete. This would lead us to believe that the base course contains untreated distresses which will likely reflect through into the surface course if not treated.

<p>Cracking in bottom two layers only</p>	<p align="center">Core Photo 1 Sta. 1+012, Northbound Lane 2 m Lt CL</p> <table border="1"> <thead> <tr> <th>Type</th> <th>Core (mm)</th> </tr> </thead> <tbody> <tr> <td>Surface Course</td> <td>30</td> </tr> <tr> <td>Binder Course</td> <td>40</td> </tr> <tr> <td>Binder Course</td> <td>50</td> </tr> <tr> <td>Surface Course</td> <td>30</td> </tr> <tr> <td>Surface Course</td> <td>30</td> </tr> <tr> <td>Total</td> <td>180</td> </tr> </tbody> </table>	Type	Core (mm)	Surface Course	30	Binder Course	40	Binder Course	50	Surface Course	30	Surface Course	30	Total	180
Type	Core (mm)														
Surface Course	30														
Binder Course	40														
Binder Course	50														
Surface Course	30														
Surface Course	30														
Total	180

As noted in Sections 4.3 and 6.1.2, there are locations where the base course contains untreated distresses which will likely reflect through into the surface course if not treated. As these have yet to reflect through the surface course, there may be sections left untreated that would shorten the service life of the overlay.
