## **STRUCTURAL EVALUATION OF MAIN CULVERT**

# The Regional Municipality of Halton

## Class Environmental Assessment Study for Ninth Line

<b>Structure Name</b>	Ninth Line, Lot 3, Conc IX/X		
<b>ID Number</b>	13-1159210 CU01		
<b>Classification</b>	<input type="checkbox"/> Bridge	<input checked="" type="checkbox"/> Culvert	<input checked="" type="checkbox"/> Structure <input type="checkbox"/> Municipal
<b>Location</b>	1.00 km North of Steeles Avenue		
<b>Load Posting</b>	No Posting	<b>Span Lengths</b>	3.02 m
		<b>Board Order / Agreement</b>	<input type="checkbox"/>
<b>Structure Type</b>	RF		
<b>Yr Constructed</b>	1960		
<b>Yr Rehabilitated</b>	N/A		
<b>Inspection Date</b>	22-May-14	<b>Current AADT</b>	10210
<b>Previous Inspection</b>	09-Oct-12	<b>Date AADT</b>	
<b>Next Inspection</b>		<b>Projected AADT</b>

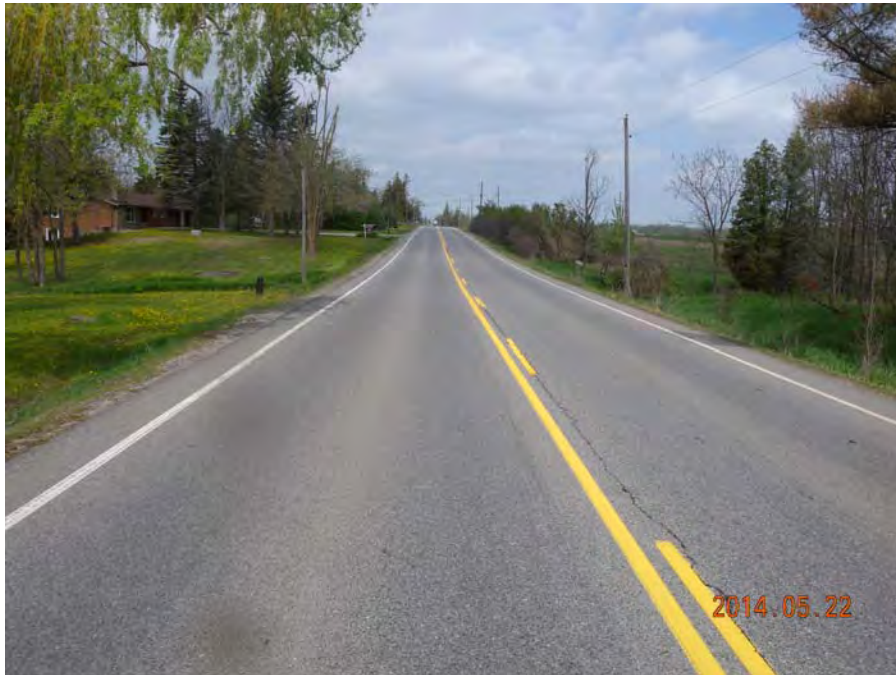
Photograph No. 1: 8633: Roadway over structure looking North

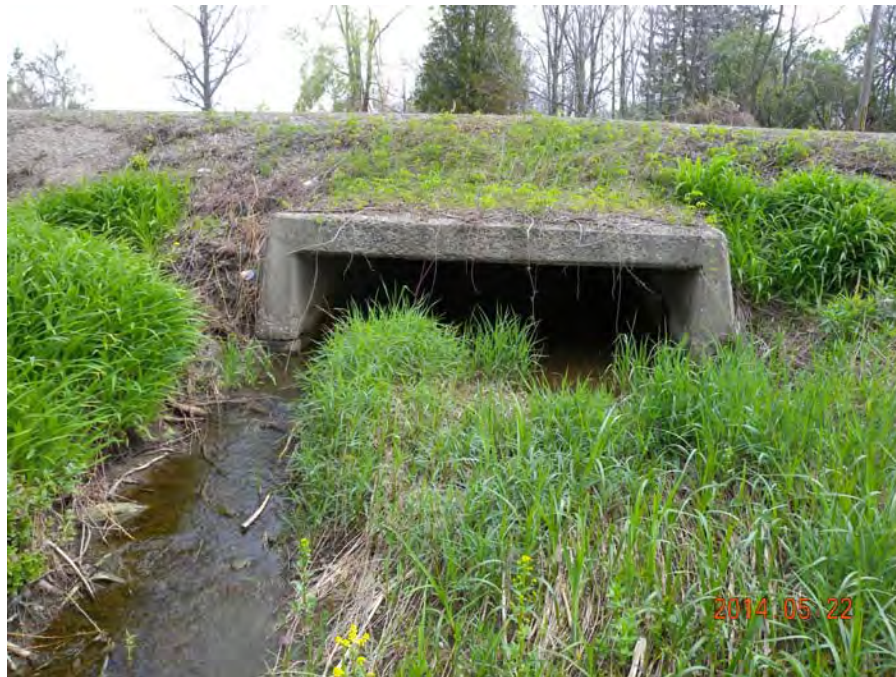
Photograph No. 2: 8638: West Elevation

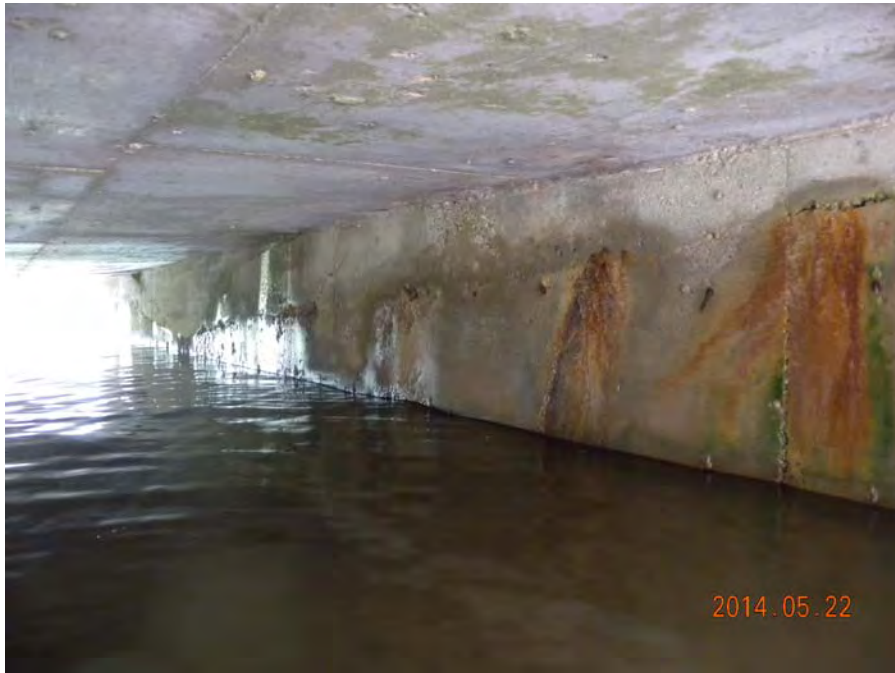
Photograph No. 3: 8665: North abutment wall looking west

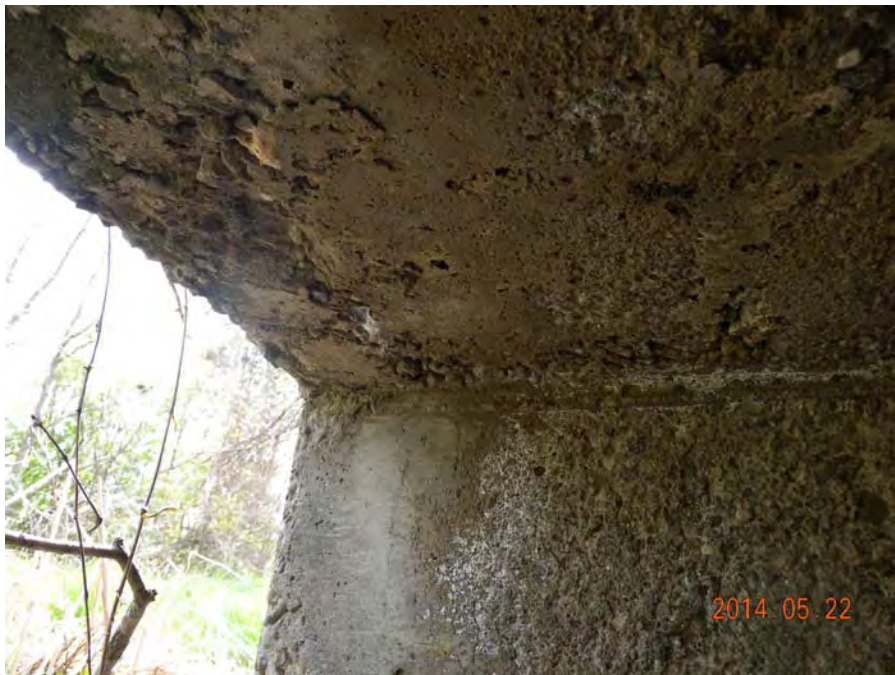
Photograph No. 4: 8662: Deck soffit at Southeast corner of structure
