# Geomorphological Report: Sixteen Mile Creek and Tributary NW-1-E

## Steeles Avenue West, Municipal Class Environmental Assessment Study Town of Milton

April 27, 2022  
Project No. PN18143a

**Report Title:** Geomorphological Report, Sixteen Mile Creek and  
Tributary NW-1-E, Steeles Avenue West MCEA, Milton

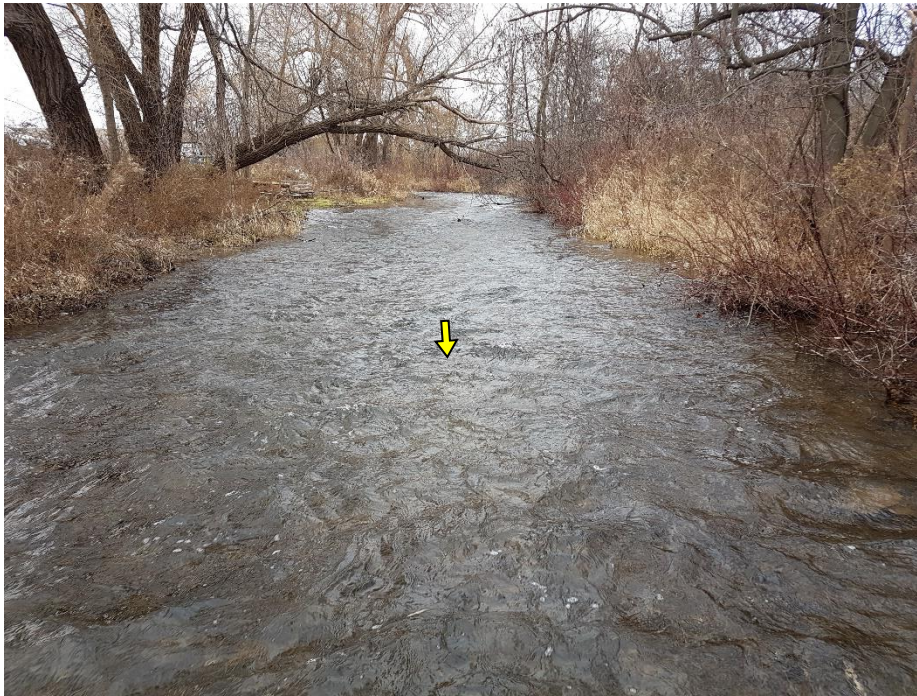
**Reach R1 - Photo 1**

Upstream (North) of Steeles Avenue West, Sixteen Mile Creek was wide, relatively shallow, and dominated by riffle and run features.

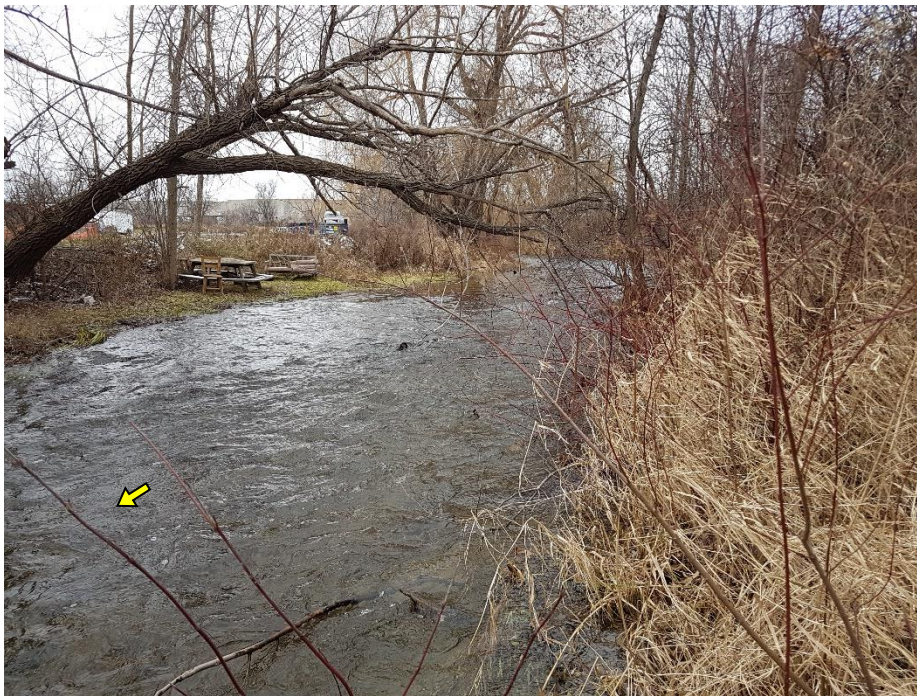
**Reach R1 - Photo 2**

The riparian area on the west side of the channel consisted of a narrow, forested buffer next to a residential lot.

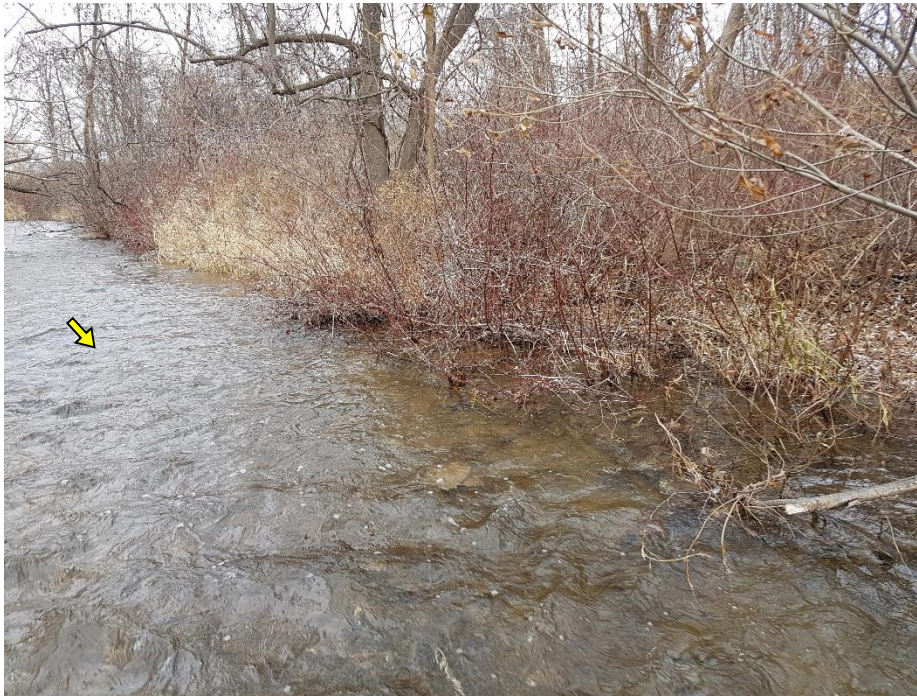
**Reach R1 - Photo 3**

The east riparian area was wooded with a high density of shrubs. Red Osier Dogwood was particularly abundant. Some shrubs were inundated as a result of channel widening.

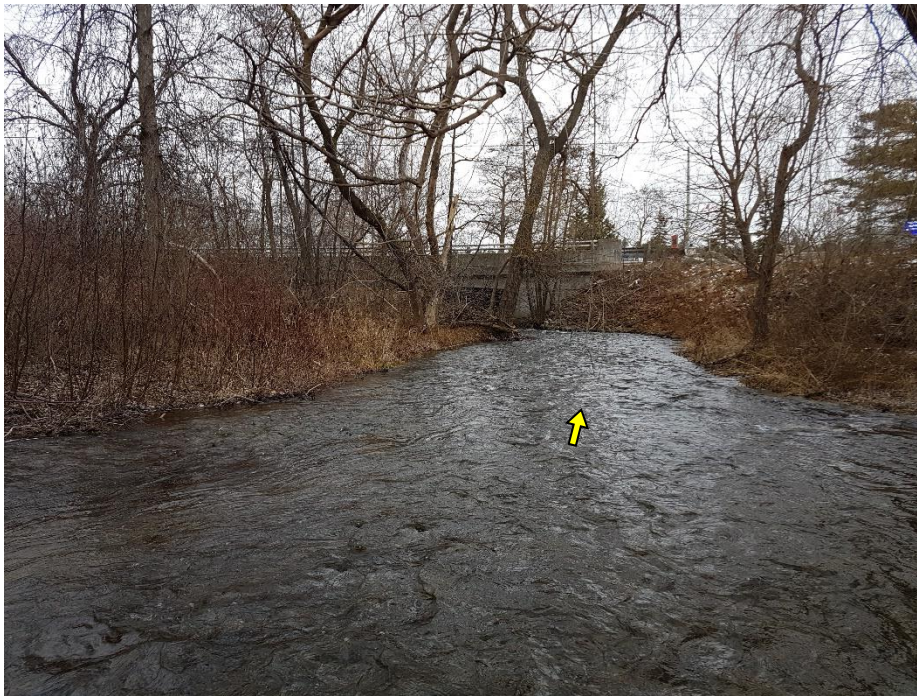
**Reach R1 - Photo 4**

The run-dominant reach extended to the Steeles Avenue crossing. Bed substrates consisted of range of coarse sands to small subangular boulders.

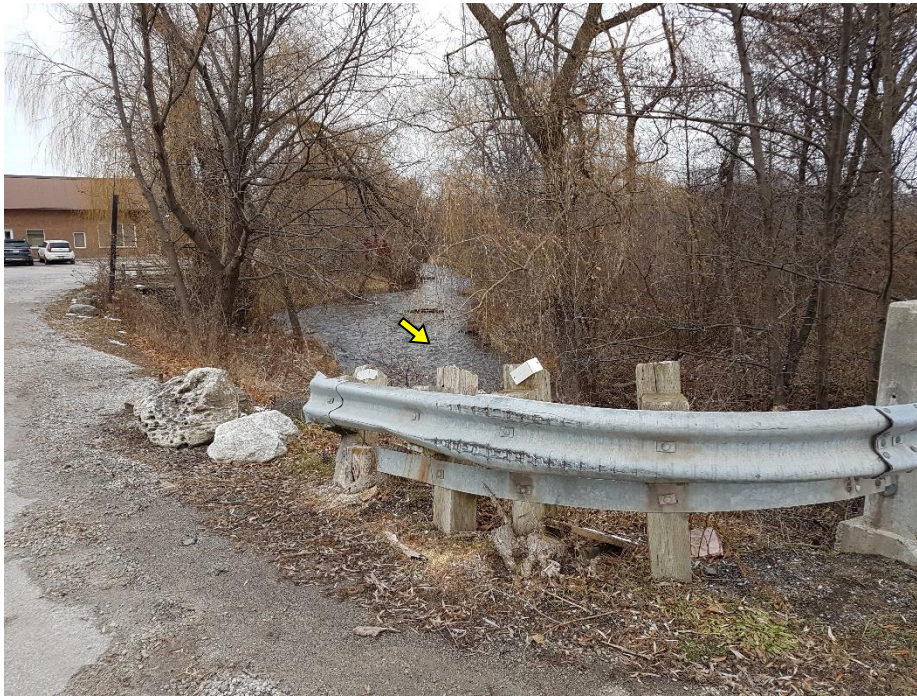
**Reach R1 - Photo 5**

View of the upstream valley corridor from Steeles Avenue.

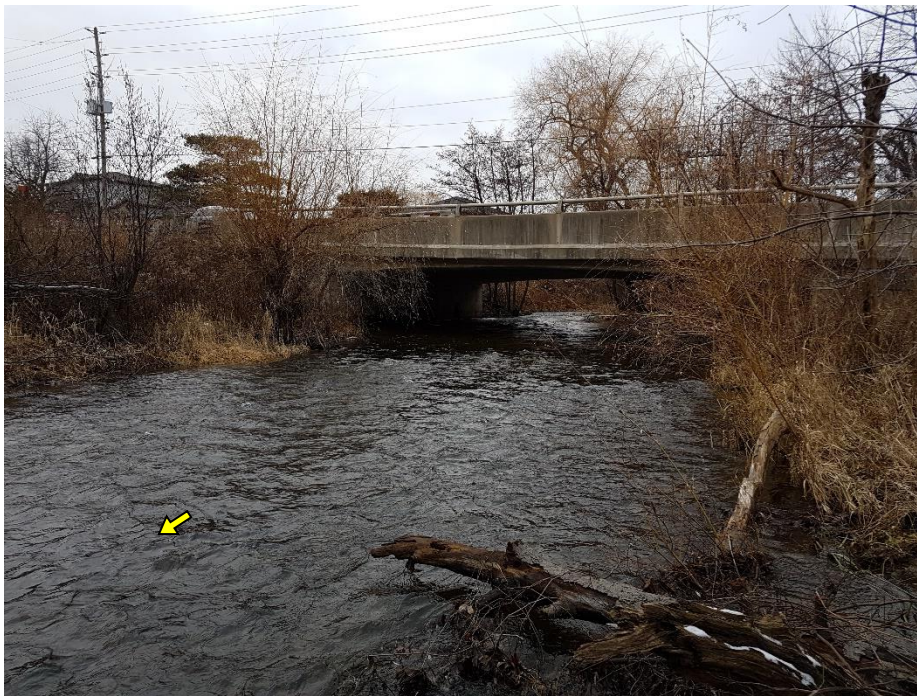
**Reach R2 - Photo 6**

The Steeles Avenue crossing consisted of a 14.8 m concrete bridge structure, built in 1985. The crossing was partially degraded and undersized relative to the bankfull channel. For instance, the channel wetted width extended the full span of the crossing. The right bank leading up to the crossing was reinforced with a stone revetment. The opposite bank was vegetated and moderately stable. The right channel bank on the downstream side were gradually sloped, vegetated, and moderately stable. The left banks on both the upstream and downstream sides were relatively low-lying and therefore likely prone to flooding during rainfall events. Two additional pedestrian crossings, associated with the Milton Banquet and Conference property, were observed downstream of Steeles Avenue. The pedestrian crossings appeared dated with rotted logs and corroded rails. Erosion around the crossings and footings was limited.

- The existing 14.8 m structure at Steeles Avenue and the 3 m x 4 m culverts at the CNR are undersized relative to the channel, as evidenced by the absence of channel banks (e.g., the channel wetted width spanned the full extent of the bridge openings). Despite the undersized condition, there was limited evidence of channel adjustment or erosion around the structures. For example, the upstream and downstream banks were gradually sloped and well-vegetated.

The Steeles Avenue crossing was undersized relative to the channel. The channel wetted width extended the full span of the crossing.

At this time, the existing 14.8 m bridge over Sixteen Mile Creek is proposed to be replaced with a relatively enlarged structure located approximately 50 m downstream (south) of the roadway.

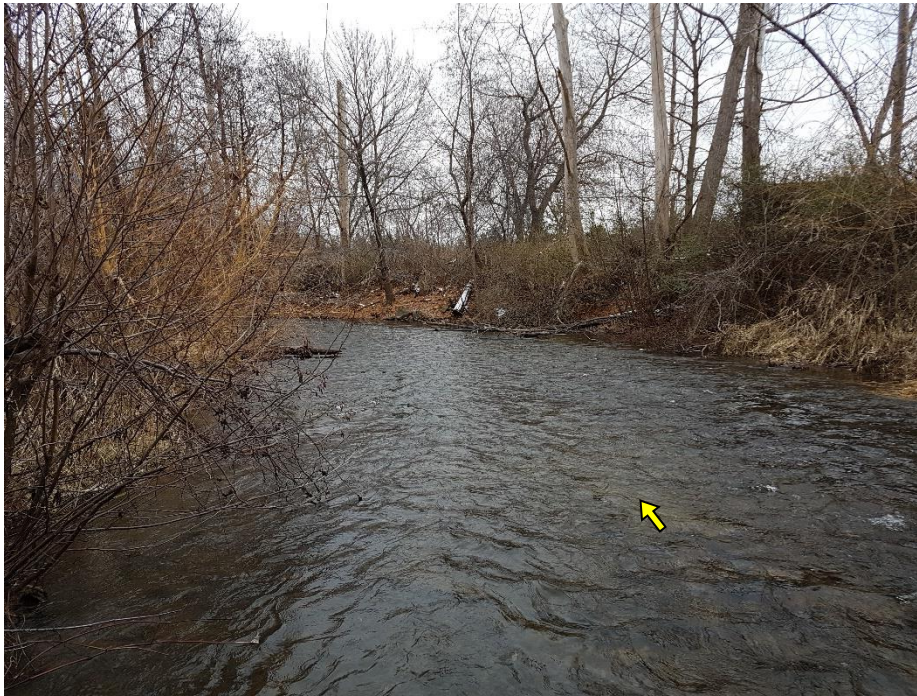
**Reach R2 - Photo 7**

The homogenous bed morphology persisted downstream of the crossing. There was limited erosion observed around the crossing.

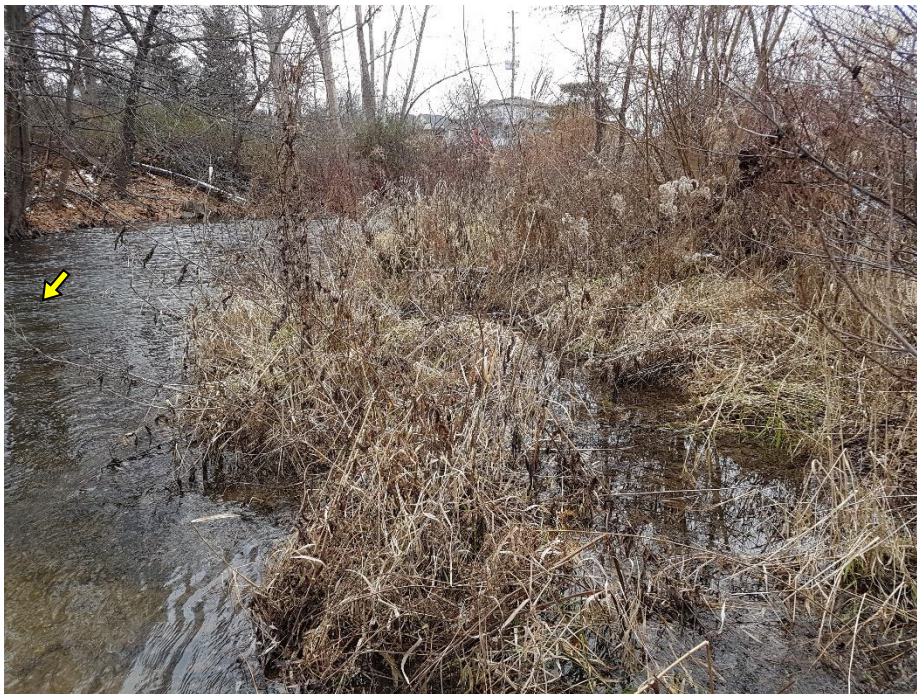
**Reach R2 - Photo 8**

The east bank was relatively shallow and partially inundated. A remnant channel avulsion was observed within the floodplain.

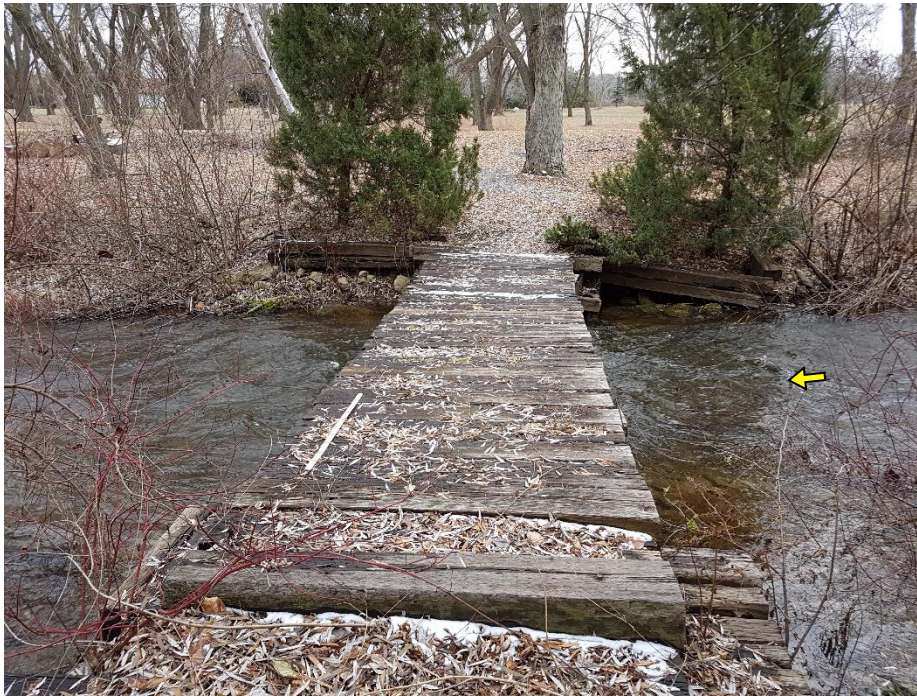
Reach R2 - Photo 9

100 m downstream of the crossing, there was a wooden bridge associated with the Milton Banquet and Conference Centre lot. The bridge was partially-rotted, though not displaced.

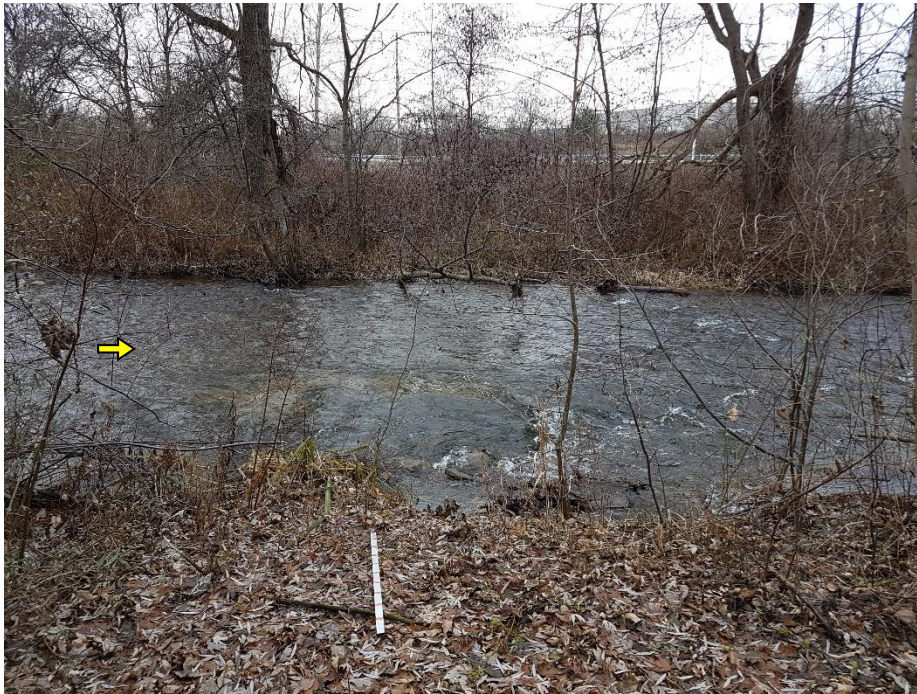
Reach R2 - Photo 10

Short segments of exposed till were observed along the channel bed, indicative of widening processes. Channel banks were gradually sloped and vegetated. The adjacent floodplain was relatively low-lying.

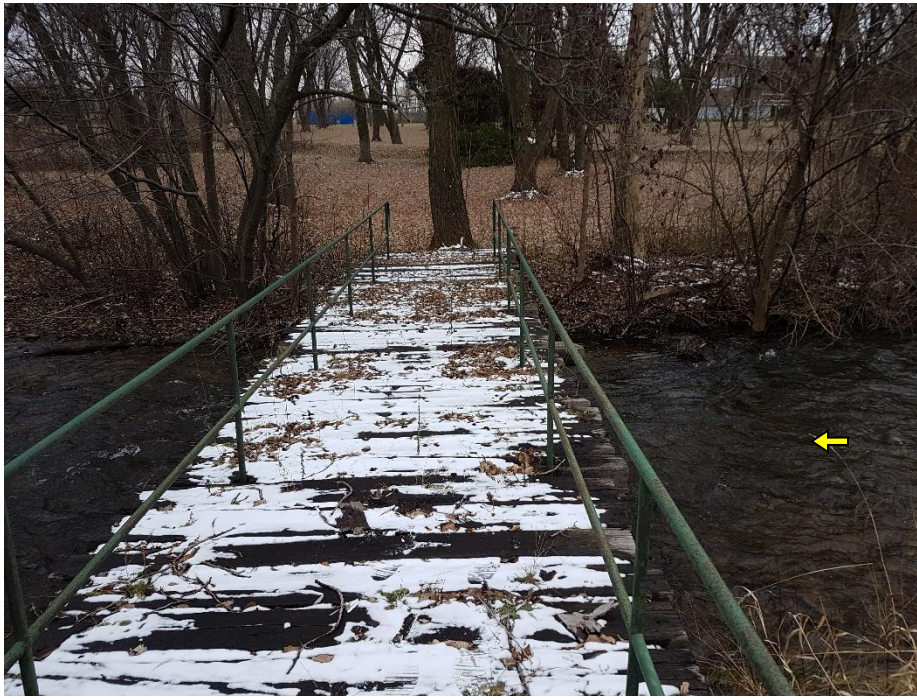
Reach R2 - Photo 11

An additional wooden bridge was noted 180 m downstream of the Steeles Avenue crossing. The adjacent channel banks were vegetated and moderately stable.

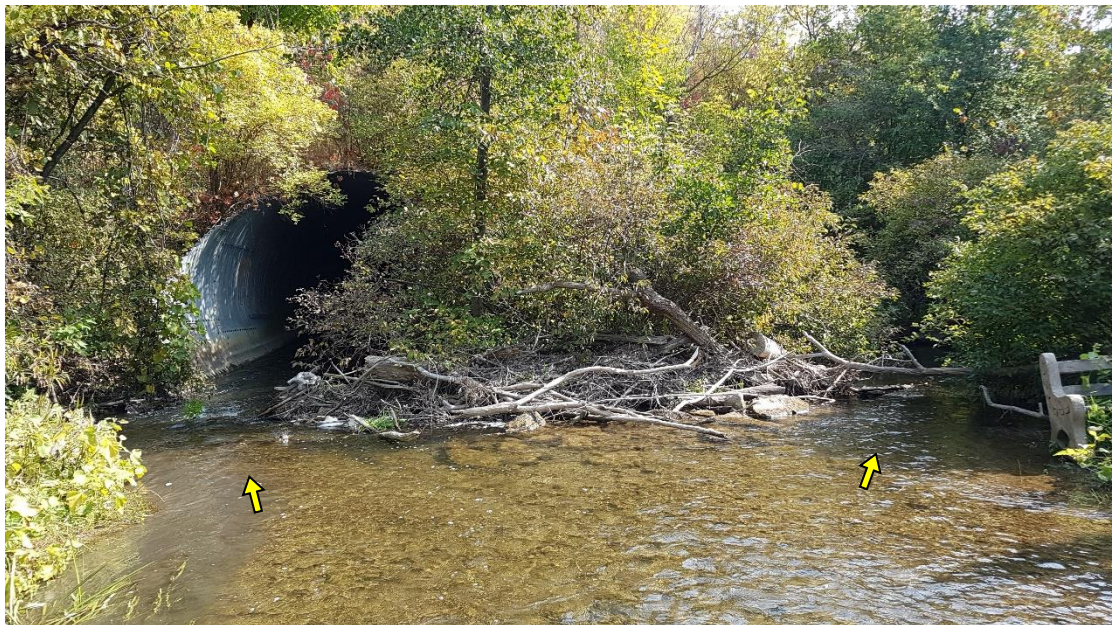
Reach R2 - Photo 12

The CNR crossing of Sixteen Mile Creek consisted of two 3 m x 4 m culverts. Woody debris had collected along the bank between the culverts.

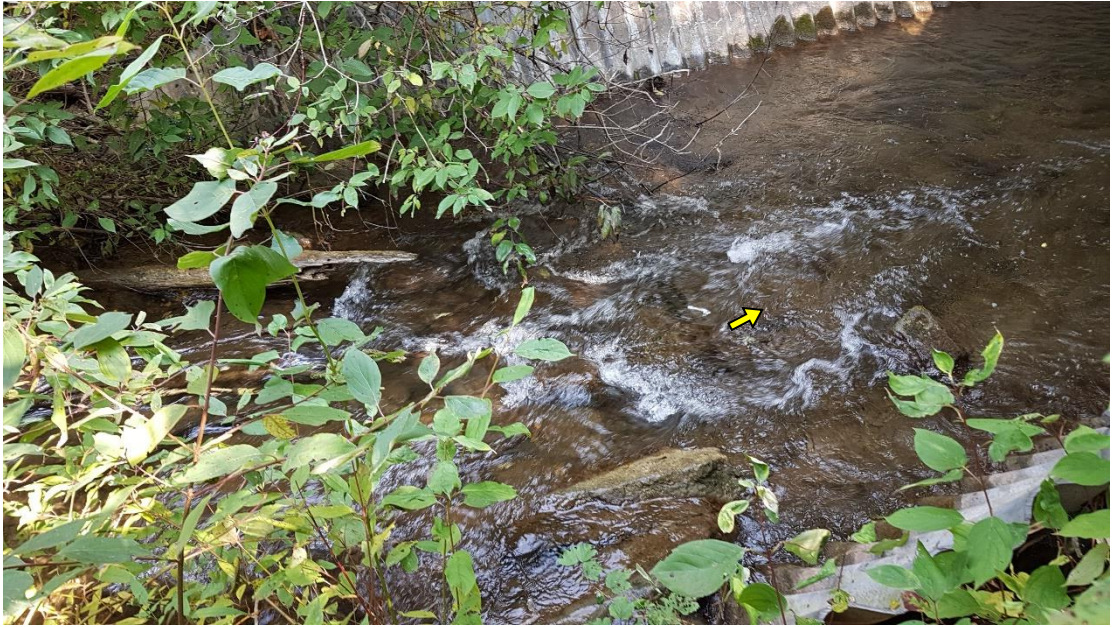
Reach R2 - Photo 13

The culverts were slightly embedded into the riverbed.

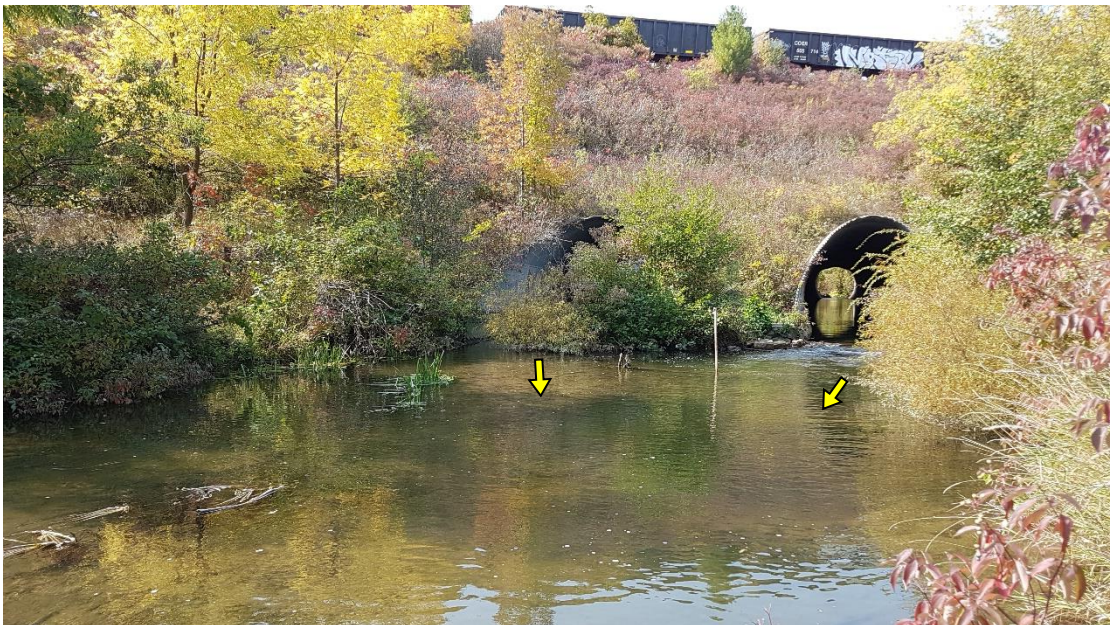
Reach R2 - Photo 14

The two culverts fed into an overwidened pool on the opposite side of the CNR crossing. Channel banks were vegetated and stable. Minor scouring was observed along the pool bed.

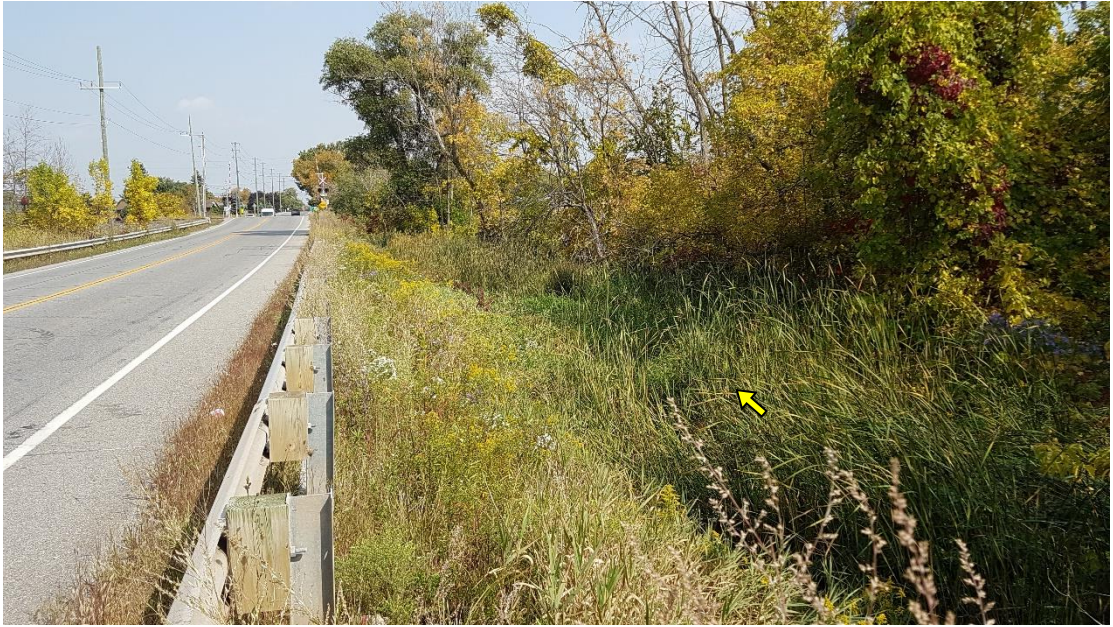
NW-1-E - Photo 15

NW-1-E consisted of a 2.5 m wide, well-vegetated swale, which extended from the adjacent farm field and followed the Steeles Avenue embankment.

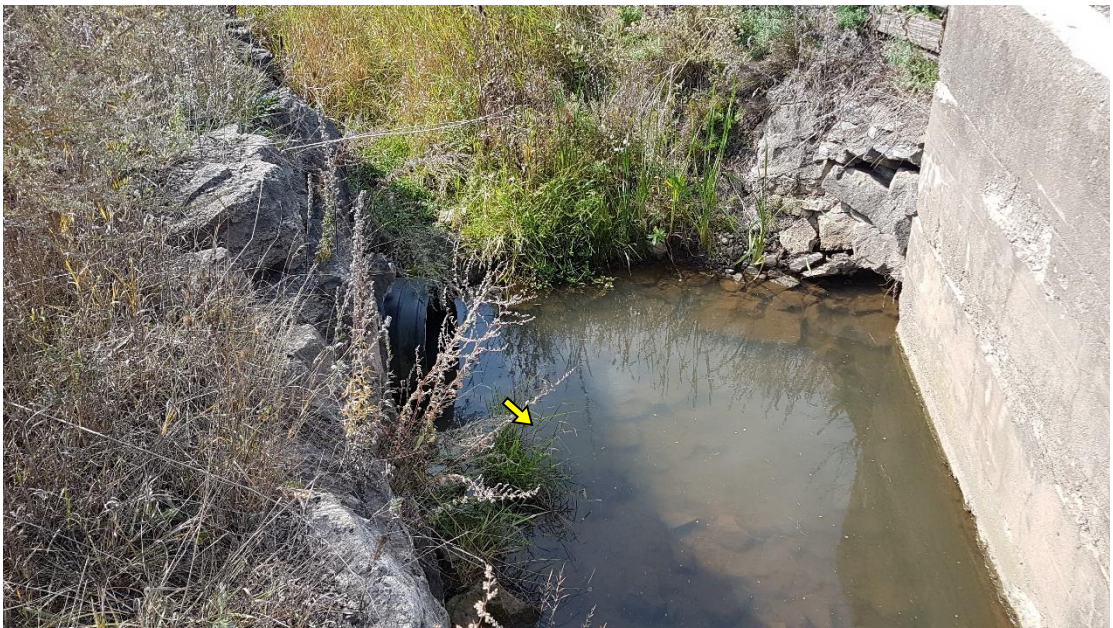
NW-1-E - Photo 16

The **NW-1-E** crossing consists of a 750 mm CPP pipe. Based on an initial review of the channel, the crossing is functioning adequately to convey flows, as evidenced by the stable condition of the channel. However, the pipe is undersized relative to the ~2.5 m wide watercourse. This may lead to erosion issues in the future with further changes to the sub-catchment hydrological regime due to land development and/or climate change.

NW-1-E was conveyed beneath Steeles Avenue within a 750 mm diameter corrugated plastic pipe. The channel fed into a stone-lined plunge pool at the base of the road / rail embankment.

At this time, the 6.5 m span is considered a suitable recommendation, given the favourable condition of the relatively undersized 750 mm CPP culvert at Steeles Avenue and the intermittent flow conditions of the watercourse. A 6.5 m span permits the incorporation of a ~2.5 m wide low flow channel with 2 m of overbank buffer to either side to serve as an erosion allowance and to maintain terrestrial passage opportunity within the culvert. This preliminary recommendation is contingent upon the confirmation of **NW-1-E** bankfull dimensions during the latter stages of planning or detailed design.

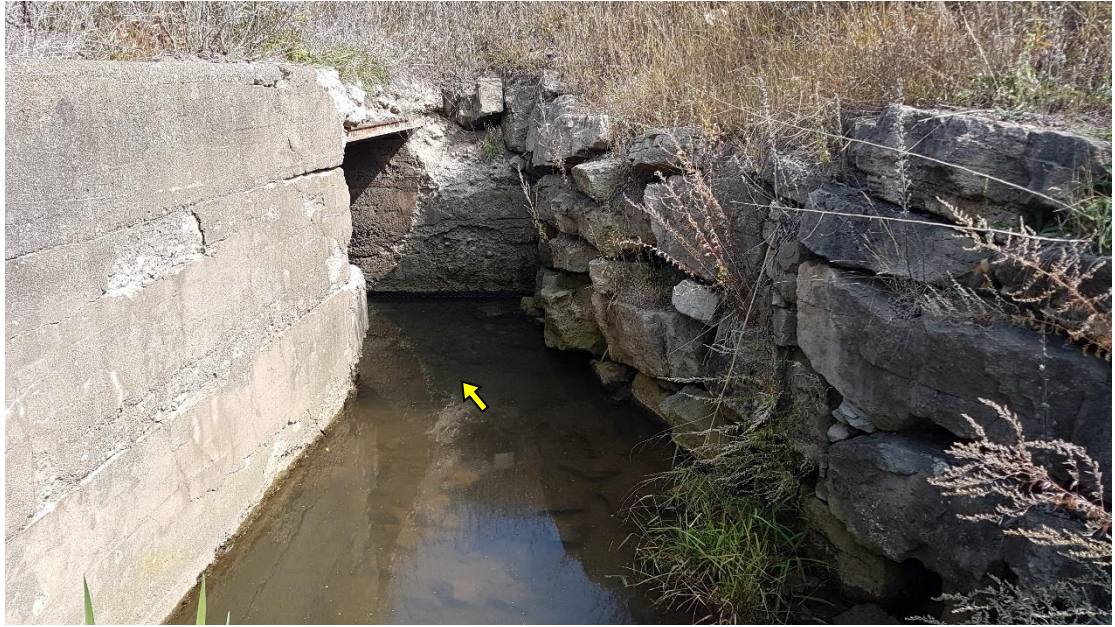
NW-1-E - Photo 17

The supporting headwall and concrete retaining walls of the plunge pool were degraded and in poor condition.
