# **New North Oakville Transportation Corridor and Crossing of Sixteen Mile Creek**

## **Appendix G: Fluvial Geomorphological Assessment**

**NEW NORTH OAKVILLE TRANSPORTATION CORRIDOR  
(BURNHAMTHORPE ROAD) – CLASS EA STUDY  
~ FLUVIAL GEOMORPHOLOGICAL COMPONENT ~**

**TO:** MR. MIKE DELSEY, P.ENG., TSH ENGINEERS.  
**FROM:** KIM LEBRUN, B.SC. AND JOHN PARISH, P. GEO, M.A.  
**SUBJECT:** EROSION ASSESSMENT – NEW NORTH OAKVILLE  
TRANSPORTATION CORRIDOR (BURNHAMTHORPE ROAD) –  
CLASS EA STUDY  
(FINAL)  
**DATE:** APRIL 2008

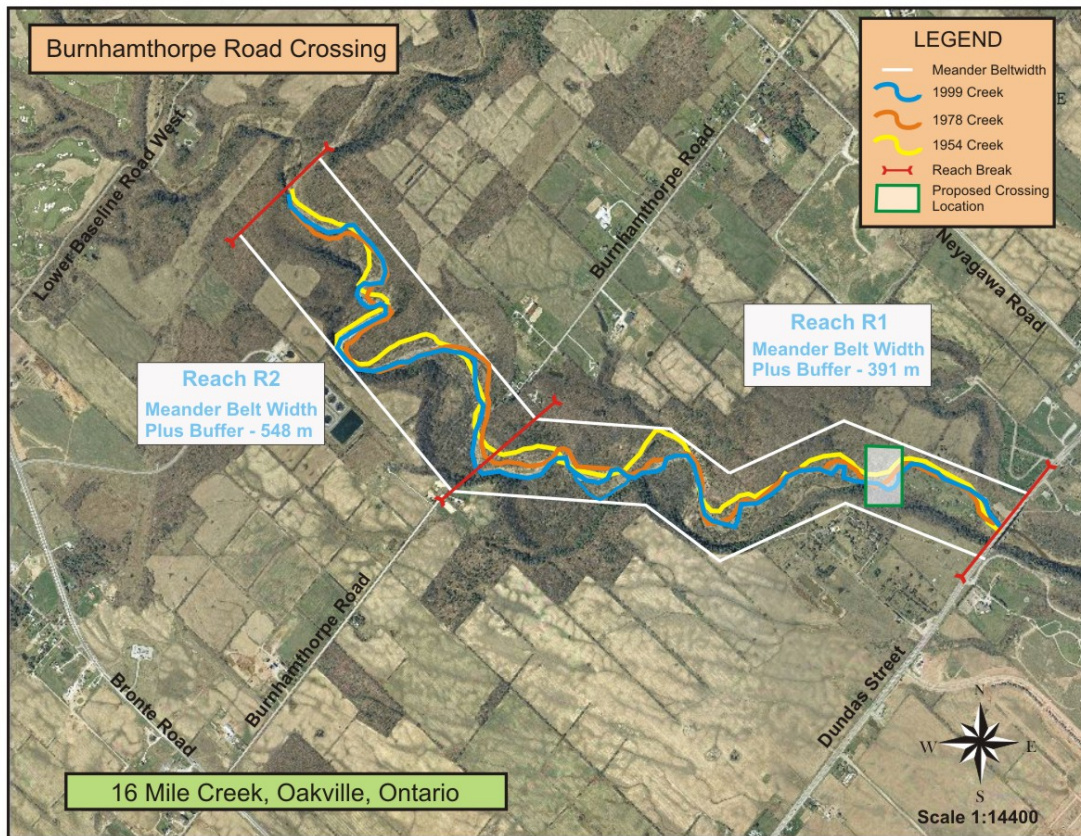
**Figure 3.** Historical overlay of 16 Mile Creek from 1954 to 1999, and the associated meander belt widths calculated from the historic assessment.

The extent of any belt width is based on the largest meander form observed within the valley corridor (based on the centre line of the channel). In such, the belt width values calculated for both reaches were based on the largest of all meander bends observed within the study area. However, the location of the proposed crossing in Reach R1 has a smaller meander amplitude than the meander bend used to calculate the belt width. Therefore, the final meander belt width should be considered a conservative value with respect to the application of the proposed road crossing in reach R1.

The meander belt width identified for Reach R1 was 391 m, and 548 m for Reach R2, including the buffer limits outlined in the protocols used. In theory, the proposed crossing location should span this width, however, in design this is most likely not obtainable. Therefore, it is recommended that the footings for the crossing be installed well outside the natural area of the existing channel and lined by large substrate to ensure that erosion and out-flanking of the footings does not occur.
