TECHNICAL MEMORANDUM

DATE August 26, 2019

Project No. 1648031

FLUVIAL GEOMORPHIC ASSESSMENT IN SUPPORT OF THE NINTH LINE MUNICIPAL CLASS ENVIRONMENTAL ASSESSMENT, HALTON REGION

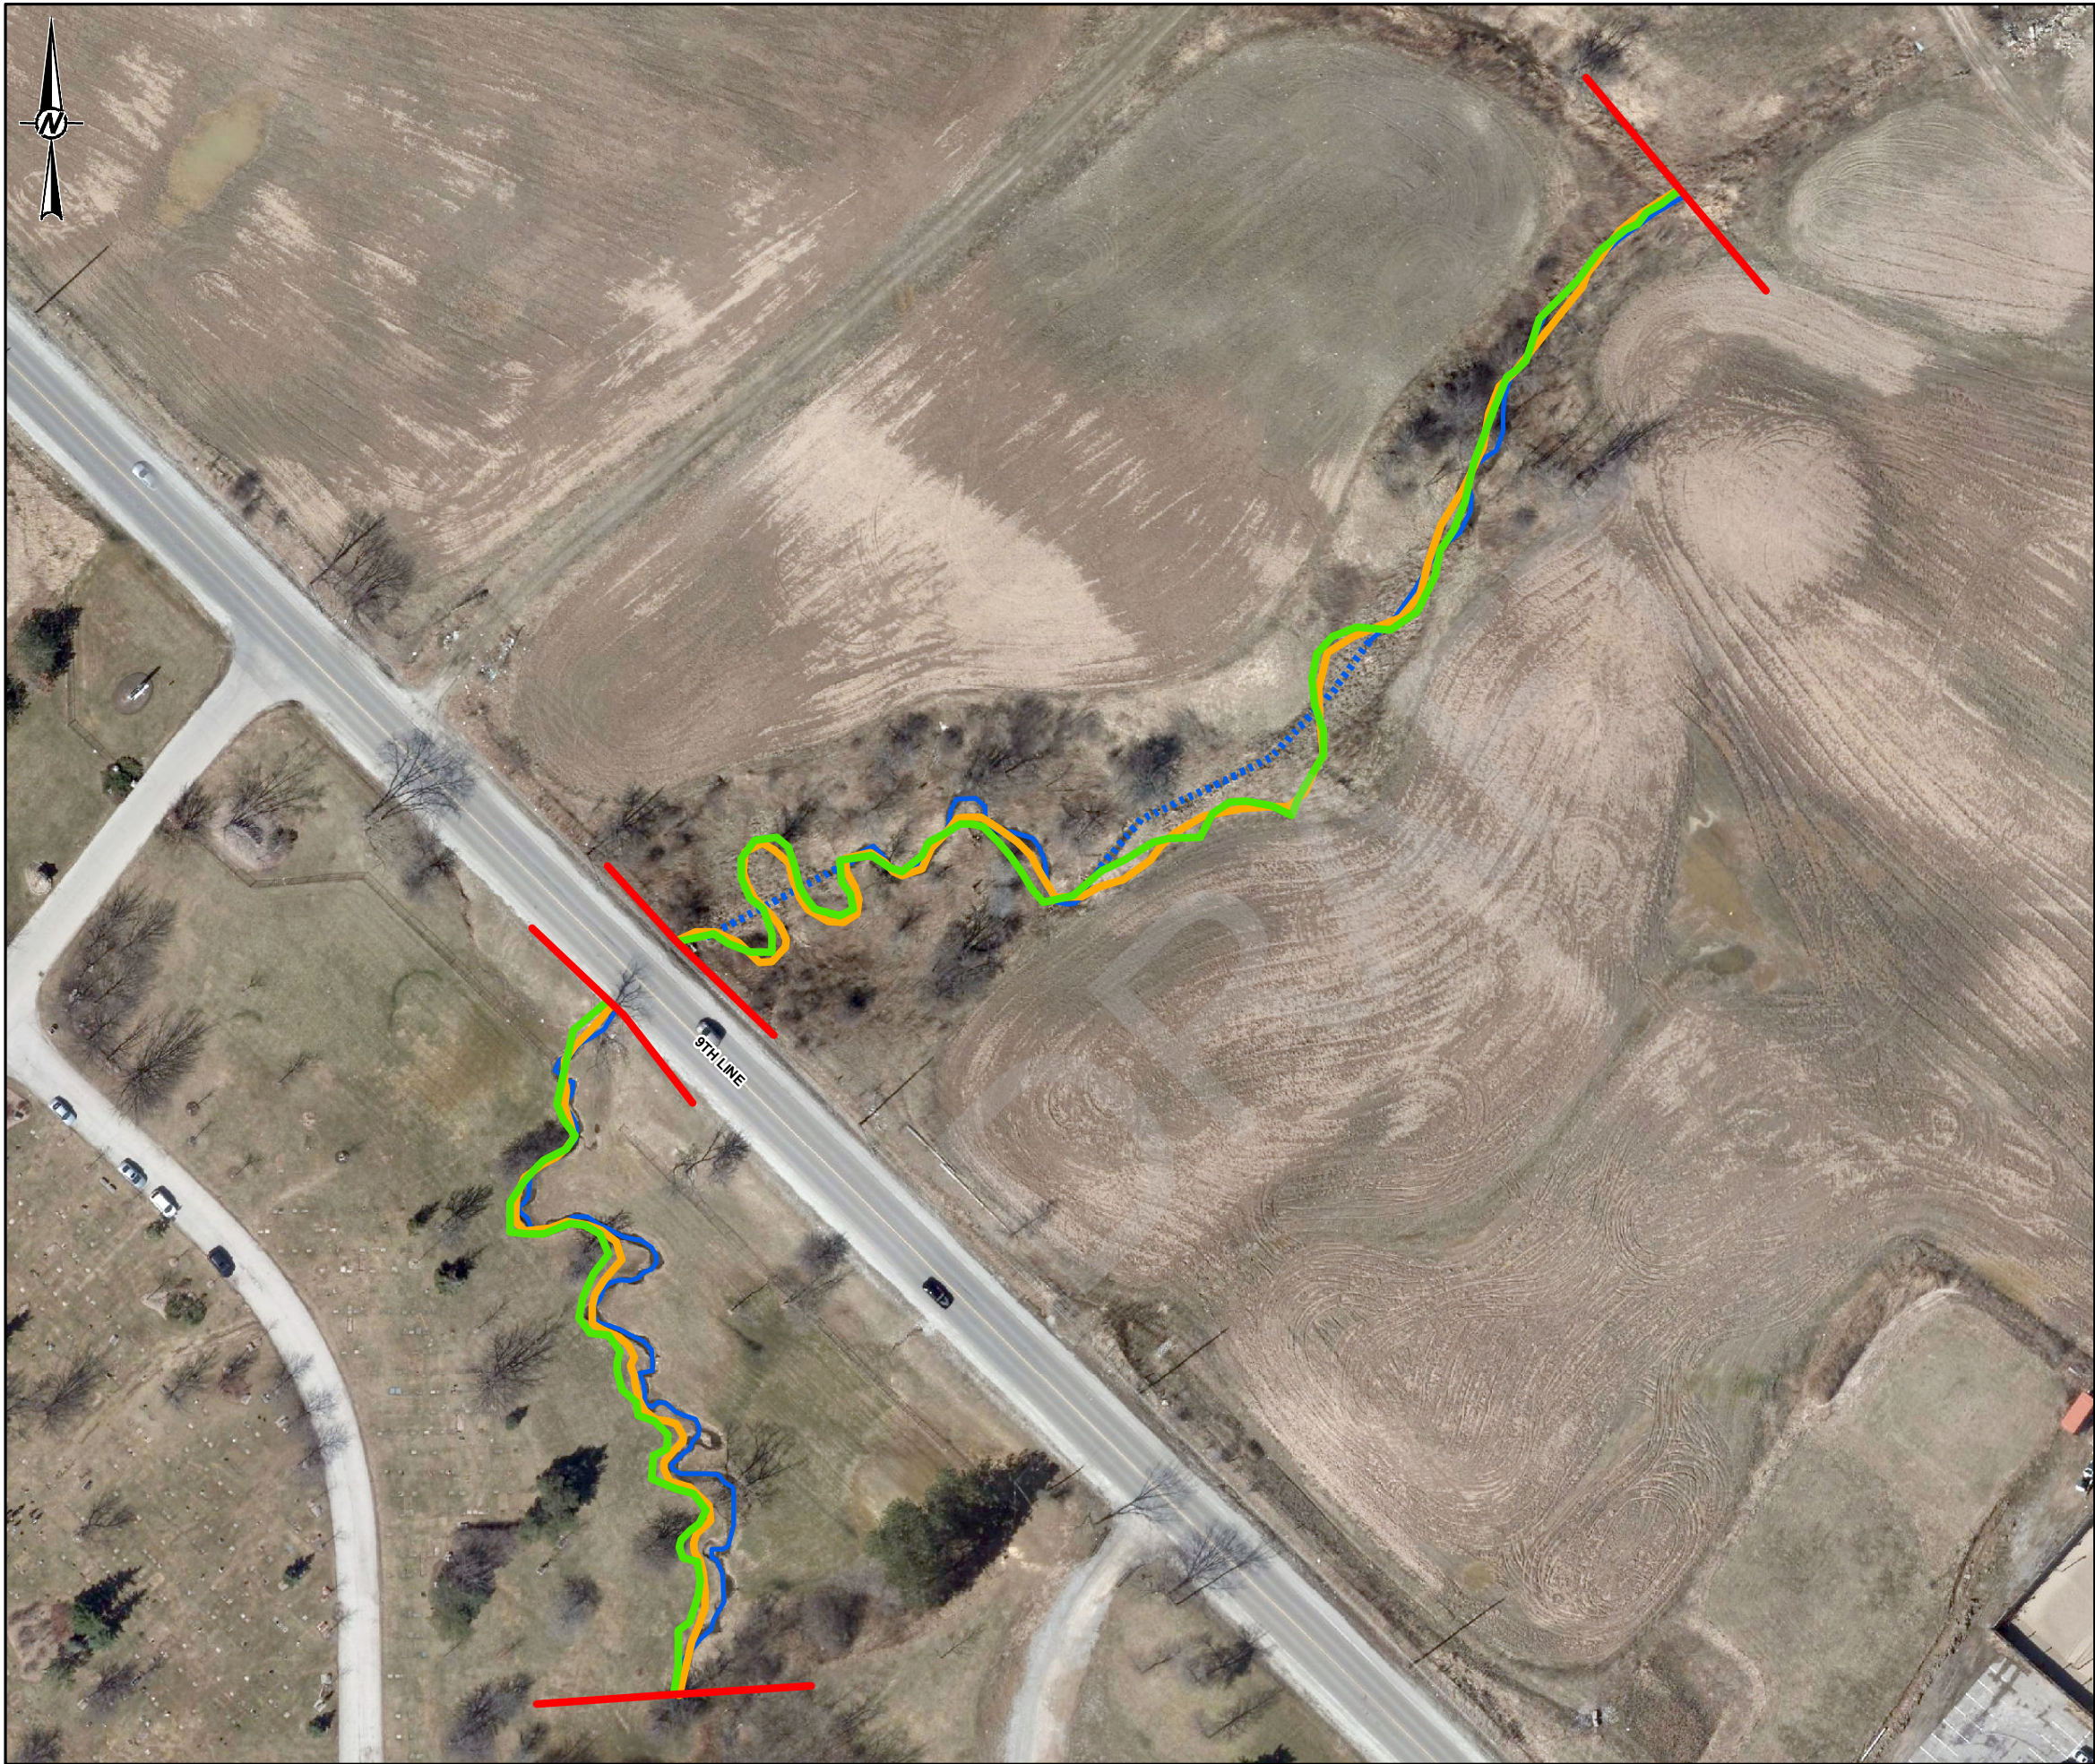
Figure 2 – Historical Channel Patterns for Study Area at Ninth Line

A historical air photograph analysis was completed in support of the meander belt assessment, and relied on aerial photography from 1960 and 1980, as well as orthoimagery from 2015. These images/photos were used to evaluate changes in channel patterns and surrounding land use over time at RL-01 and RL-02. The key results of the historical air photo analysis are summarized in Table 2, noting that channel and riparian conditions were largely discernible in each of the available photos/images. The observed changes in the channel planform are illustrated on Figure 2.

Overall, land use in the surrounding areas at RL-01 and RL-02 has been dominated by agriculture for the duration of the historical air photo record, recognizing that the conversion of agricultural fields to transportation infrastructure (specifically the Highway 403 corridor) and other land uses have occurred over the past 35 years. Channel planform at RL-01 and RL-02 remained largely unchanged for the initial 20 years of the air photo record (between 1960 and 1980); however, channel conditions at RL-01 has showed marked evidence of lateral instability (i.e., adjustment and migration of several meander bends) during the most recent period of record.

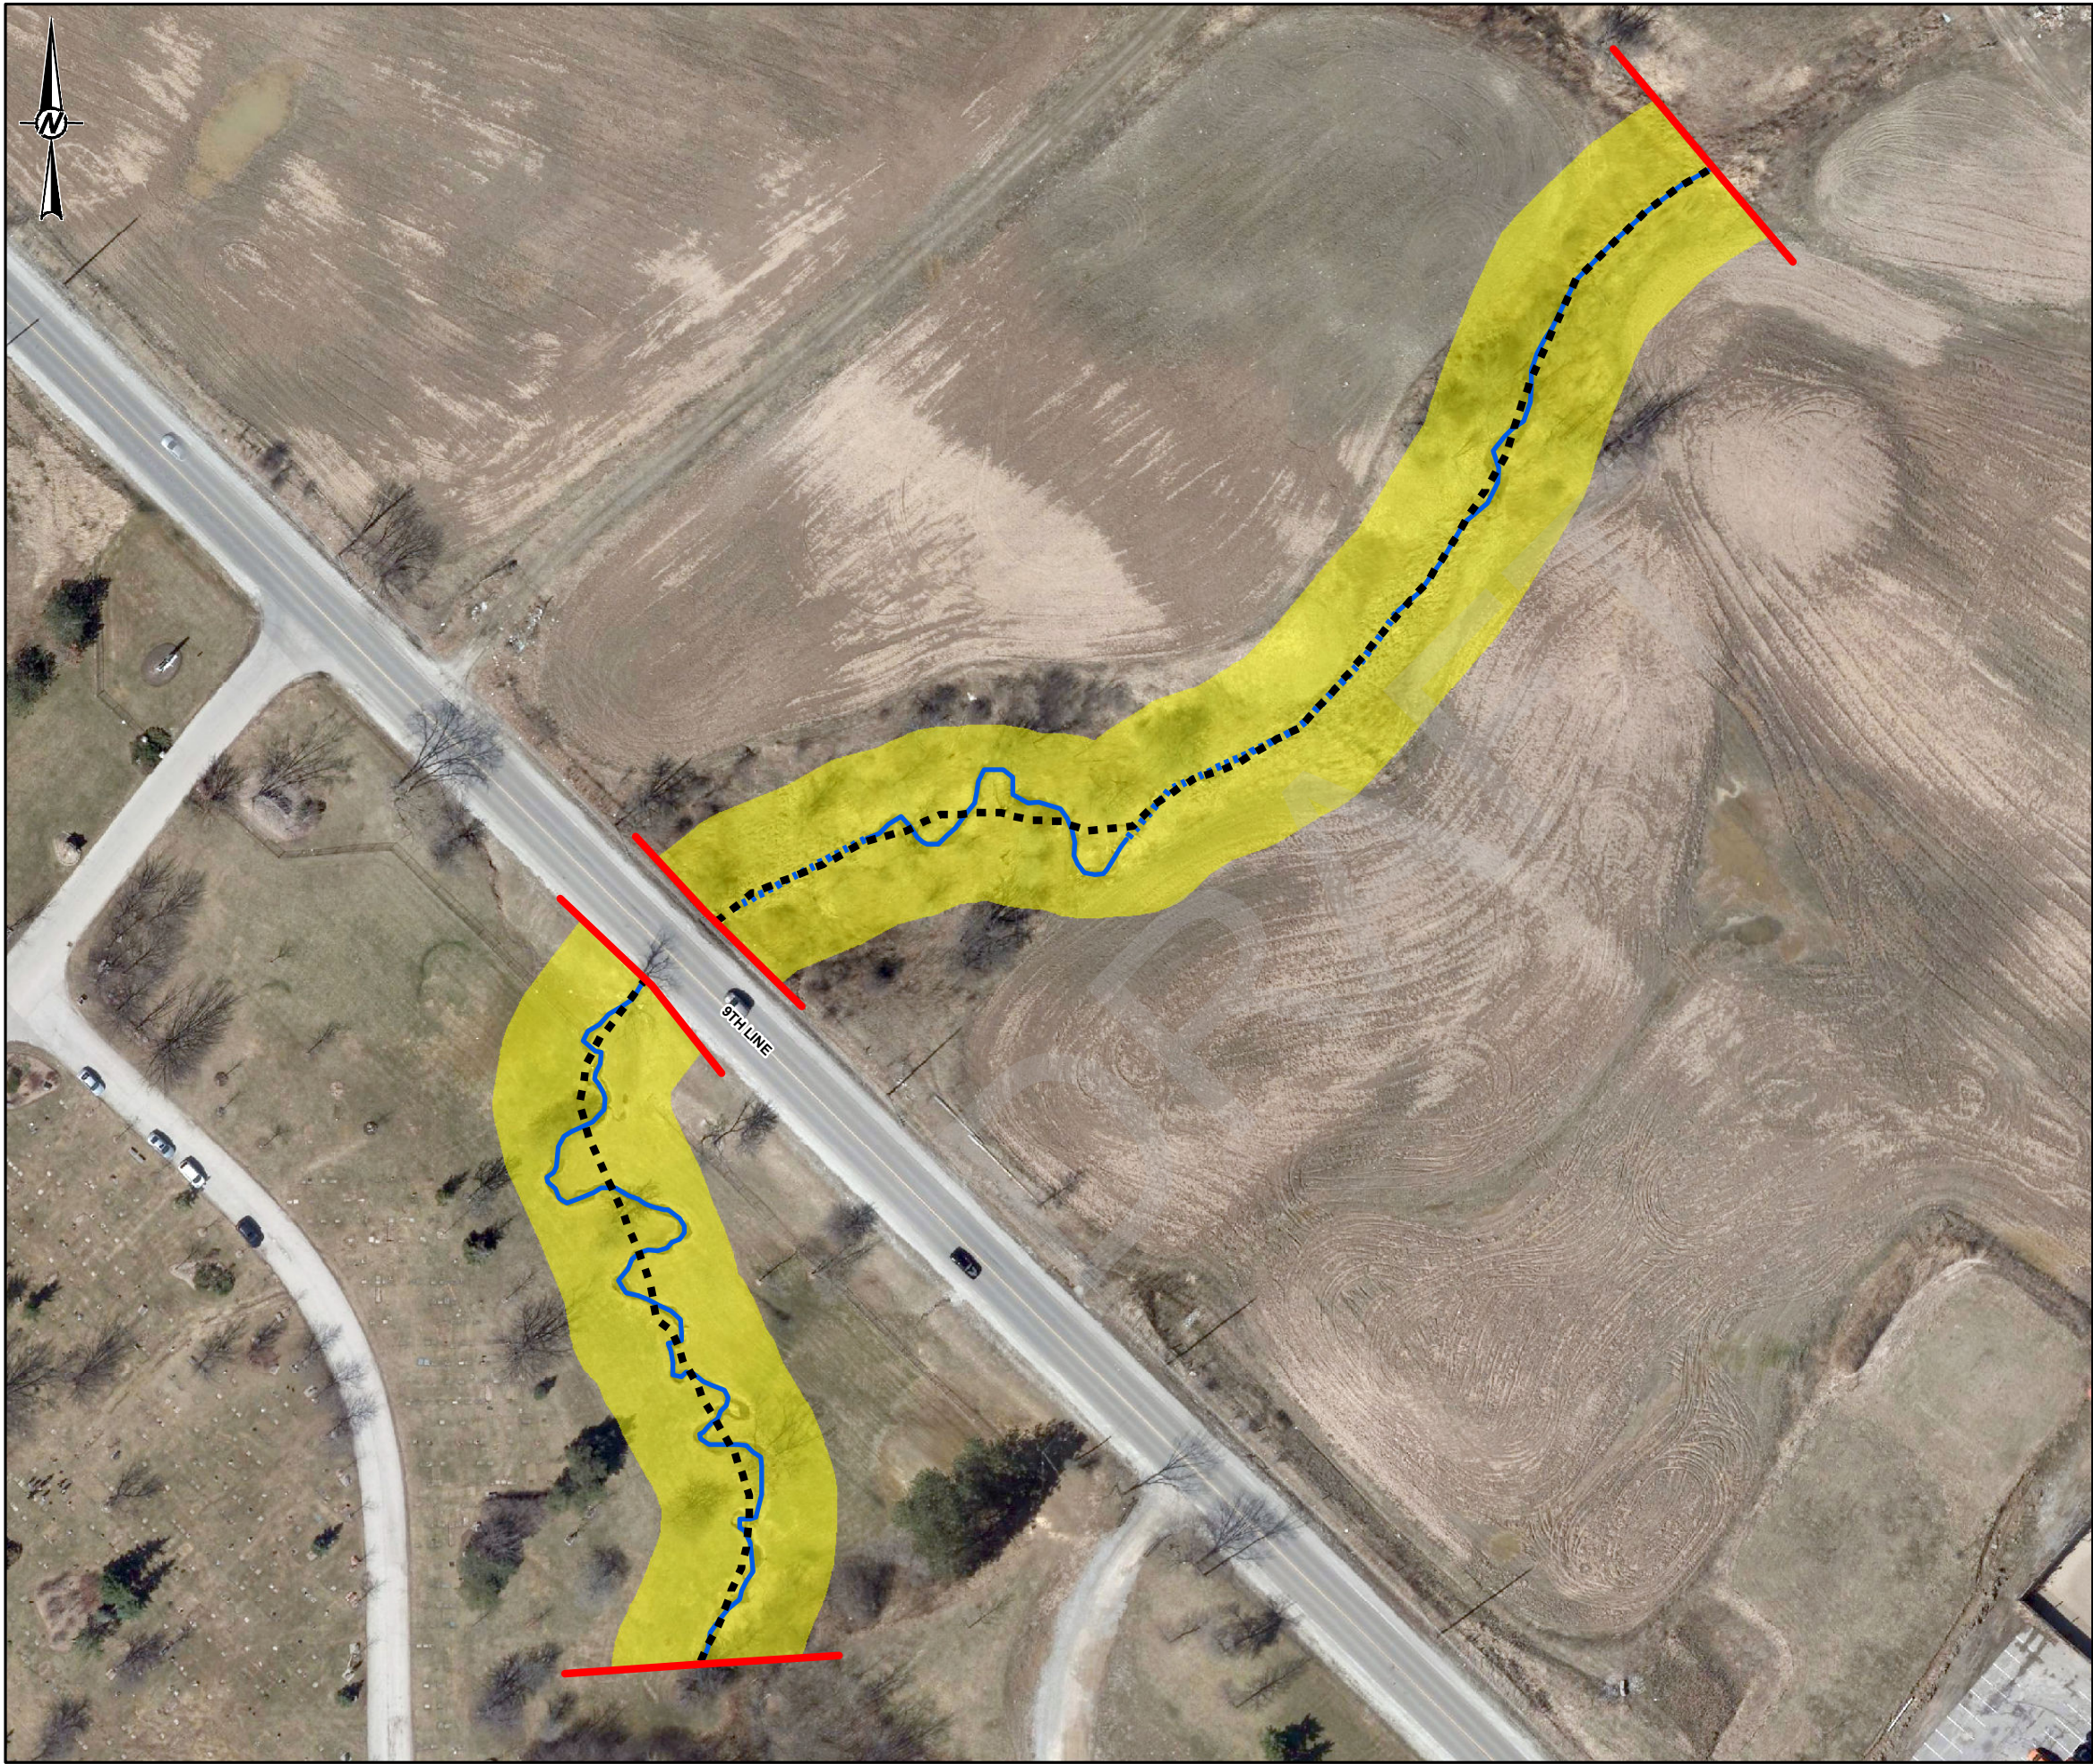
Figure 3 – Estimated Meander Belt Width for Study Area at Ninth Line

The final meander belt width of approximately 30 m was plotted on the 2015 aerial image (Figure 3); divided over the meander belt width axis to allow equal channel buffer on either side of the axis.

- The results of the desktop analysis at RL-01 and RL-02 suggest a meander belt width and an associated 100-year erosion limit of approximately 30 m and 27 m, respectively, noting that the estimated meander belt width is relatively consistent with the associated belt width boundaries from the North Oakville Creeks Subwatershed Study (for the portion of stream reach where this overlap between both assessments). Based on TRCA protocols, crossing structures should be constructed outside of the meander belt width of a watercourse to the extent possible, or, alternatively, the features should be designed to match or exceed the 100-year erosion limit of the channel. However, for this particular study, Golder is of the opinion that a crossing span less than the estimated dimensions of the meander belt width and 100-year erosion limit at RL-01 and RL-02 would be appropriate with consideration of the following:

For the reasons identified above and from the perspective of fluvial geomorphology, it is suggested that upgrade or replacement of the existing crossing structure at RL-01 and RL-02 include a width of approximately two (2) to three (3) times the average bankfull width of the channel, recognizing that the preliminary design of Culvert #9 (located at the crossing that separates RL-01 and RL-02) includes a span that is approximately three (3) times the bankfull width of the downstream channel. This suggested crossing span is expected to accommodate the identified fluvial geomorphic processes and hazards at the subject reaches. The preliminary recommendations described here are based on the results of the fluvial geomorphology assessment alone. Any modification to the crossing structure span will also need to consider the required hydraulic conditions (e.g., flood conveyance for the design event) and the relevant ecological functions (e.g., wildlife passage in the riparian zone).

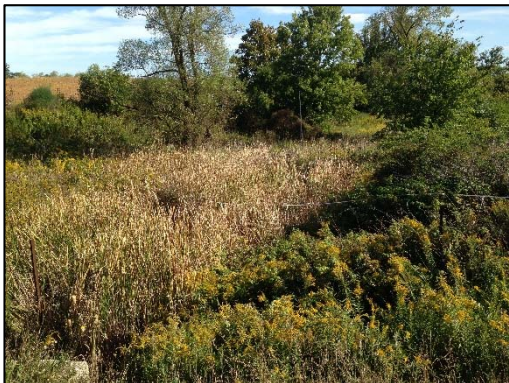
Photograph 1: RL-02; view looking upstream from the concrete box culvert on September 16, 2016.

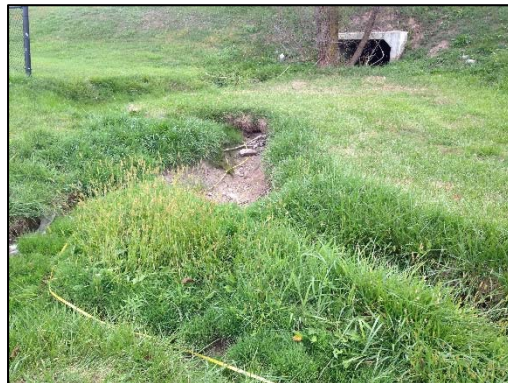
Photograph 2: RL-01; view looking upstream at a location immediately downstream of the concrete box culvert on September 16, 2016.

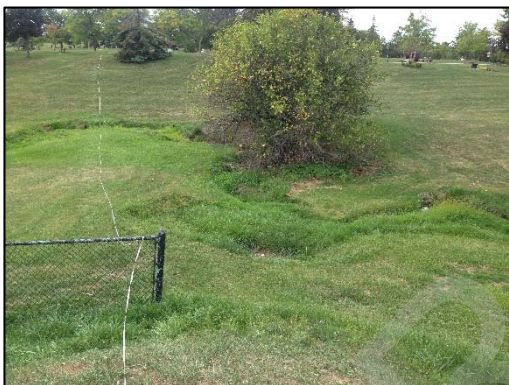
Photograph 3: RL-01; view looking downstream from the concrete box culvert on September 16, 2016.

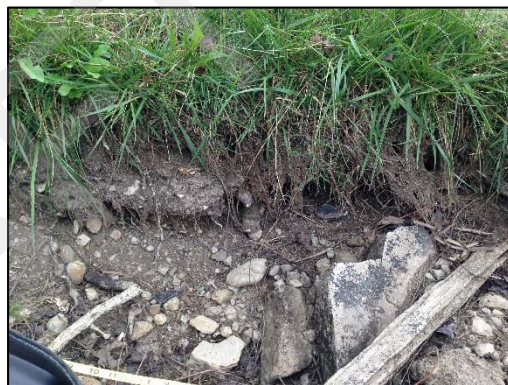
The completed RGA forms at RL-01 and RL-02 are presented in Attachment B. Grain size results for these reaches are presented in Attachment C. The results of the RGAs suggest that RL-01 is in adjustment (undergoing widening and planform changes), while RL-02 is comparatively stable.

- The identified channel instability at RL-01 is consistent with the results of previous studies at this stream reach (i.e., North Oakville Creeks Subwatershed Study). The observed conditions may reflect one or more of the following factors: channel alterations (i.e., straightening) in the upstream catchment, particularly the section of channel located immediately downstream of the Highway 403 crossing, coupled with potential changes to the local flow regime to accommodate drainage/runoff from the highway corridor; sediment aggradation or trapping at RL-02 (and hence reduced sediment conveyance to RL-01); and land management practices in the immediate riparian areas at RL-01 (i.e., manicured grass cover at the funeral home and cemetery) resulting in increased runoff to the channel and reduced stability in the overbank zone (relative to natural riparian vegetation).

Photograph 4: RL-01; observed bank erosion at a mid-reach location on September 16, 2016.

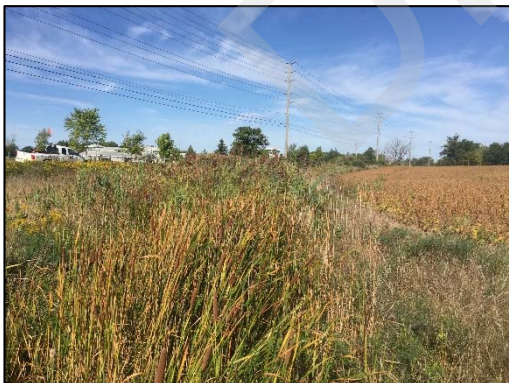
Photograph 5: RL-03; view looking upstream on September 21, 2016.

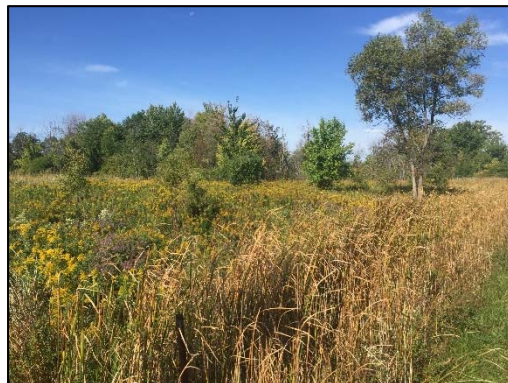
Photograph 6: PSW (RL-04); view looking west from Ninth Line on September 21, 2016.
