# **Appendix E**

## **Sheldon Creek – East Branch Fish Habitat Conditions Technical Memorandum**

To	Wolfgang Wolter, AECOM	Page 1
CC	File	
Subject	Sheldon Creek – East Branch Fish Habitat Conditions	
From	Sarah Aitken, Nicola Lower, AECOM	
Date	April 24, 2012	Project Number 60114069

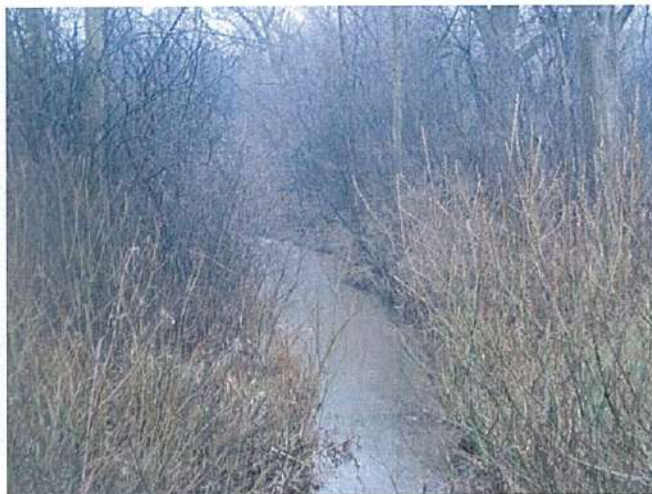
**Photograph 1 ↑**  
Reach 1 facing downstream from Creek Path Ave.

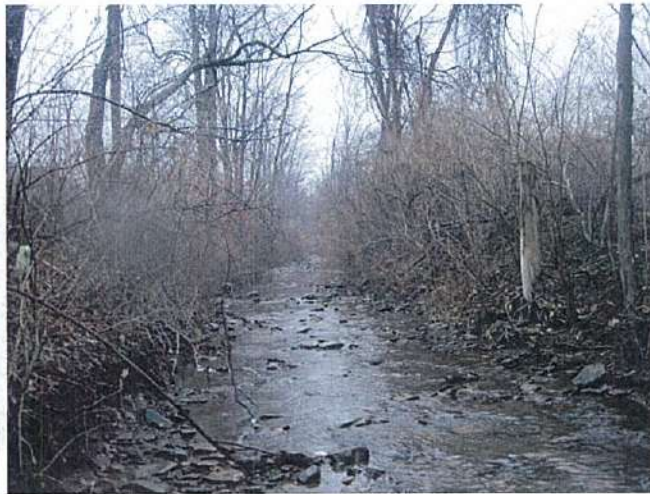
**Photograph 2 ↑**  
Reach 1 facing upstream.

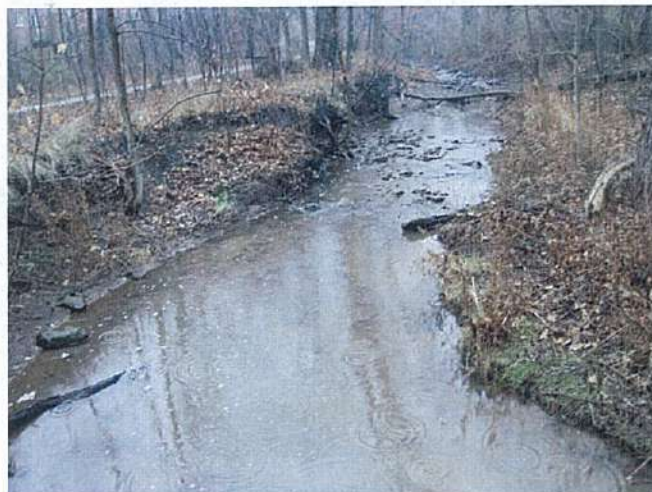
**Photograph 3 ↑**  
Reach 2 facing upstream

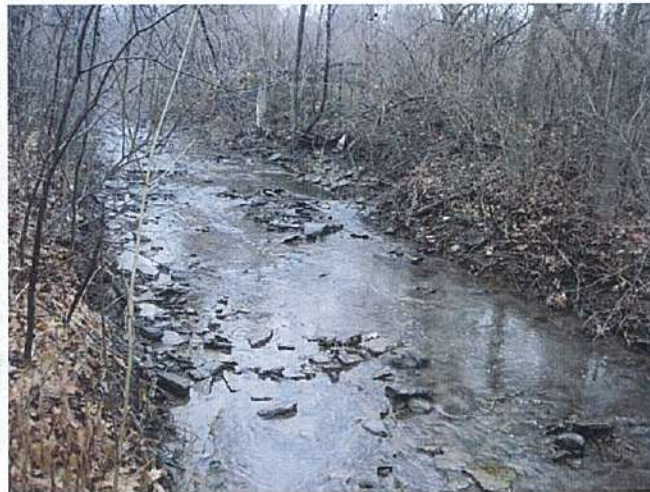
**Photograph 4 ↑**  
Reach 2 cobble substrate and instream cover.

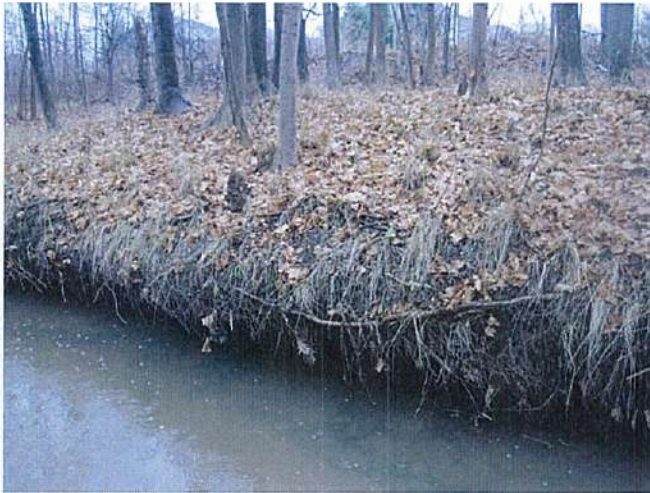
Riparian cover along this reaches is provided by large overhanging mature trees and shrubs. The stream banks are steeply graded, and appear moderately stable to unstable. Erosion and scouring was evident throughout Reach 2 and 3, particularly along the meander bends.

**Photograph 5 ↑**  
Reach 3 undercut banks providing refuge areas.

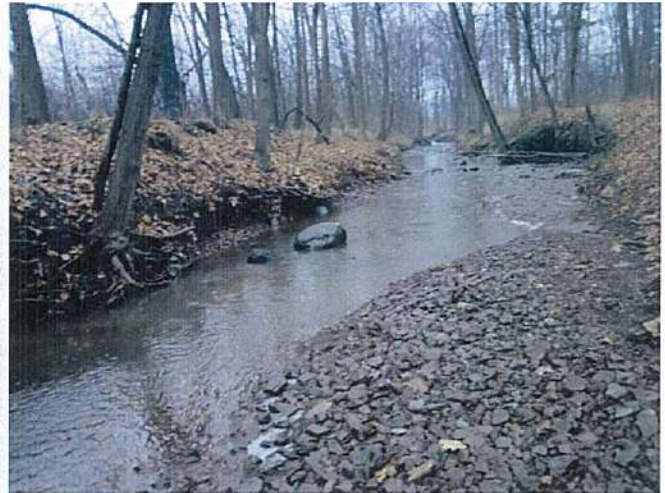
**Photograph 6 ↑**  
Reach 3 facing upstream

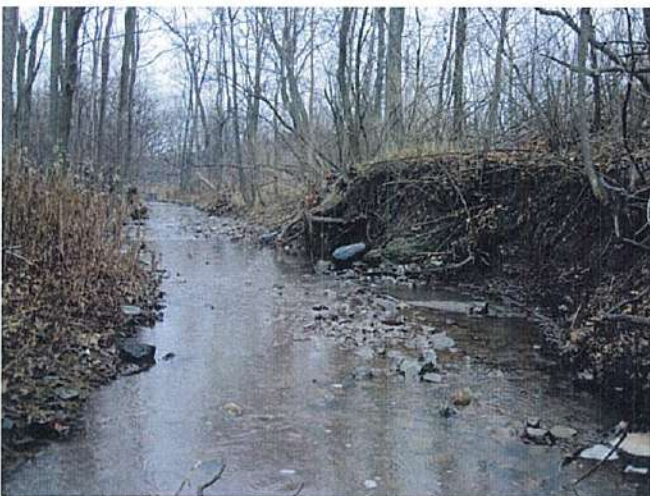
The stream banks in Reach 4 consist of sandy soils, with exposed shale that are steeply graded, and appear moderately stable to unstable. There was evidence of severe erosion and scouring throughout Reach 4. The severe erosion is likely the result of fast, high flows from rain events and the spring freshet. The intensity of the high flow events are characterized by debris up in tree branches, exposed root masses and the severity of the bank erosion. Rip-rap has been placed along the meander of the right bank of the east branch of Sheldon Creek near the Storm Water Management Pond (SWMP). The rip-rap extends into the floodplain approximately 10 m back from the creek bank. Filter cloth has also been installed along this bank and the banks are severely eroded behind the cloth. Rip-rap has fallen into Sheldon Creek and more rock sits precariously on top of bank.

**Photograph 7 ↑**  
Reach 4 facing downstream at eroded left bank

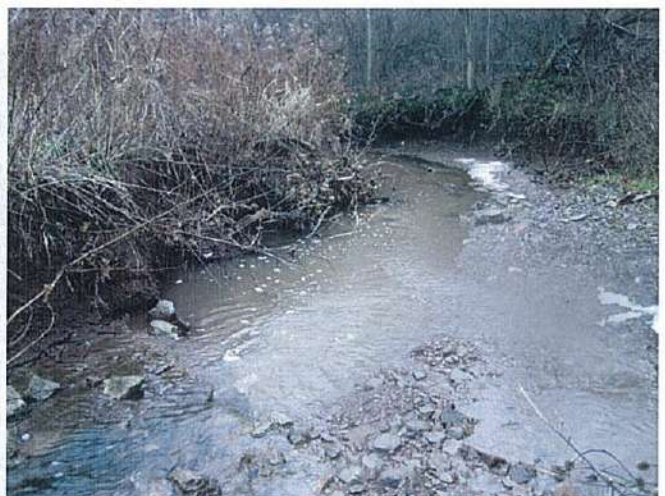
**Photograph 8 ↑**  
Reach 4 facing downstream riffle/pool sequence
