New North Oakville Transportation Corridor and Crossing of Sixteen Mile Creek

Appendix G: Fluvial Geomorphological Assessment

**NEW NORTH OAKVILLE TRANSPORTATION CORRIDOR
(BURNHAMTHORPE ROAD) – CLASS EA STUDY
~ FLUVIAL GEOMORPHOLOGICAL COMPONENT ~**

TO: MR. MIKE DELSEY, P.ENG., TSH ENGINEERS.
FROM: KIM LEBRUN, B.SC. AND JOHN PARISH, P. GEO, M.A.
SUBJECT: EROSION ASSESSMENT – NEW NORTH OAKVILLE
TRANSPORTATION CORRIDOR (BURNHAMTHORPE ROAD) –
CLASS EA STUDY
(FINAL)
DATE: APRIL 2008

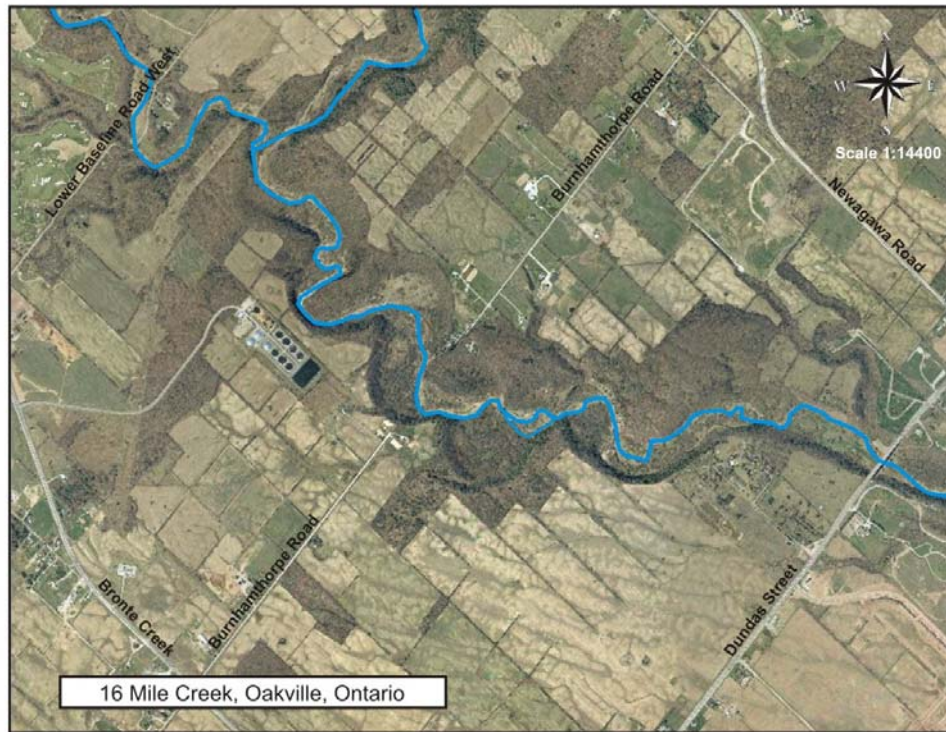
Figure 1. Map identifying the area included in the study and assessment of an appropriate watercourse crossing or the Burnhamthorpe road extension.

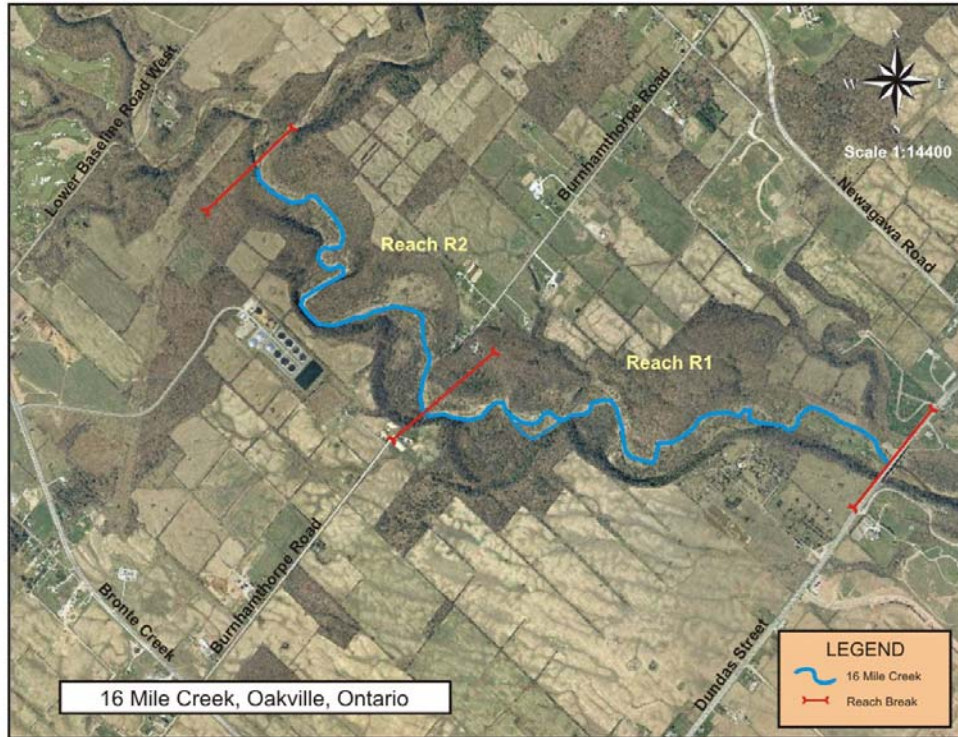
Figure 2. Map identifying the reaches delineated from historical aerial photographs and topographic mapping.

Channel form is a product of the flow (magnitude) and the channel materials (sediment type, supply, and bed/bank strength). If one of these parameters is altered, the channel adjusts its form to retain or find a new ‘dynamic equilibrium’. The characteristics of the flow or channel materials can change along a creek or stream. In order to account for these changes, channels are separated into reaches - generally several hundred meters to several kilometres in length. Delineation of a reach considers sinuosity, gradient, hydrology, local geology, degree of valley confinement, and vegetative control using methods outlined in PARISH Geomorphic Ltd. (2001). The section of 16 Mile Creek being considered for potential bridge crossing locations was broken down into two reaches based mainly on channel confinement and surrounding land use (See **Figure 2**).
