Appendix E
Black Creek Geomorphic and
Hazard Limit Assessment –
revised report

Black Creek

Geomorphic and Erosion Hazard Limit Assessment

May 2011

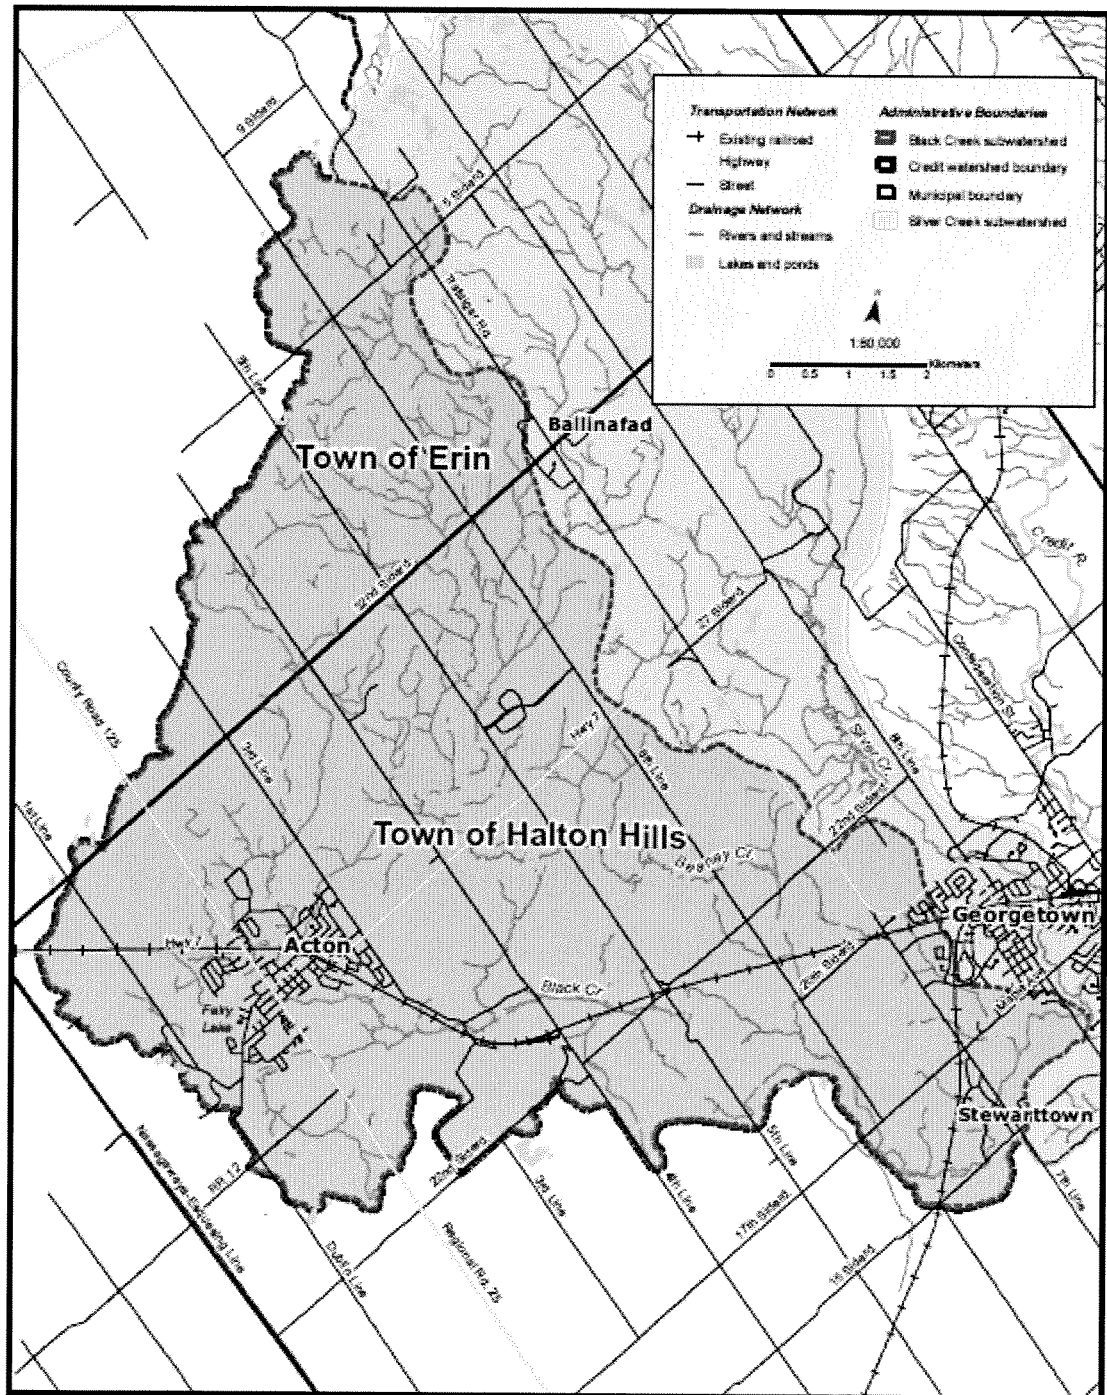
Figure 1. Black Creek subwatershed (image courtesy of CVC, 2009).

The Black Creek subwatershed is approximately 79.28 sq. km in area and is a major tributary of Silver Creek (**Figure 1**). The majority of land use within the subwatershed is agricultural, with areas of wetland and tracts of forest cover. Acton and Georgetown represent the two main zones of urbanization within the catchment. Within the study area, Black Creek flows through till moraine, a sandy to silty till which is hummocky in nature. Underlying bedrock within the area is dominated by the Amabel/Lockport formation, a grey to medium blue-grey dolostone. This study area has been identified as the Black Creek at Acton Wetland Complex (CVC, 2009). This complex covers an area of 78.4 ha and straddles the Niagara Escarpment and horseshoe moraines to the northwest end. The wetland complex is largely a floodplain wetland. This wetland environment has been noted as providing habitat for brook trout and the provincially rare redbreasted dace as well as habitat for many regionally rare plant species.

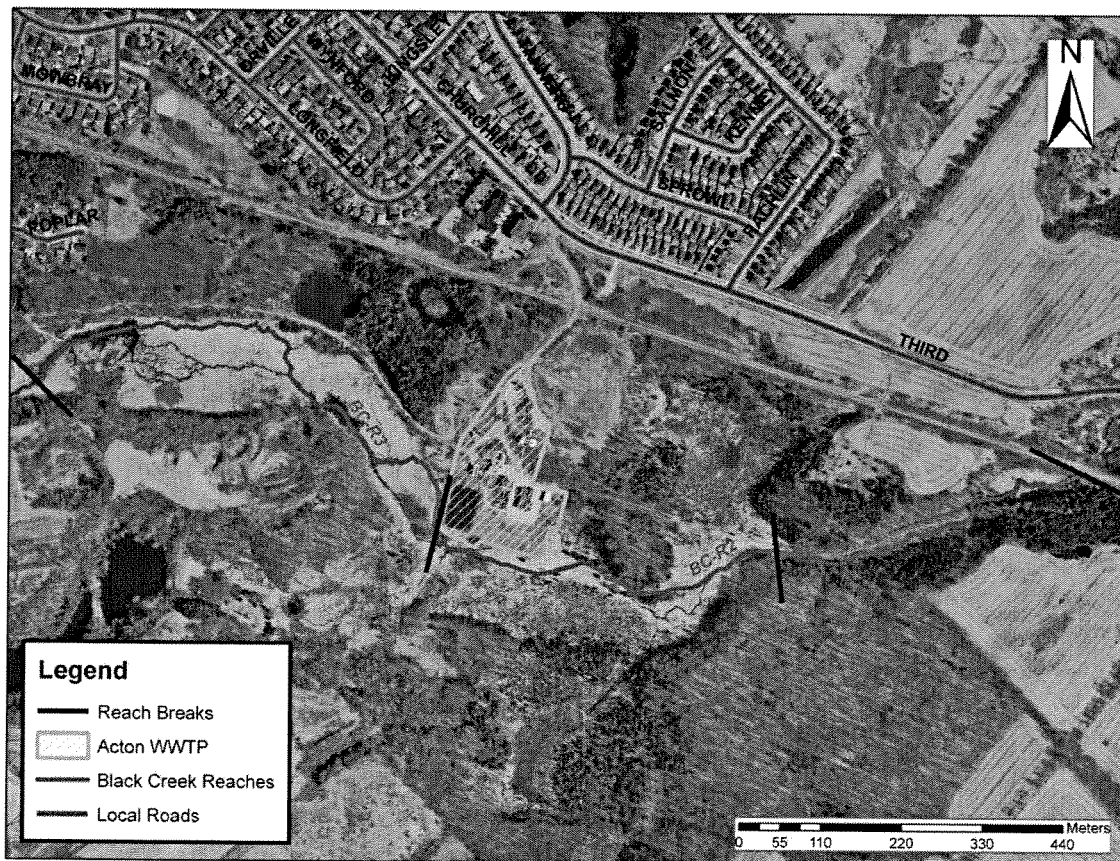
Figure 2. General study area (Acton WWTP highlighted).

The characteristics of the flow or channel materials can change along a creek or stream. In order to account for these changes, channels are separated into reaches – normally several hundred meters to several kilometers in length. A reach displays similarity with respect to its physical characteristics, such as channel form, function, and valley setting. Delineation of a reach considers sinuosity, gradient, hydrology, local geology, degree of valley confinement, and vegetative control using methods outlined in PARISH Geomorphic Ltd. (2001). Based primarily upon land-use, sinuosity, and topography, a total of three reaches were identified for Black Creek within the vicinity of the Acton WWTP (**Figure 2**). Reaches BC-R3, BC-R2, and BC-R1 measure 720, 480, and 460 meters, respectively. As illustrated in **Figure 2**, the broad floodplain conditions surrounding Black Creek within the study area contain a channel that displays multiple channels and standing water conditions typical of a wetland/marsh area. For the purposes of mapping, the main channel (preferential flow route) has been identified.

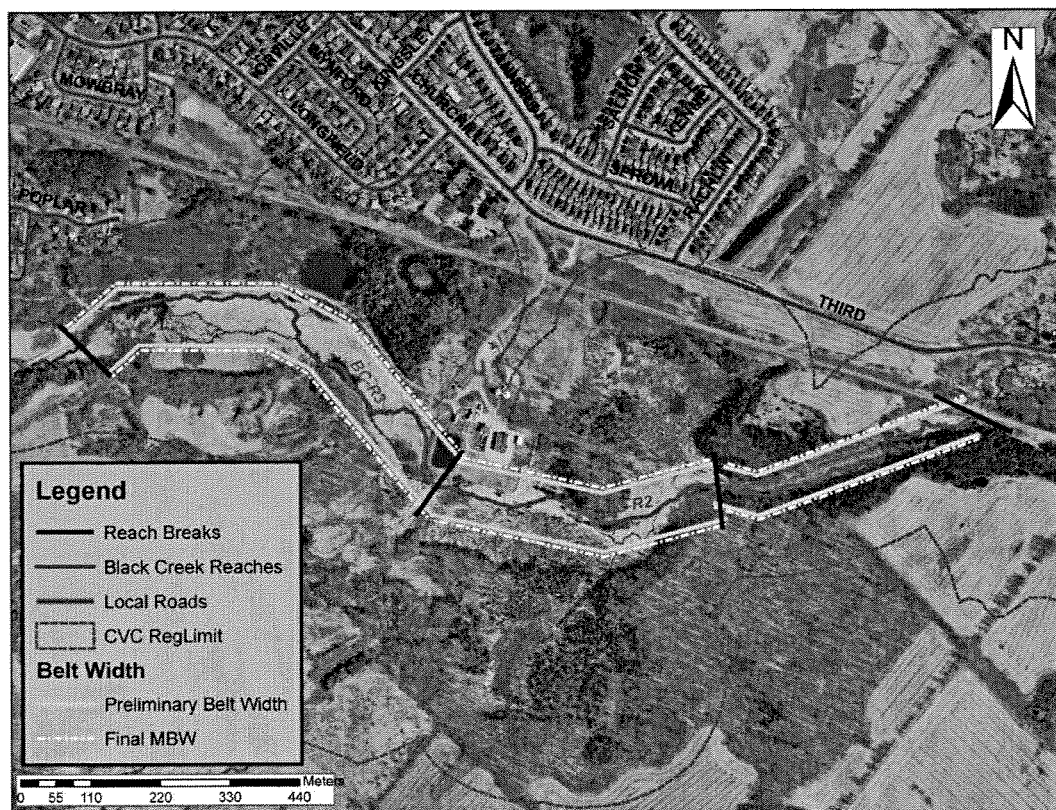
Figure 3. Geomorphic hazard limit delineation for expansion of the Acton WWTP.

In support of the Provincial Policy Statement, the Toronto and Region Conservation Authority (TRCA) has produced a detailed document which outlines Belt Width Delineation Procedures (PARISH Geomorphic Ltd., 2004) for confined and unconfined systems. This document provides a process-based methodology for determining the meander belt width for watercourses within the jurisdiction of the TRCA based on background information, historic data (including aerial photography), degree of valley confinement and channel planform. Based on available mapping and digital aerial photography, a preliminary belt width was delineated for Black Creek in vicinity of the subject property on a reach basis. Due to the nature of wetland setting, the dimension of the meander belt width was largely driven by the dimension of the active floodplain in order to capture the multiple flow patterns associated with this section of Black Creek. This resulted in a preliminary belt width of 90 m for Reaches BC-R2 and BC-R3, and a preliminary belt width of 60 m for Reach BC-R1 which displayed a much more defined channel and flow pattern (**Figure 3**).

As illustrated in **Figure 3**, a portion of the Acton WWTP property is located within the meander belt width. As such, following the letter of regulatory policy, this would characterize the Acton WWTP as being situated within hazard lands. However, the evaluation of geomorphic risk to this facility should also be cognizant of the extent of the regulatory limit also identified in **Figure 3**, and the low-energy wetland environment that typifies Black Creek within the study area. The WWTP property has been in existence since at least 1978. Based on aerial photography analysis, the property does not appear to show evidence of active erosion due to its proximity to Black Creek. The proposed WWTP expansion does not require an expansion of the original development footprint (**Figure 5**); therefore, the risk to this proposed development is no greater than to that of the original plant. With this in mind, the actual risk to the Acton WWTP in the form of channel migration or erosion was deemed minimal.

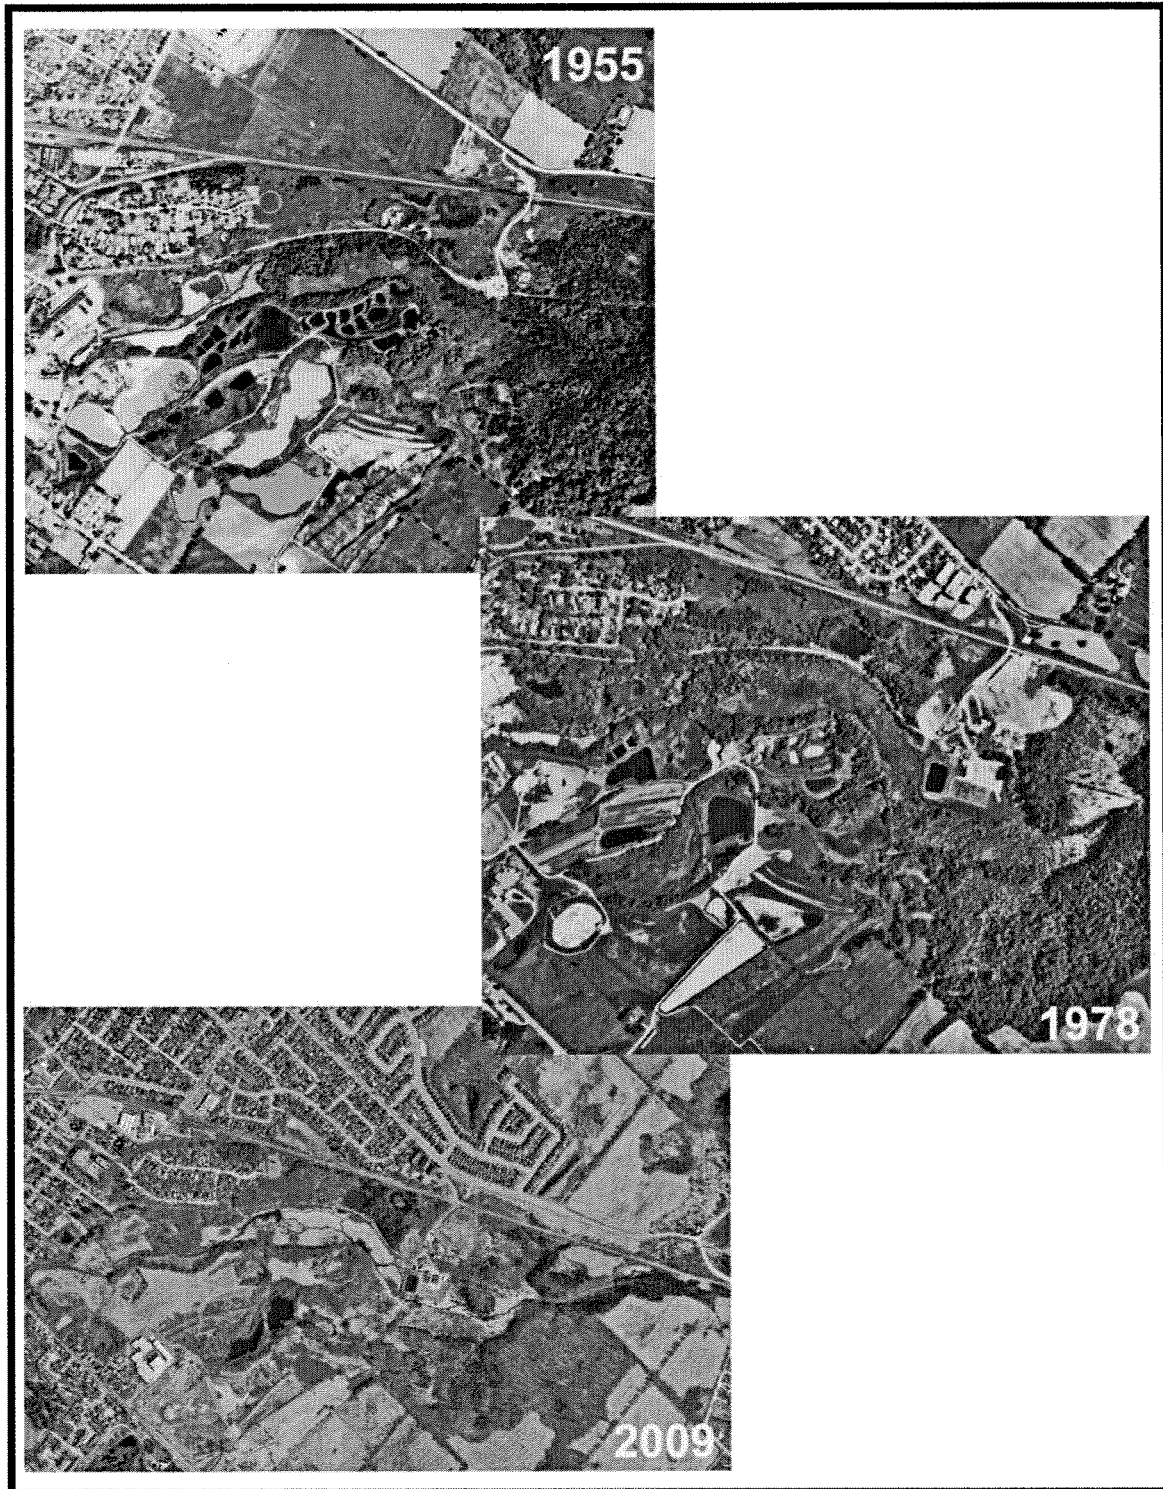
Figure 4. Historic aerial photography coverage of the general study area.

For the purposes of this study, historic aerial coverage of the general study area dating from 1955 and 1978 was compared to recent digital ortho imagery (2009) in order to document changes in land use and channel form over time (**Figure 4**). In 1955, the access road to the WWTP is evident off of Third Line. Residential development can also be observed, largely northwest of Highway 7. This development then expands east towards the WWTP between 1955 and 2009. The greatest observable change within the stream corridor is the modifications to the floodplain and wetland complex. In 1955, a series of ponds are visible just upstream of the general study area. By 2009, only two such ponds are visible. The footprint of the WWTP was established by 1978.

Typically, air photo analysis also supports the quantification of the 100-year erosion rate. From a geomorphic perspective, the 100-year migration rate generally represents the erosion setback to be applied to either side of the meander belt width in order to account for bank erosion and channel migration over time. However, due to the degree of vegetative cover and wetland/multiple flow path nature of Black Creek within the study area, migrations could not be quantified on a reach basis in vicinity of the study site. In lieu of applying the 100-year migration rate, however, an erosion setback that considered both the preliminary meander belt width, the findings of the field investigation and the Provincial Policy Statement 3.1 guidance on toe erosion allowance was applied to either side of the channel. For the Black Creek study area, this resulted in a setback of 8 meters on either side of the channel for Reaches BC-R2 and BC-R3 and a setback of 6 m for BC-R1 (**Table 2**). These setbacks were based on the reported average bankfull channel widths of less than 5 m, as well as the observed evidence of active erosion in the form of channel widening. Given that the majority of this widening appeared to be associated with the numerous woody debris jams and beaver dams, the minimum toe erosion allowance was applied for Reaches BC-R2 and BC-R3. Since Reach BC-R1 scored as the most stable reach within the study area, the setback represents 10% of the meander belt width and was considered appropriate within the context of the PPS (**Table 3**).

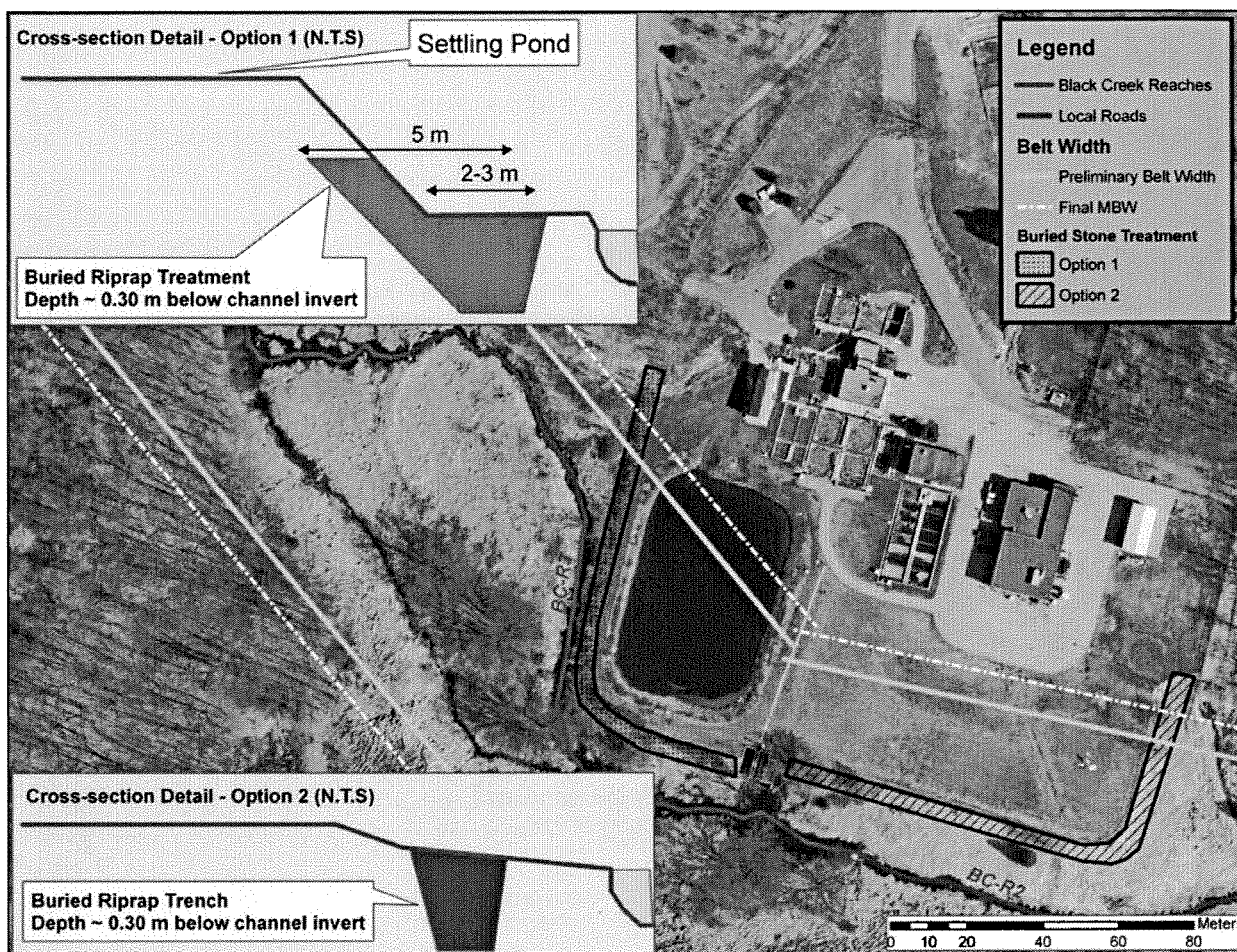
Figure 6. Potential erosion mitigation measures.

While the risk to the WWTP due to erosion was deemed minimal, the results of the field evaluation did identify evidence of some active erosion (channel widening). With this in mind, two potential mitigation measures have been developed in order to provide an additional factor of safety against future bank erosion or channel migration. **Figure 6** illustrates a treatment involving a trench and bank work (Option 1) and a buried trench/barrier treatment (Option 2). Both of these treatments incorporate the use of Class 1 rip rap (D50 of 30 cm). Rip rap is a special application of rock protection. It consists of rocks, broken rocks, angular stones or concrete debris placed together in a set and stable manner to a specified thickness for the protection of slopes and surfaces. It is used in areas where erosion is presently a problem or is an anticipated concern. While the size class associated with Class 1 rip rap may vary slightly depending on the source of the aggregate

materials, the general size range corresponds to 15-45 cm. The treatment could also include finer material (sand and gravel to fill the voids). It should though be of a large enough size (as we have specified D50 of 30cm) to resist any possible future erosive force from the creek.

Option 1 (trench & bank treatment) is best suited for the length of property located along the existing settling pond where the difference in grade is sufficient to allow the incorporation of a stone treatment into the bank/berm face. In the event though that the ponds are not required and are de-commissioned, then there would not be a need for the protection measures. Along the portion of the property identified for the new secondary clarifiers and UV disinfection building, a buried trench/barrier treatment (Option 2) is likely more appropriate as the property appears to be at sitting close to floodplain elevation. In both cases, the Class 1 rip rap should be installed to a depth greater than that of the existing channel invert (by around 0.3 m). The width and location of the treatments were designed in such a way to avoid disturbance of the active channel, while also avoiding encroachment on the property limits. The width of the stone trench treatment will largely be driven by the depth of stone required and an optimal side slope greater than 1:1.

However, the findings of the field investigation did indicate evidence of active erosion along the study reaches, thus mitigative measures were developed for the property. These measures entail the installation of a trench/barrier treatment along the property limits that provide an additional factor of safety against bank erosion/channel migration. In support of the detailed design stage, some additional analyses would be required in order to ensure appropriate stone sizing and depth of treatment. This would entail the collection of detailed geomorphic field information within the study reach (sections, substrate/bank characterization and long profile). This data would then be processed in order to estimate a range of velocities and shear stresses for the active channel, as well as provide a context for scour potential along the bed. Detailed cross-sectional information would also confirm the required depth of the stone treatment such that it achieves the minimum 0.30 m below the existing channel invert. The results of this work would support or refine the mitigation concepts presented in this report.
