BRITANNIA ROAD TRANSPORTATION CORRIDOR IMPROVEMENTS: TREMAINE ROAD TO HIGHWAY 407 CLASS EA STUDY

**ENVIRONMENTAL STUDY REPORT –
TERRESTRIAL AND AQUATIC RESOURCES**

A Report Submitted by:
Aquafor Beech Limited

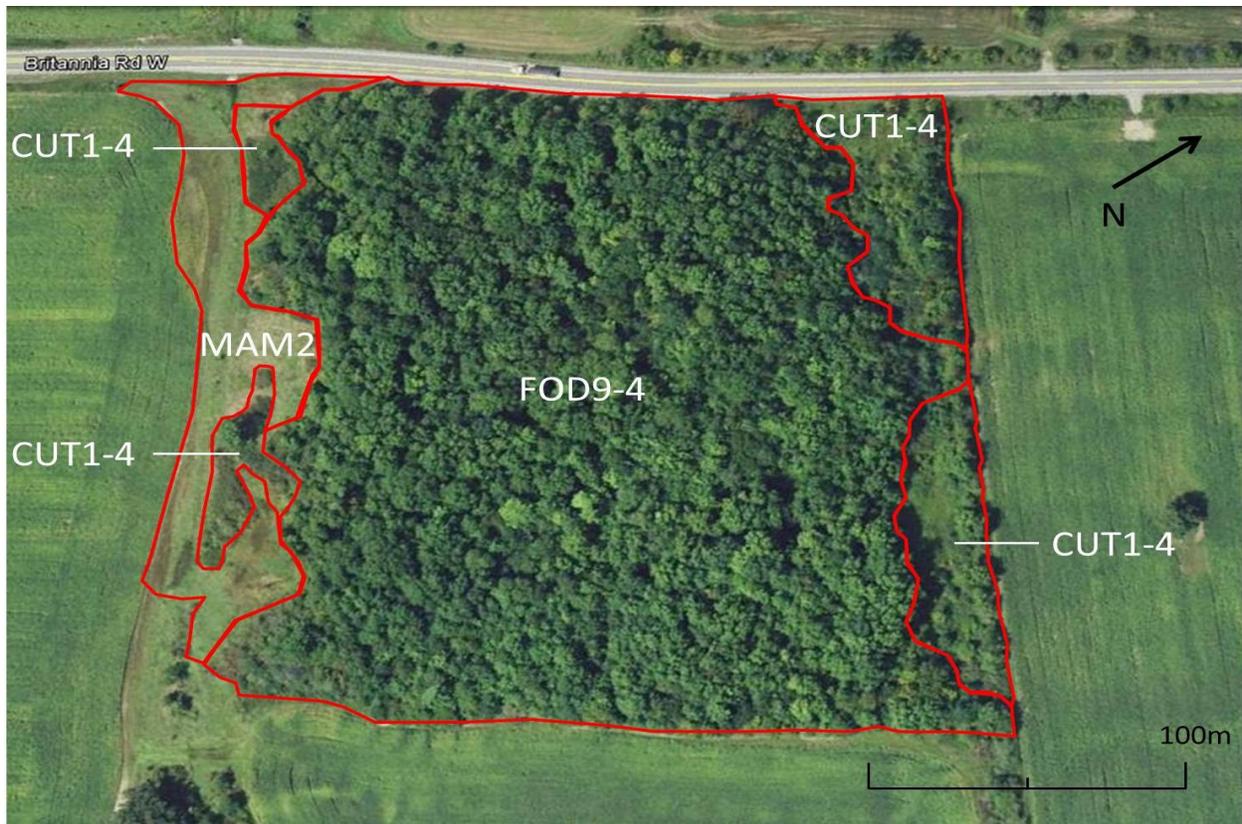
Figure 3.1: ELC Mapping for the Western Woodland and Adjacent Natural Areas

ELC mapping for the Western Woodland is found in Figure 3.1. The Western Woodland is composed of a Fresh-Moist Shagbark Hickory Deciduous Forest (FOD9-4), with a Grey Dogwood Cultural Thicket (CUT1-4) complex present along the western and eastern margins. A Mineral Meadow Marsh flanks the west tributary of Sixteen Mile Creek between the woodland and agricultural fields to the west.

In terms of landscape position, the Western Woodland is situated on the tablelands and exhibits a slight decline in elevation in a north-south direction. Vernal pooling was observed throughout the woodland (particularly within the northern half), and many pools still contained standing water a few centimeters deep at the time of field activities. The soil texture was a heavy clay, and composed of a thick A horizon (16cm) stained black with humus. Mottling was observed at the boundary of the A and B horizons, consequently indicating the woodland is very moist (engendered by the heavy clay soil).

The dominant canopy species include shagbark hickory, green ash, basswood (*Tilia americana*) and sugar maple, with lesser amounts of bur oak, American elm, ironwood, red maple (*Acer rubrum*) and red oak. Sugar maple (*Acer saccharum*) becomes more dominant as one travels south through the woodland. A few scattered individuals of white oak, American beech (*Fagus grandifolia*) and bitternut hickory were also observed as canopy trees. The understory contained mostly regenerating tree species (particularly shagbark hickory and green ash) along with grey dogwood (*Cornus foemina*), European buckthorn and musclewood (*Carpinus caroliniana*). Hawthorns (*Crataegus* spp.) and European buckthorn are more common along the eastern margin (particularly in the northern half) of the woodland where light penetration is more pronounced. Dominant groundcover species include wild geranium (*Geranium maculatum*), Virginia waterleaf (*Hydrophyllum virginianum*), garlic mustard, and enchanter's nightshade (*Circaea lutetiana*).

A Grey Dogwood Cultural Thicket (CUT1-4) complex was noted on the eastern and western margins of the woodland. The dominant species include grey dogwood, European buckthorn and various hawthorn species. Scattered American elm and bur oak trees were also observed. The groundcover consisted of a mix of both facultative species, including Kentucky blue grass (*Poa pratensis* ssp. *pratensis*), cow vetch (*Vicia cracca*), smooth brome (*Bromus inermis*), and paniced aster (*Symphotrichum lanceolatum*). Scattered wetland species such as American water-horehound (*Lycopus americana*) and fragrant bedstraw (*Galium triflorum*) were noted in wetter hollows.

A Mineral Meadow Marsh (MAM2) dominated almost exclusively by meadow foxtail (*Alopecurus pratensis*) has developed along the west tributary of Sixteen Mile Creek between the Western Woodland and agricultural fields to the west. Only scattered individuals of path rush (*Juncus tenuis*), broad-leaved cattail (*Typha latifolia*), narrow-leaved cattail (*Typha angustifolia*), cursed crowfoot (*Ranunculus sceleratus*) and curly dock (*Rumex crispis*) were found amongst the broad expanse of meadow foxtail. Western chorus frog was found to be breeding within the tributary (see Section 3.1.5).

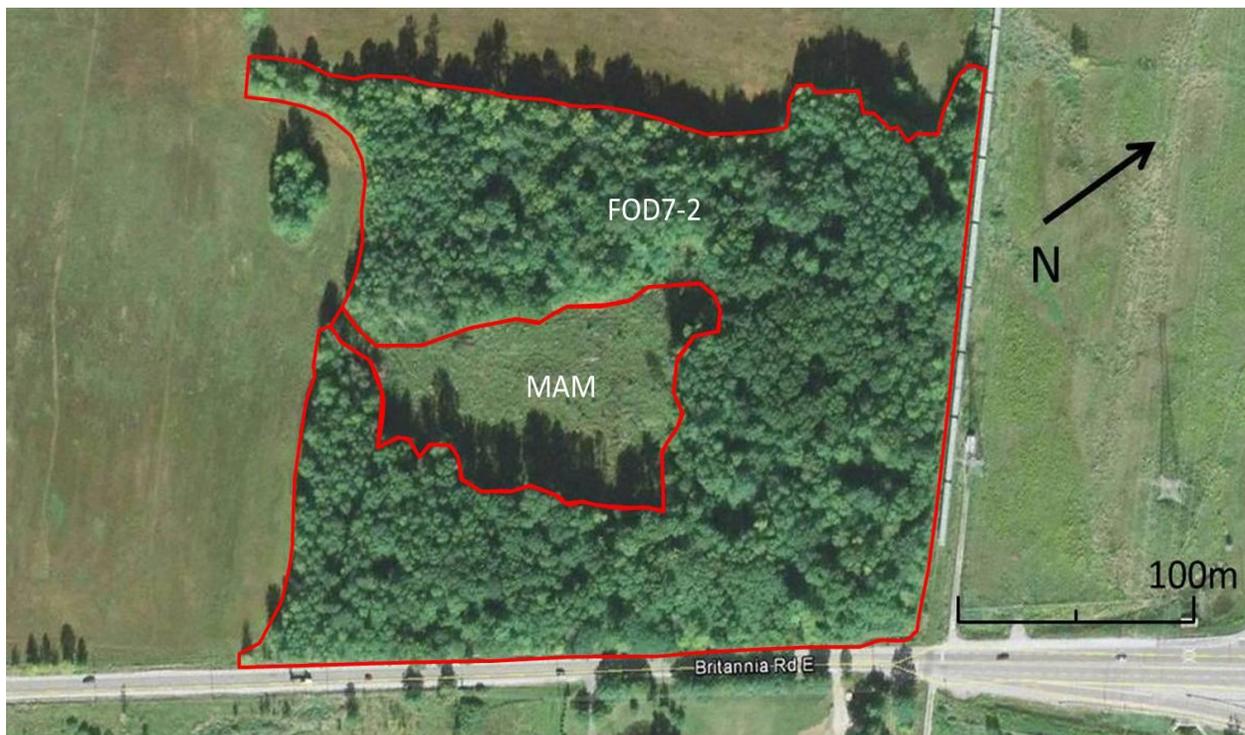
Figure 3.2: ELC Mapping for the Eastern Woodland and Adjacent Natural Areas

ELC mapping for the Eastern Woodland is found in Figure 3.2. As noted previously, this mapping is based on surveys from the roadside and adjacent ORC lands.
