Class Environmental Assessment Study  
Guelph Line (Regional Road 1) Transportation Corridor  
Improvements from 1 Kilometre North of Derry Road  
(Regional Road 7) to Conservation Road  
Town of Milton – PR-2596A

**Class Environmental Assessment Study  
Guelph Line (Regional Road 1) Transportation Corridor Improvements  
1 Kilometre North of Derry Road (Regional Road 7) to Conservation Road**

**Environmental Study Report  
November 2010**

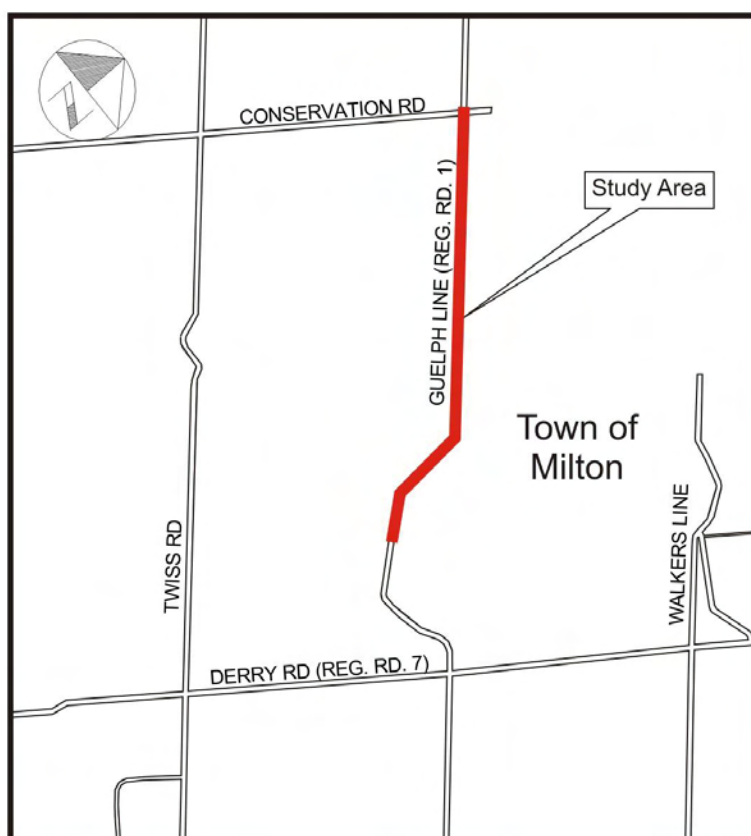
**Figure 1-1: Study Area Limits**

Within the study area limits, Guelph Line maintains a two lane rural road cross-section with a posted speed limit of 60 km/hr. The intersection at Conservation Road to the north is a STOP controlled intersection for Conservation Road. The Guelph Line intersection at Derry Road (Regional Road 7) is currently controlled via signalized control. The existing right-of-way limits

vary from about 20 to 26 metres with varying partially paved/granular roadside shoulders and ditches throughout the study area.

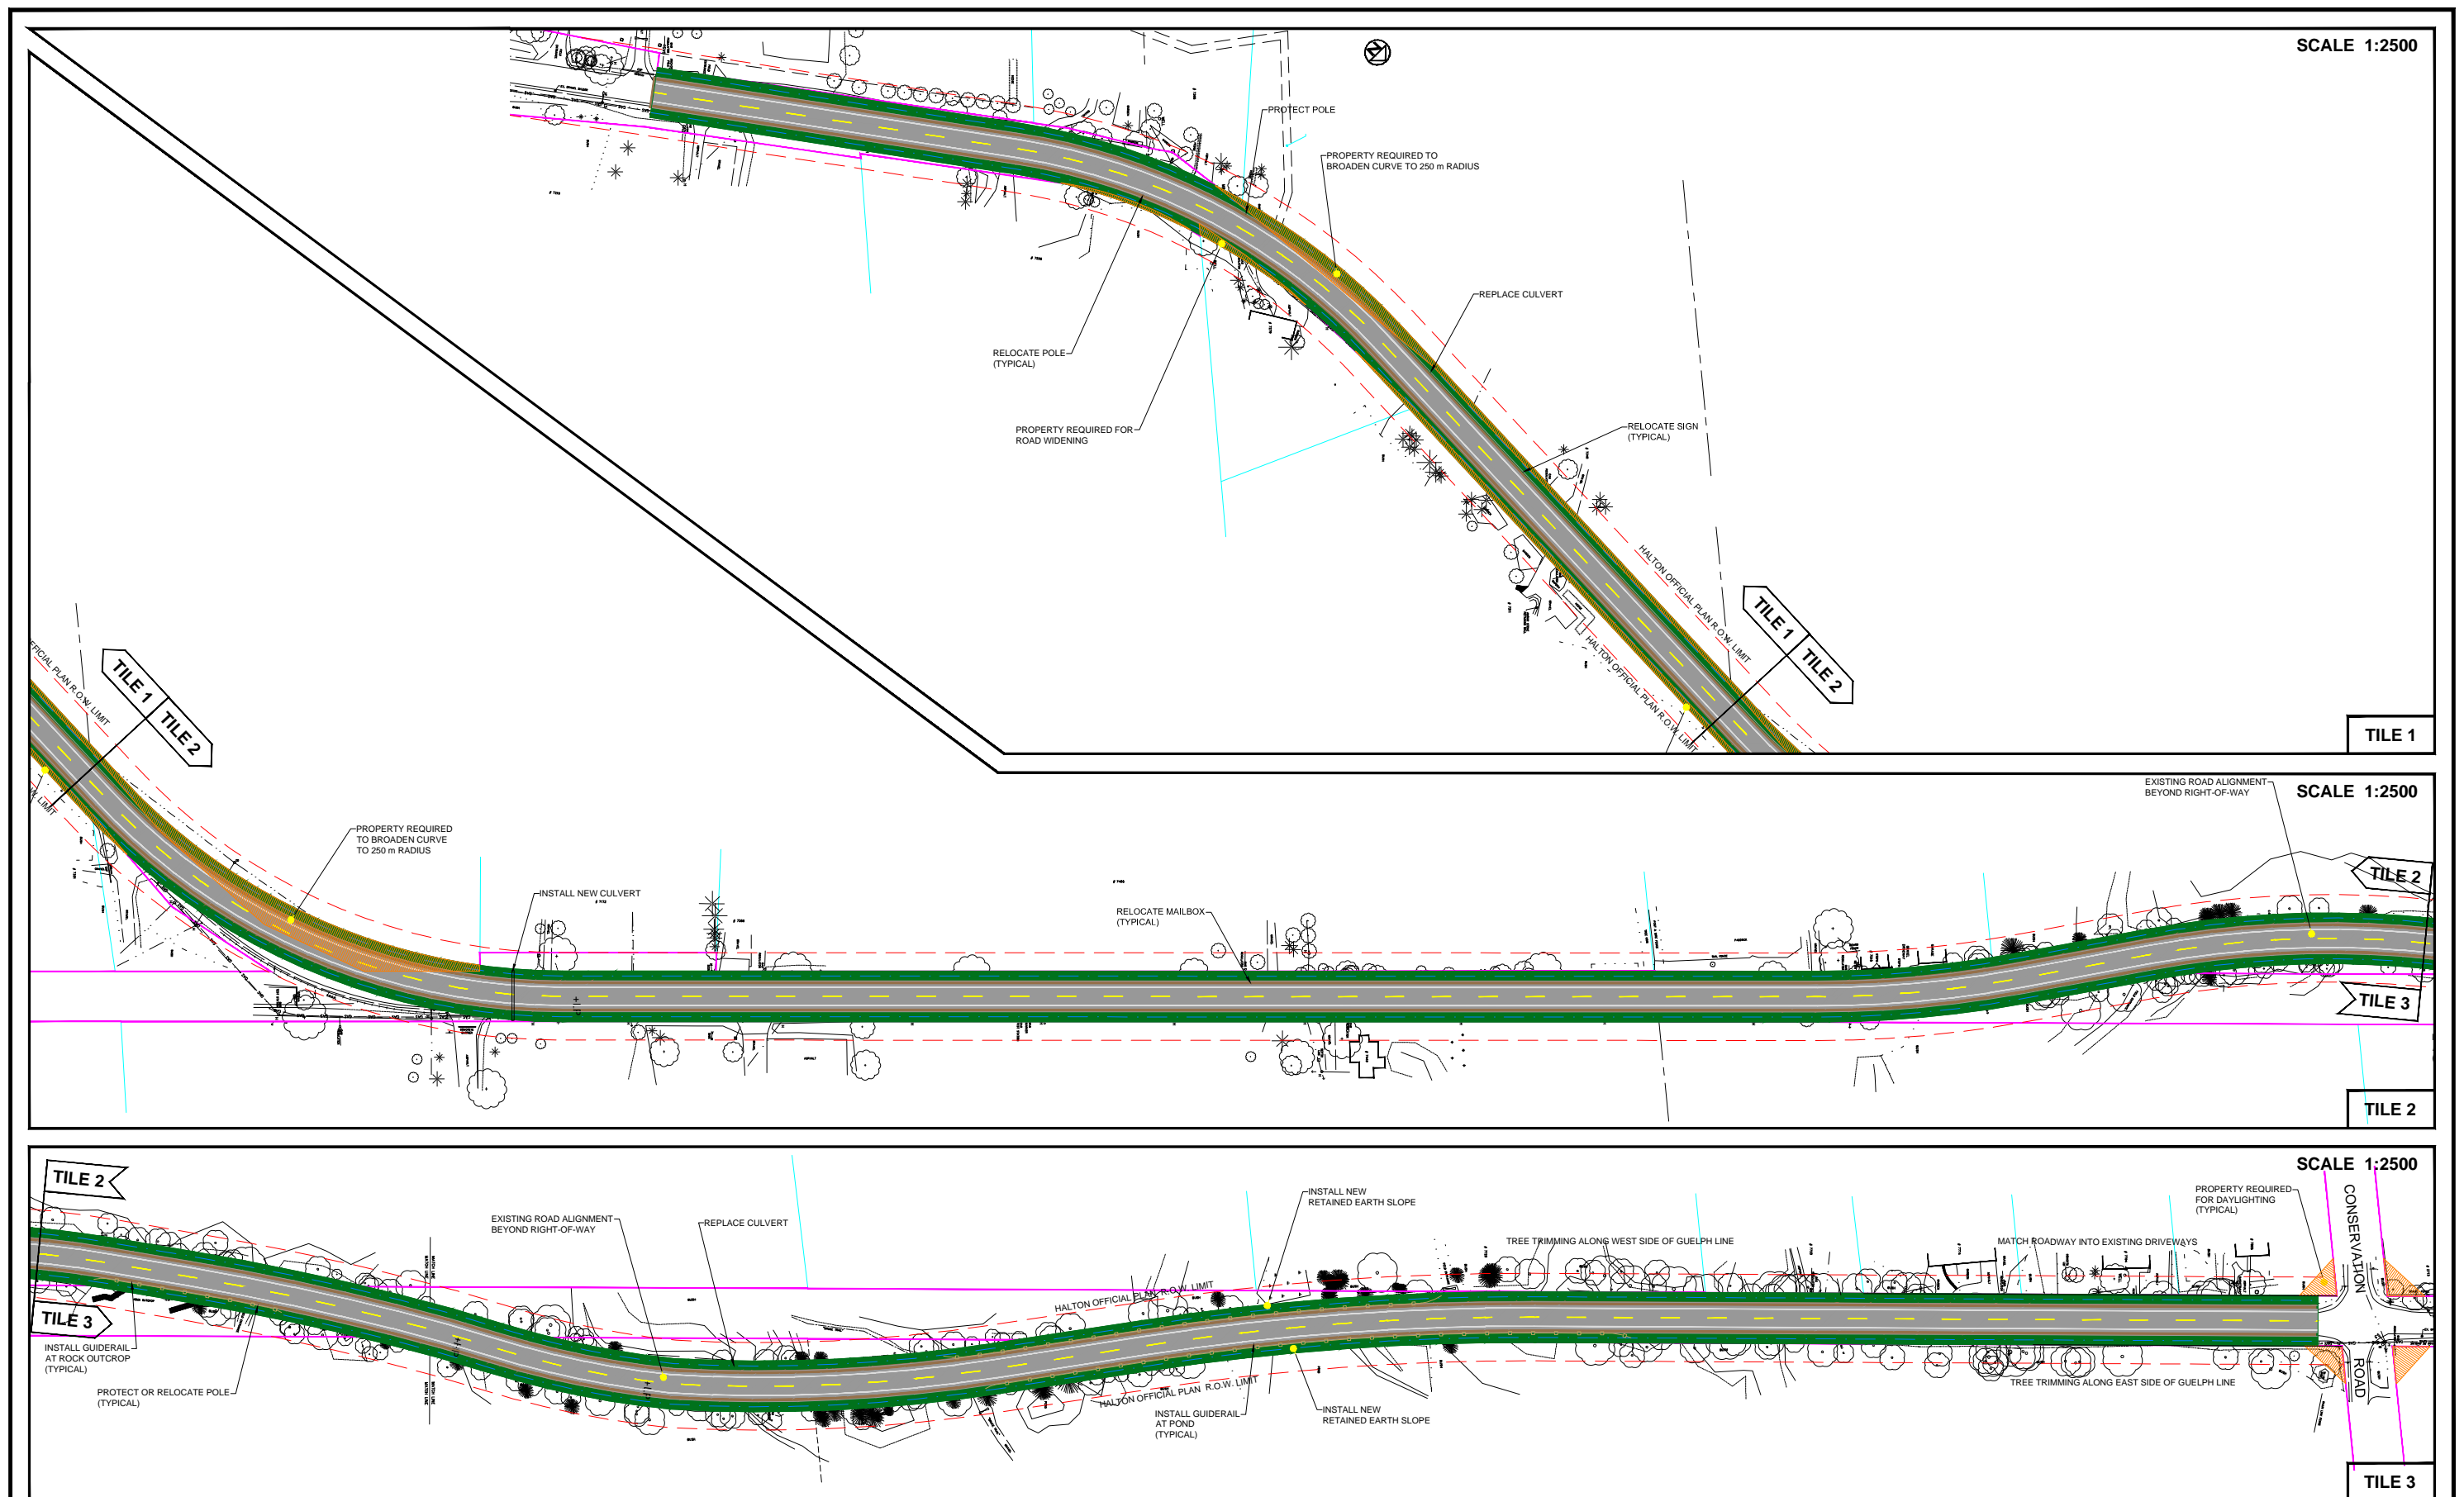
**FIGURE 5-2**

## ALTERNATIVE DESIGN CONCEPTS 2 AND 1-A

Alternative 2 (Mainline Section) - Rural Road Cross-section Centred within Existing Right-of-Way Alignment  
Alternative 1-A (Northern Section) - Rural Road Cross-section Centred within Existing Right-of-Way Alignment
