## Appendix A

### **Natural Environment Memos**

Date:	January 29, 2018	Project No.: 300039946.0000
Project Name:	John St WWPS Class EA - Vege Wildlife Habitat	tation Community Survey and Significant
Client Name:	Halton Region	
Submitted To:	Avid Bani Hashemi	
Submitted By:	Peter De Carvalho	
Reviewed By:	Nicholle Smith

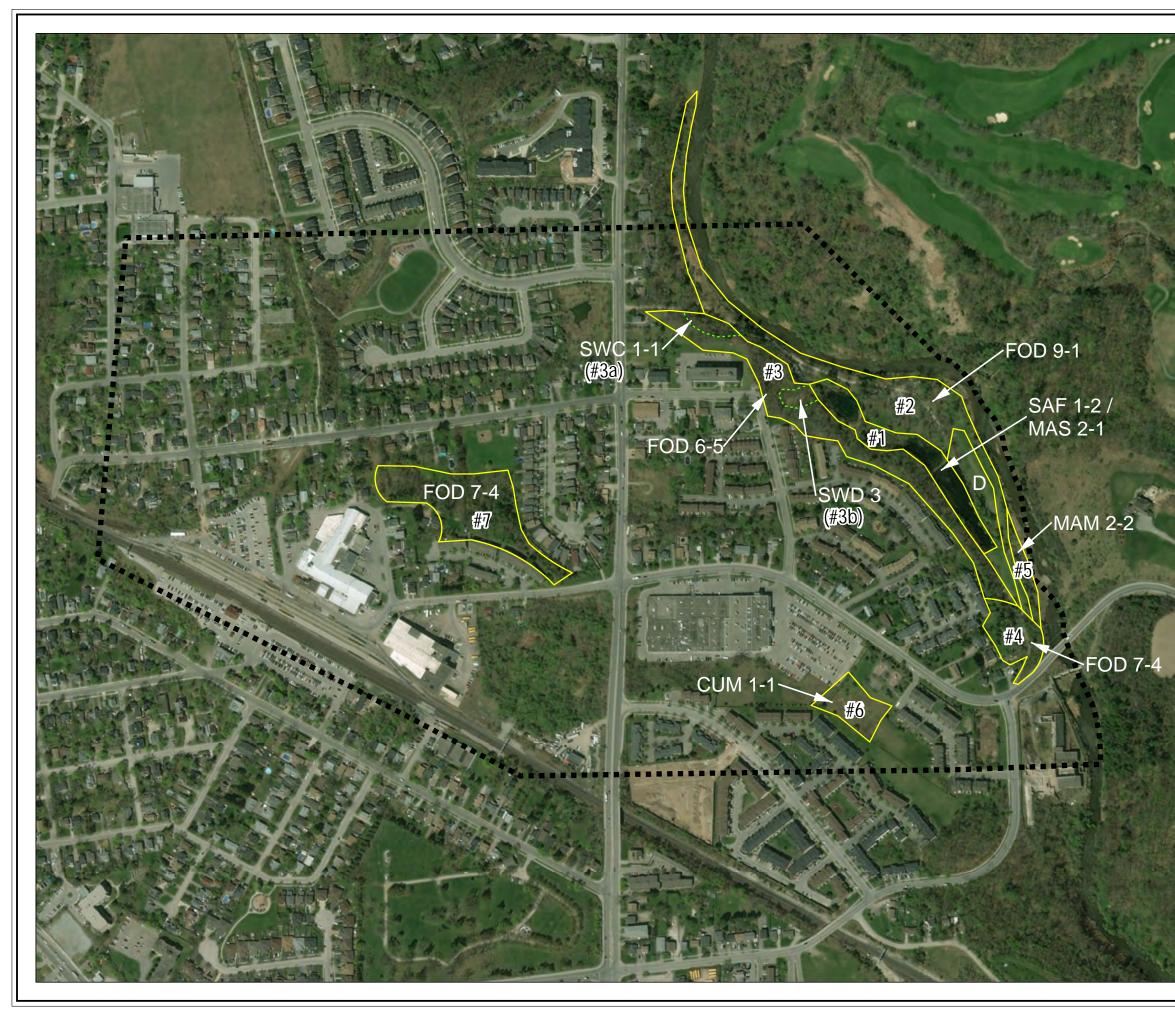
Vegetation communities were characterized using methodologies as presented by Lee *et al.* (1998) in the Ecological Land Classification (ELC) System for Ontario (First Approximation). During these studies, information on the plant species documented within the Study Area was also compiled into a plant inventory. Field surveys were conducted on July 13, 2017 by two Burnside terrestrial ecology staff. The ELC system involves gathering data on topography, soil moisture regime and effective texture, as well as density and composition of plant species to map and characterize the existing plant species and vegetation communities within an area of study. These data are then used to arrive at specific ecosites that best represent each distinct ecological unit which have been mapped (Figure 2, attached) and described below.

Two wetland pockets were identified within Polygon #3 as seen in Figure 2. Inclusion #3a is a White Cedar mineral coniferous swamp. It includes a stand composed of mostly White Cedar (*Thuja occidentalis*) with substrate that was permanently inundated with water on the lower slopes; this water may have originated from a groundwater seep, though this is not confirmed. Inclusion #3b is a moist treed swamp with an overstorey of mature Sugar Maple which appeared to be growing perched from the water table. The understorey consisted of Green Ash (*Fraxinus pennsylvanica*) with a groundlayer dominated by Spotted Jewelweed and Ostrich Fern (*Matteuccia struthiopteris*).

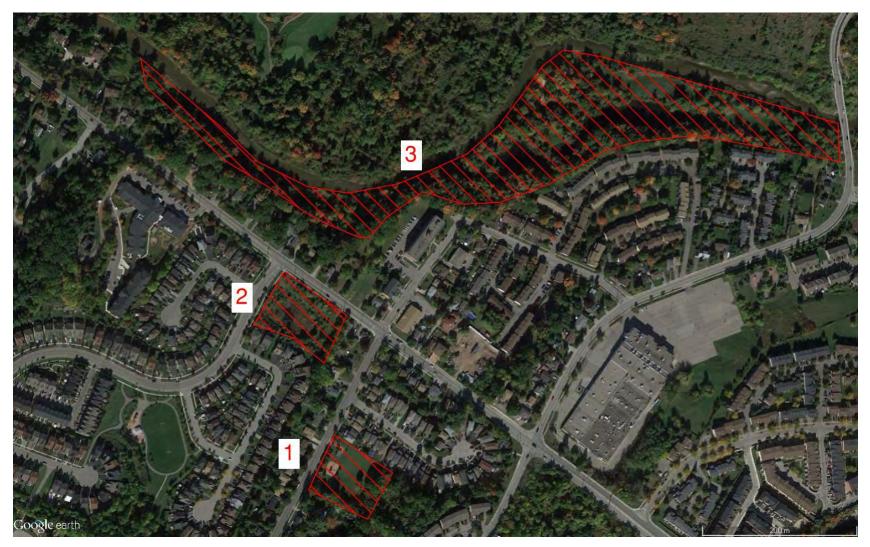
Figure 2: John Street EA with Site Surveys for Bat Maternity Habitat Outlined / Hatched in Red

Survey area #1 was not surveyed during the leaf-on period because the mature woodlot that may offer potential as BMH is set back far enough from areas being considered for development that no disturbance to trees is expected. In the event that development does threaten to impact treed ecosites in these areas, additional surveys for BMH will need to be considered.

Survey area #2 was not surveyed during the leaf-on period because the stormwater management pond is too high in elevation when considering alternatives for potentially relocating the John Street pumping station to this location.

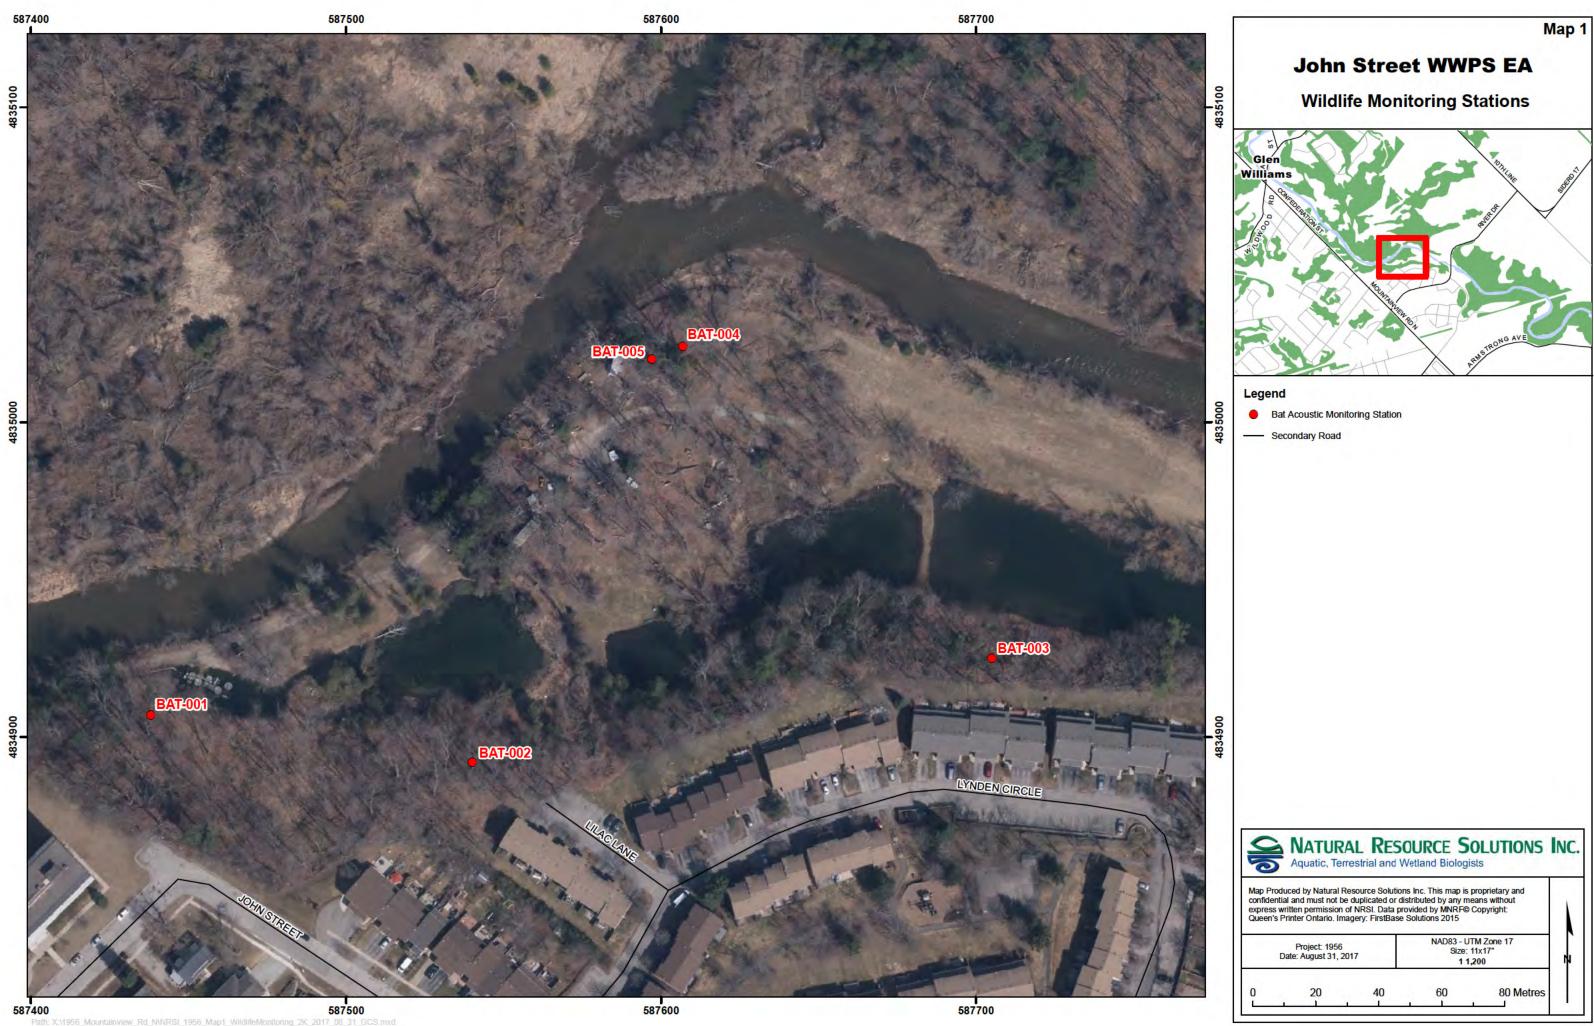
MAP

Re: John Street WWPS Environmental Assessment 203 Mountainview Rd. North, Georgetown, ON, L7G 4T8 Bat Acoustic Monitoring Results

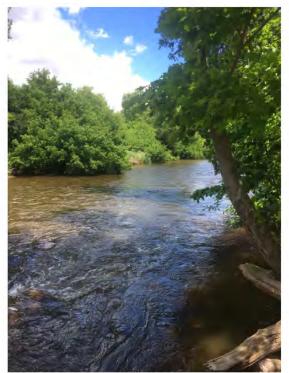
Photo 2: Credit River – Looking downstream from area of shoreline stabilization near CRAA Hatchery

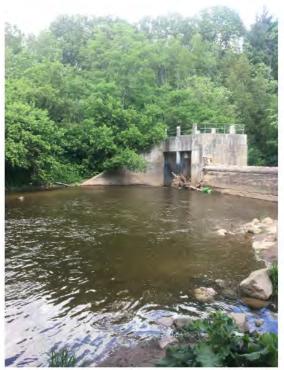
Photo 3: Paper Mill Dam at downstream end of Study Area

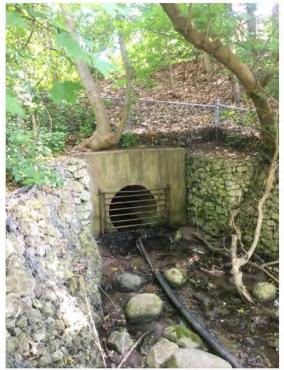
Photo 4: Stormwater outlet between Pond 1 and Pond 2

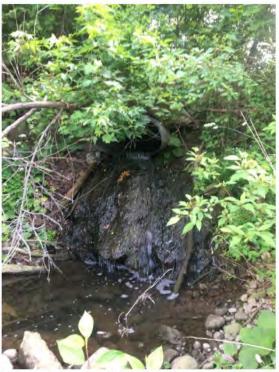
Photo 5: Stormwater discharge to Credit River

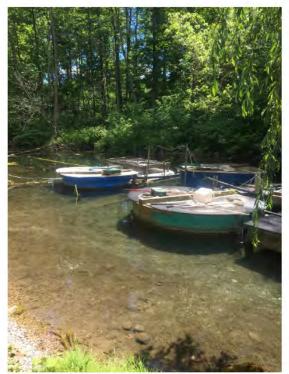
Photo 6: CRAA Hatchery

The CRAA Hatchery is located south of the private property's driveway and the forested ravine slopes of the corridor. It consists of several closed tanks and pens as well as a pond feature (approximately 25 m x 30 m) which is located around its tanks (Photo 6). This waterbody did not appear to be flowing and was connected to the western extent of Pond 1 though a narrow and short wooded area. Substrate within the waterbody consisted of sand, silt, gravel and the

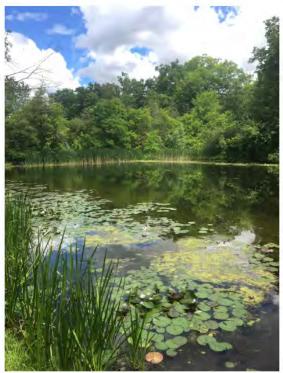
Photo 7: Looking east at Pond 1

Pond 1 is the western most of the four on-site ponds and is connected to the CRAA Hatchery through a narrow and short wooded area. The dimensions of this pond were noted as being approximately 30 m x 50 m, while the maximum depth was visually estimated to be approximately 2.5 m. Substrate within the pond is primarily comprised of detritus and muck, as well as sand and gravel nearer the banks. Mature trees are present throughout the southern banks of Pond 1, while manicured lawn was observed along the northern banks. There is minor instream large woody debris. Cattails are present within the eastern end of the pond, and lilly pads are present around the edges of the pond (Photo 7). Submergent aquatic macrophytes, chara and curly-leaf pond weed, are present within Pond 1. Largemouth bass (*Micropterus salmoides*) and sunfish species (*Lepomis sp.*) were observed within this pond and it has been noted that they have been stocked and are not resident species of the Credit River. The water level in Pond 1 appeared to be maintained through natural groundwater contributions likely flowing from the toeslope south of the pond and flows north, toward the river. At the eastern end of Pond 1 a 15 cm diameter PVC pipe conveys flow downstream to Pond 2, and crosses the on-site stormwater drain.

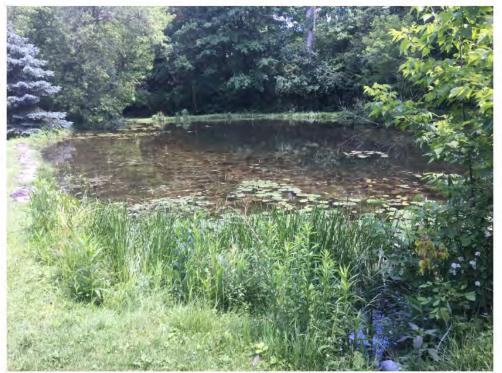
Photo 8: Looking east at Pond 2

As mentioned above, Pond 2 is located east of Pond 1 and is approximately 32 m long and 21 m wide, while the maximum depth was approximately 1.2 m (Photo 8). Reeds are located within the northwestern portion of this pond while lily pads were identified as being intermittently dispersed throughout. The substrate within Pond 2 primarily consisted of detritus, sand and gravel. Submergent aquatic macrophytes, chara and curly-leaf pond weed, were observed within Pond 2. The southern bank of Pond 2 is densely vegetated with forbs, grasses and mature trees. The eastern, western, and northern banks are vegetated by manicured lawn. Similar to Pond 1, Largemouth Bass and sunfish species were present within Pond 2 and largemouth bass spawning beds were observed near the eastern pond shore (Photo 9). At the eastern end of Pond 2 a 15 cm diameter iron pipe conveys flow downstream to a small manmade channel which flows to Pond 3.

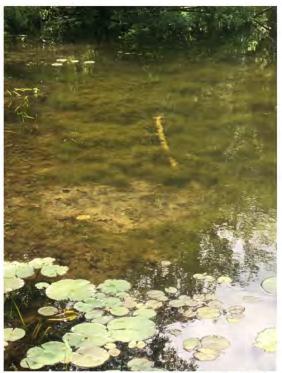
Photo 9: Largemouth bass spawning bed in Pond 2

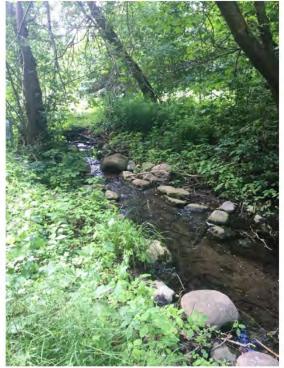
Photo 10: Looking upstream (west) at watercourse linking Pond 2 and 3

The discharge flows through a small sinuous channel comprised of a sand, gravel, and cobble substrate that is well shaded with overhanging trees along its northern bank (Photo 10). Manicured lawn with a thin riparian barrier of grasses and forbs forms the adjacent lands to the south. The morphology of the small channel was characterized as a flat with water flowing approximately 0.01 m/s.

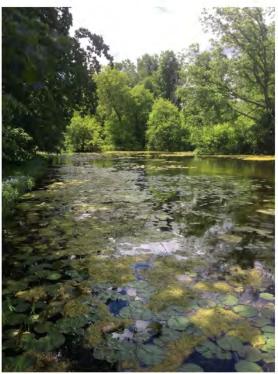
Photo 11: Looking west at Pond 3

Pond 3 is located downstream, east, of Pond 2. Pond 3 is approximately 60 m long and 30 m wide. A maximum depth could not be reliably estimated at Pond 3 due to visual obstructions, however due to the observed vegetation growth, it is thought that the maximum depth would be in the range of 2 m to 3 m. Lily pads were noted to be densely dispersed along all of the shorelines of the Pond (Photo 11). Submerged algae was also densely dispersed throughout the entirety of Pond 3 while other submergent aquatic macrophytes, chara and curly-leaf pond weed, were also present within Pond 3. The northern shoreline of Pond 3 was vegetated with trees, shrubs, forbs and grasses, while the southern and eastern shorelines of Pond 3 were characterized by manicured lawn. Largemouth bass and sunfish species along with spawning beds were observed in the southeastern corner of Pond 3. A man-made causeway separates Ponds 3 and 4. This causeway is covered with a manicured lawn and is approximately 32 m long (Photo 12). The flow of Pond 3 is conveyed to Pond 4 through a 15 cm diameter iron pipe that is located beneath the causeway.

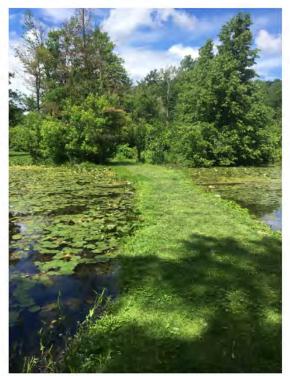
Photo 12: Looking north at the causeway between Pond 3 (left) and Pond 4 (right)

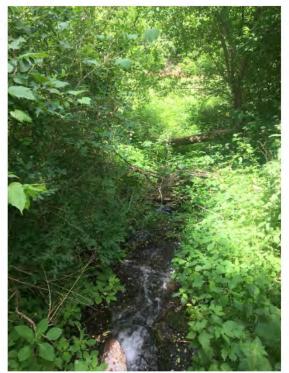
Photo 14: Outlet of Pond 4 discharging to the Credit River

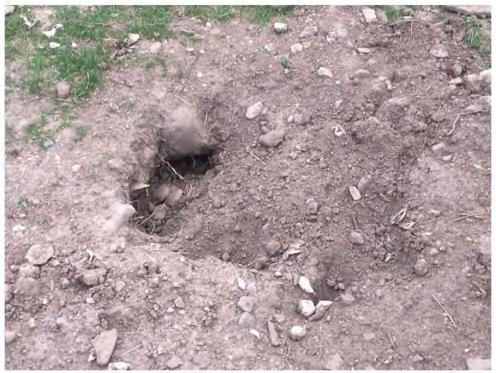
Photo 15: Predated snapping turtle nest observed north of Pond 4
