CULTURAL HERITAGE RESOURCE ASSESSMENT: BUILT HERITAGE RESOURCES AND CULTURAL HERITAGE LANDSCAPES

JUNCTION WASTEWATER PUMPING STATION MUNICIPAL CLASS ENVIRONMENTAL ASSESSMENT

CITY OF BURLINGTON, REGIONAL MUNICIPALITY OF HALTON, ONTARIO

ASI File: 16EA-196

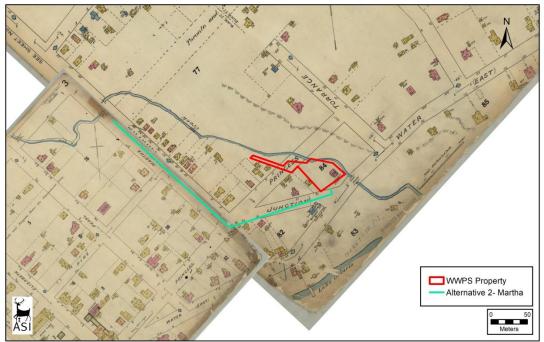
For analysis purposes, the recommended solution and the WWPS Property were overlaid on the 1924, Revised 1932, Fire Insurance Plan (Figure 11). The map shows a wooden bridge crossing along Martha Street over Rambo Creek. This bridge has been replaced and is now a concrete bridge (Plate 2). The fire insurance plan also depicts the Toronto and Niagara Power Co. Transmission Line right-of-way. It is notable that road names have changed (i.e. Junction Street and Princess Street became Lakeshore Road and Water Street became Old Lakeshore Road). A number of the structures adjacent to the proposed development have been removed, but many of them remain extant.

Figure 11: The recommended solution and the WWPS Property overlaid on 1924, Revised 1932, Fire Insurance Plan

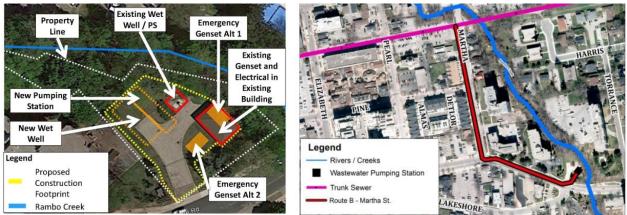
Figure 12: Recommended WWPS Site Layout Martha Street Source: Courtesy of Black and Veatch

The Sustainable Halton Water and Wastewater Master Plan (2011) identified a need to upgrade the Junction Wastewater Pumping Station (WWPS) to service future growth to 2031. The study is being undertaken in accordance with the planning and design process for Schedule 'B' Class Environmental Assessment. The recommended solution has been selected which would be to construct a new WWPS on the existing site with twin forcemain along Martha Street. The proposed plans include retention of the existing heritage building for WWPS equipment, such as housing the standby generator. The proposed improvements plan to avoid impacts to any cultural heritage resources.

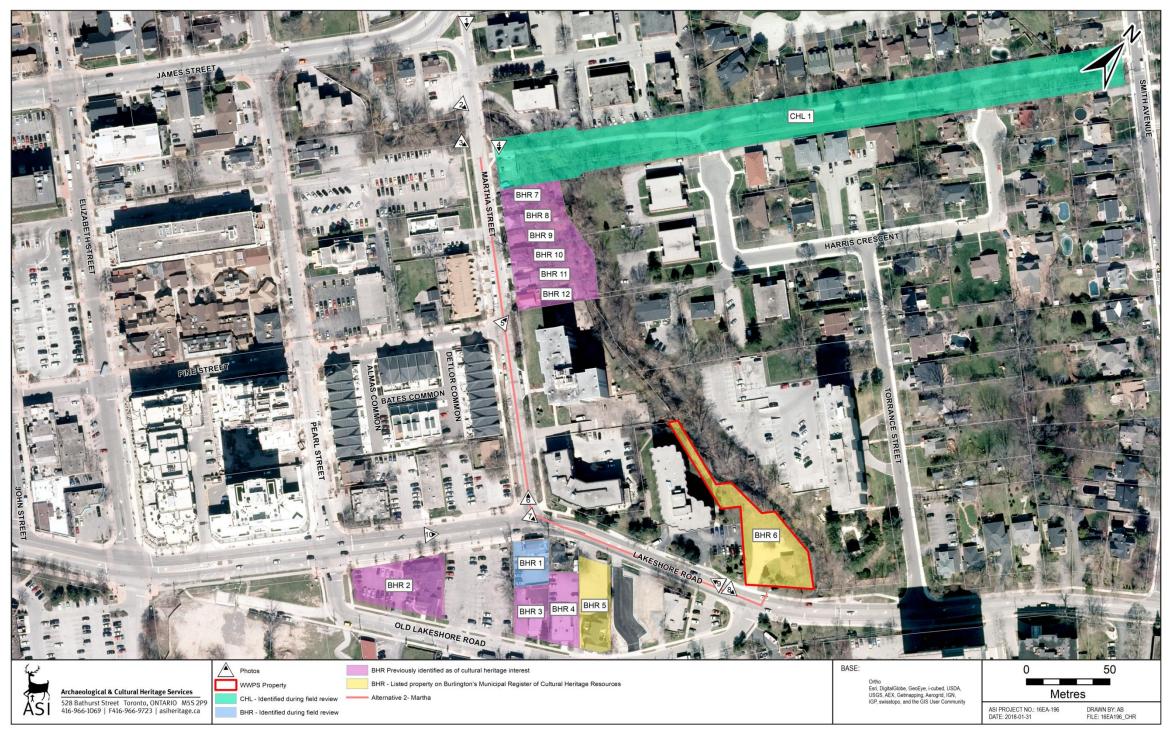
Figure 14: Location of Cultural Heritage Resources within or adjacent to the recommended solution (Alternative 2- Martha Street) and the WWPS Property
