## **CULTURAL HERITAGE ASSESSMENT REPORT**

**Cultural Heritage Assessment Report  
Schedule 'C' Class Environmental Assessment Study -  
Ninth Line (Regional Road 13) Transportation Corridor  
Improvements from Highway 407 to 10 Side Road  
(Regional Road 10), Town of Halton Hills,  
Regional Municipality of Halton  
CP# 2013-058**

Submitted October 2015

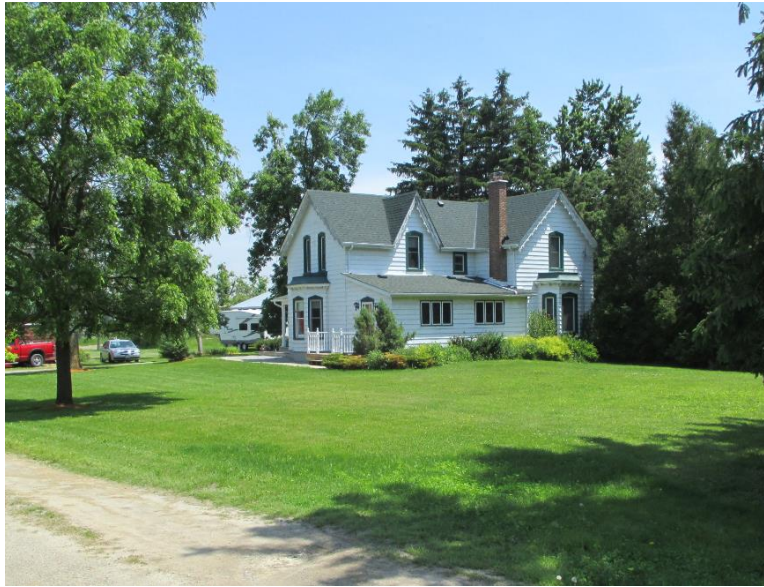
BHR 1 from Ninth Line

**Type:** Farm Complex

House occupied and probably constructed by James Anthony (farmer) and family between 1869 and 1877.

Example of a Gothic Revival style farmhouse featuring vergeboards and a steeply peaked gable. Likely constructed By James Anthony post 1869.

Condition is good.

House and yard are screened from Ninth Line by row of mature trees which helps define and maintain the character of the property. Care should be taken to maintain trees where feasible along Ninth Line.

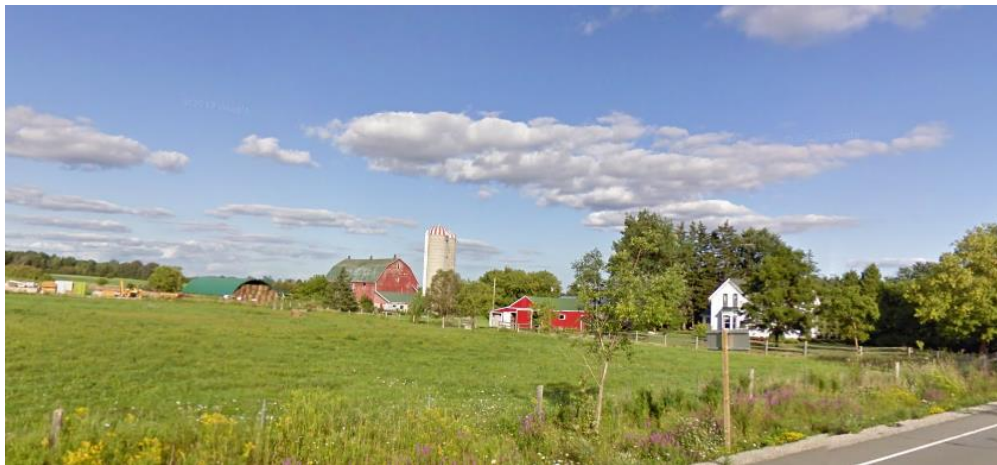
CHL 1 Farmscape

The farmscape includes a Dutch gambrel roof barn probably dating to the late 19<sup>th</sup> century and various out buildings of various periods. This property has remained in its essential form since the 1870's and is a key component of the rural, agricultural character of the study area.

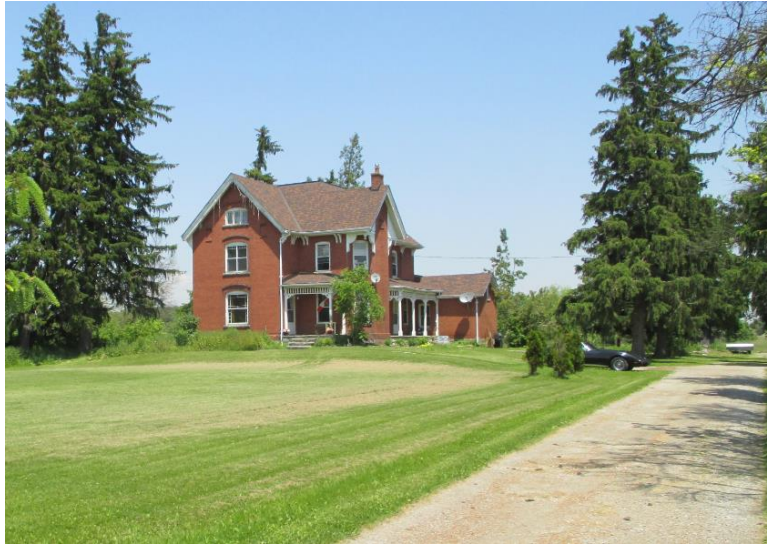
BHR/CHL 2 from Ninth Line

**Type:** Farm Complex

Owner 1877 Adam Dick. Presbyterian farmer born 1821. This house was probably constructed about 1870.

Brick 2.5 story Folk Victorian farmhouse with decorative brick work, paired cornice brackets, segmental arch windows with brick voussoirs and a large trimmed verandah. An unusual feature is the brick chimney built through the central gable.

The farmscape is enclosed by mature trees and shrubs with a large lawn in front of the house and a long scenic gravel lane leading to a crib style barn and out buildings surrounded by meadow. The barn and out buildings are not visible from Ninth Line. The effect is evocative of the 19<sup>th</sup> Century and associated with the rural development of the township.

Very good

The house is situated well back from the road but the farmstead yard is flanked by mature trees and shrubs which are at risk from roadway widening impacts.

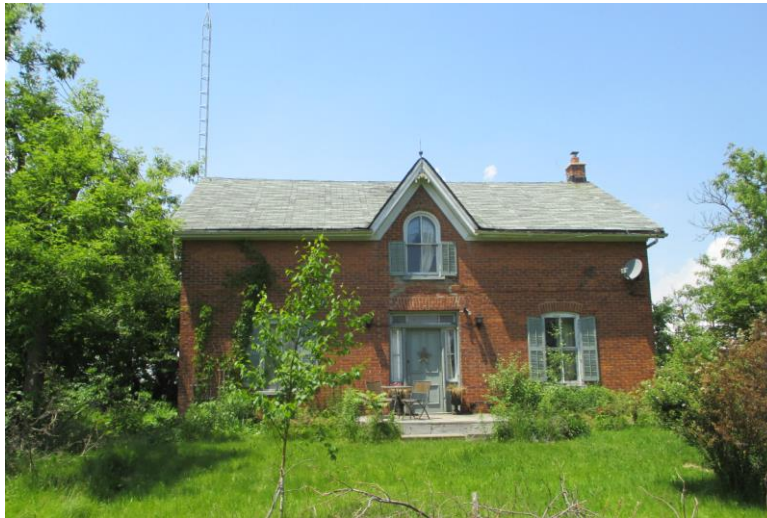
BHR/CHL 3 from Steeles Avenue

**Type:** Farm Complex

Constructed by Theodore Brain, member of Brain family who operated the Brain Bros. Brewery and Mill. This house is mapped on Illustrated Atlas of Halton County and probably constructed circa 1870.

Good example of Ontario Gothic Revival style brick farmhouse with steeply

pitched centre gable, arched central window and brick voussoirs over side ground floor segmental arch windows.

The farmscape surrounding the farmstead was enclosed by mature trees and a large lawn frames the front façade of the house. Mature trees flank the long laneway that leads to an aged gambrel style barn and outbuildings. The mature trees that once fronted the farmstead area and fields have been removed due to construction. The farmscape featuring a large Dutch gambrel style barn is a familiar landmark existing in its essential form since the 1870's and strongly associated with the rural, agricultural development of the township.

Good

Mitigation strategy: Impacts have already occurred at this location related to reconstruction of the Steeles Avenue - Ninth Line intersection. The construction proposed in the current undertaking is designed to tie into the existing new construction and will create no new impacts. No mitigation recommendations are necessary.

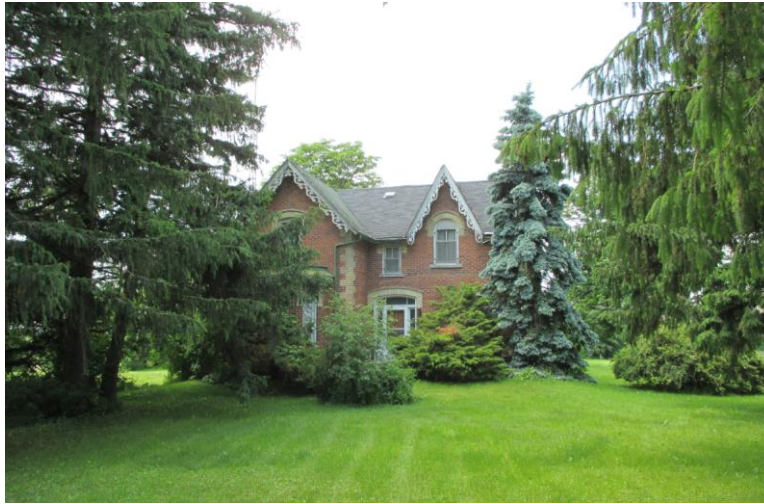
BHR/CHL 4 from Steeles Avenue

Good

House is situated well back from road and slightly northeast of study area where Steeles Avenue intersects with Ninth Line. Mature trees have been impacted by construction of the Steeles Avenue/Ninth Line intersection, which is not associated with the Ninth Line Class EA Study. The construction proposed in the current undertaking is designed to tie into the existing new construction and will create no new impacts. No mitigation recommendations are necessary.

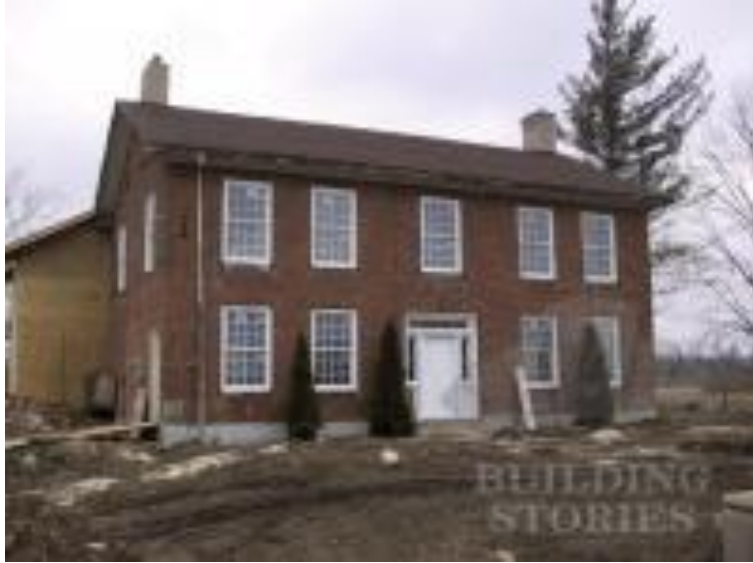
BHR 5 John Brown House from Driveway  
(Source: Halton Hills Heritage Register)

**Type:** Residence

This house is located over 300m from the study area. As such no mitigation recommendations are applicable to the house. The property will be affected along the roadside by the loss of some mature trees. These are not directly tied to the house or its surrounding farmscape.

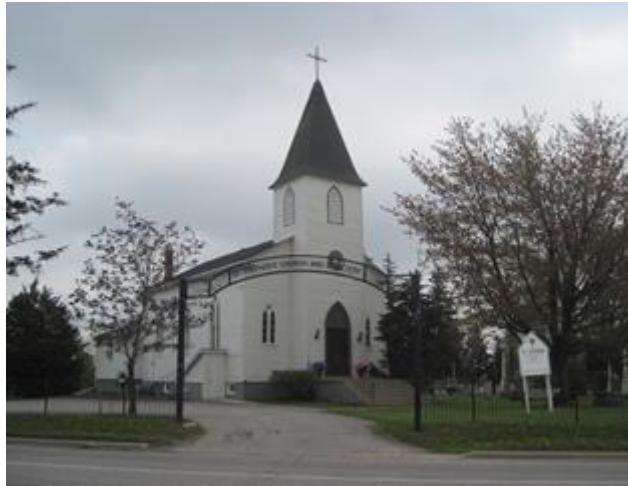
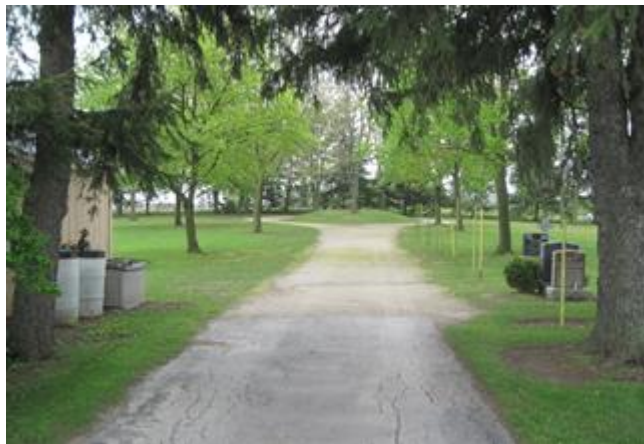
BHR 6 St. Stephen's Church from Steeles Avenue

CHL 6 St. Stephen's Cemetery

**Type:** Church and Cemetery

The church and cemetery property has already been affected by road construction along Steeles Avenue as part of the re-construction of the Steeles Avenue - Ninth Line intersection. This includes grading and construction work within a few metres of the cemetery fence and nearby mature trees. The construction proposed in the current undertaking is designed to tie into the existing new construction and will create no new impacts. No mitigation recommendations are necessary.

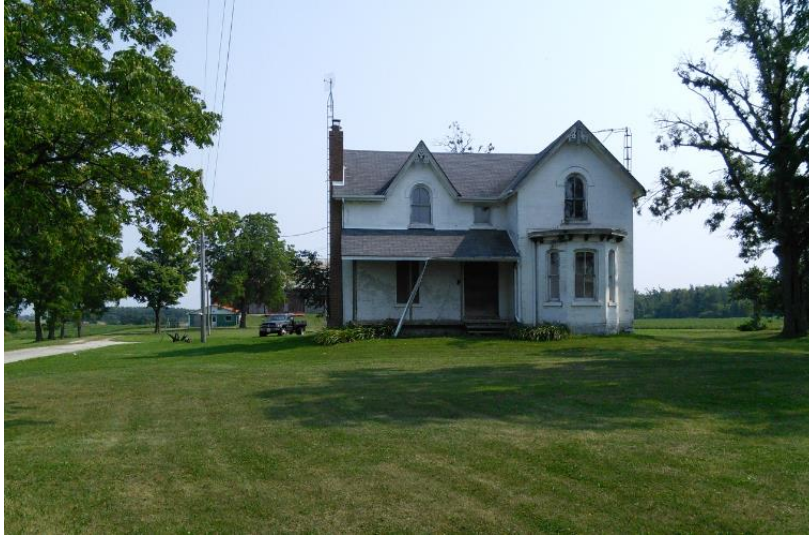
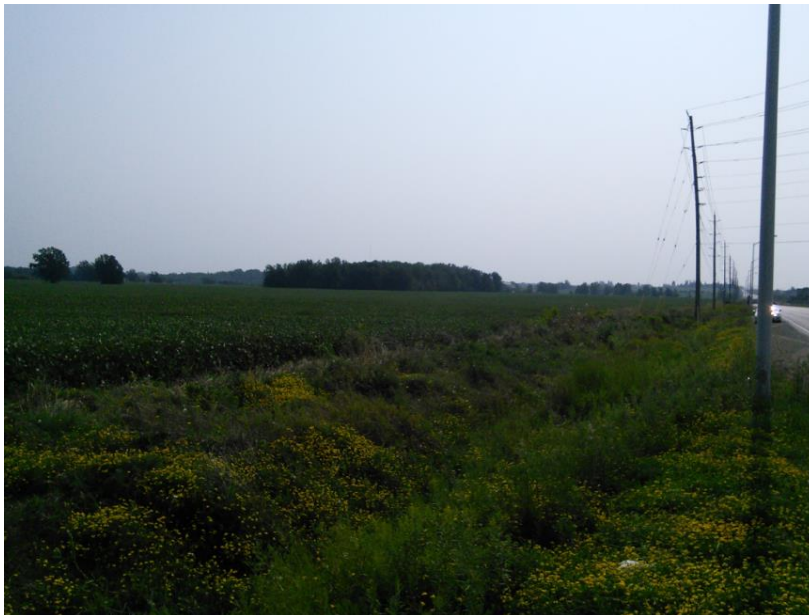
BHR /CHL 7 Main House and farmstead yard

View of farm from Ninth Line just south of 10Side Road

**Type:** Farm Complex

The house is situated over 900m from Ninth Line and there are no features such as mature trees near project area that would cause negative impacts. No recommendations for mitigation.

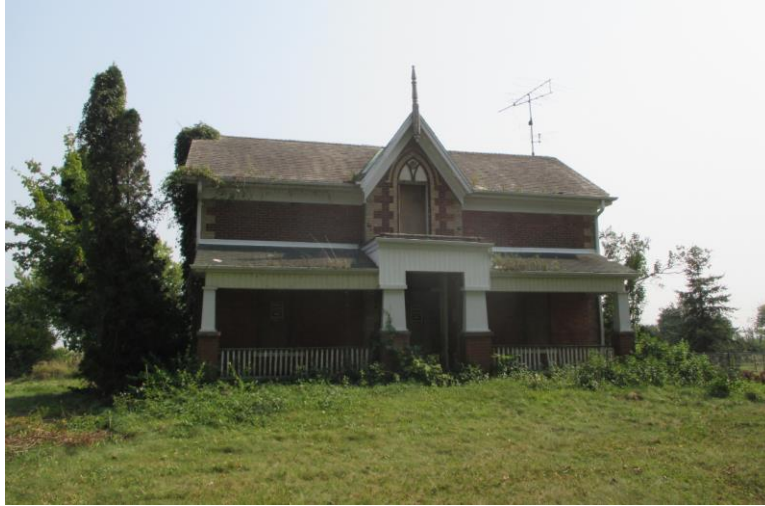
BHR 8 John Hunter House

**Type:** Residence

The house is situated over 400m from Ninth Line and there are no features such as mature trees within the study area that would cause negative impacts. No recommendations for mitigation.

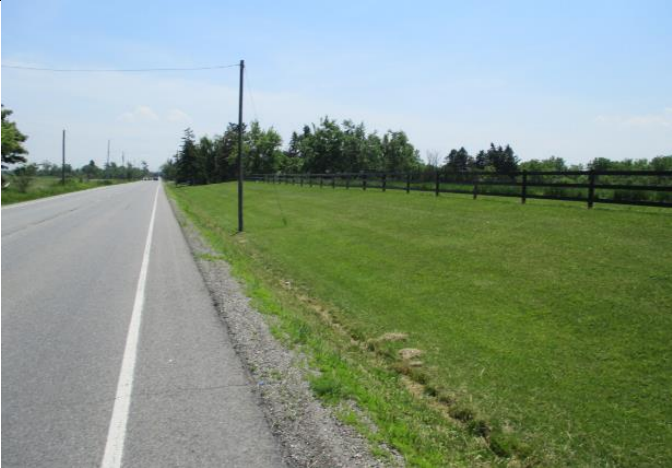
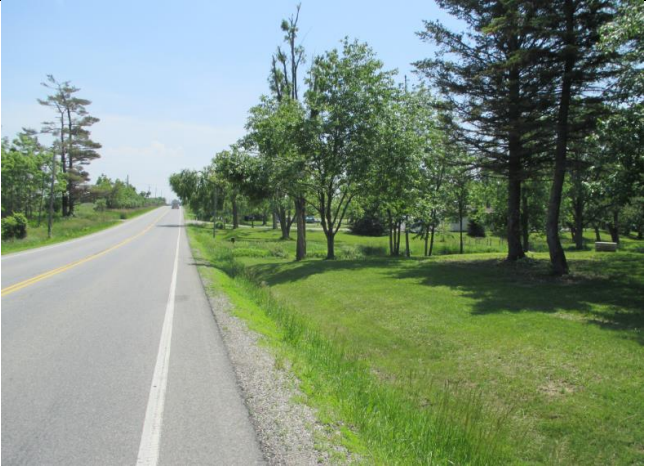
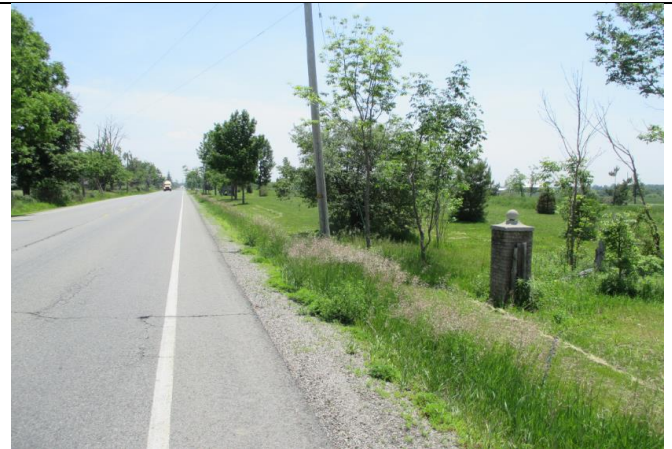
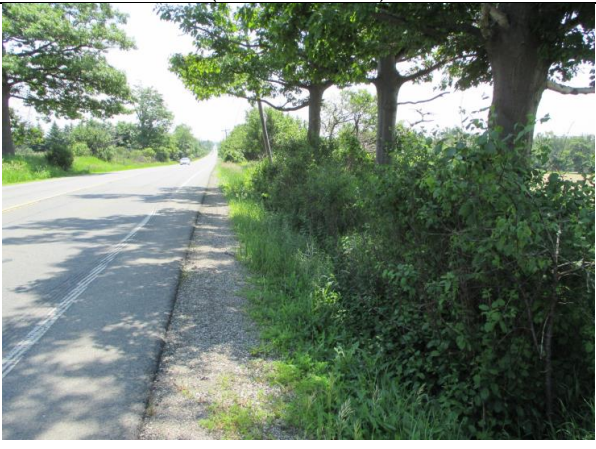
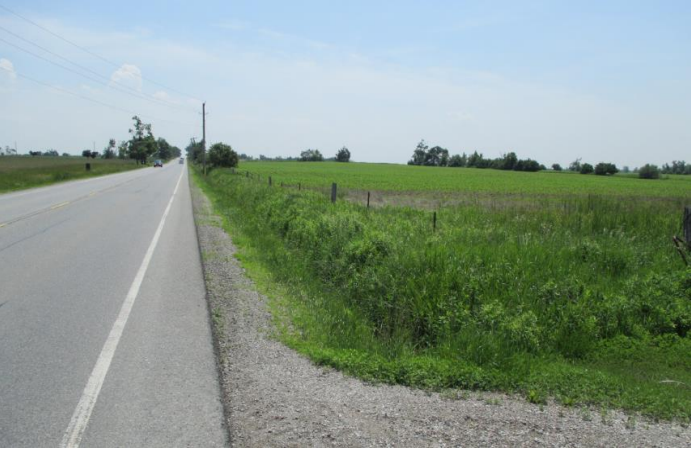
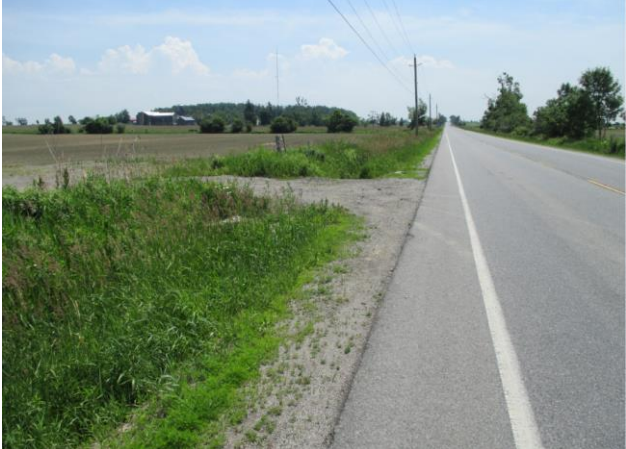
Between Steeles Avenue and 5 Side Road (Central section)	Nearing Steeles Ave. (Southern Section)

North of 5 Side Road (North Section)	5. Mature trees north of 5 Side Road (North Section)

Farm fields between 5 and 10 Side Roads (North Section)	Nearing 10 Side Road

This two lane rural road is an early settlement road in the Township constructed in the mid-19<sup>th</sup> Century and still characterized by agricultural land and 19<sup>th</sup> Century farmsteads. It is a two lane road with narrow shoulders framed by fields and occasional woodlots with mature trees, fencing, hedgerows and crop land in close proximity. There are no mitigation recommendations for this CHL. Rather the intent is to document Ninth Line as it exists now.

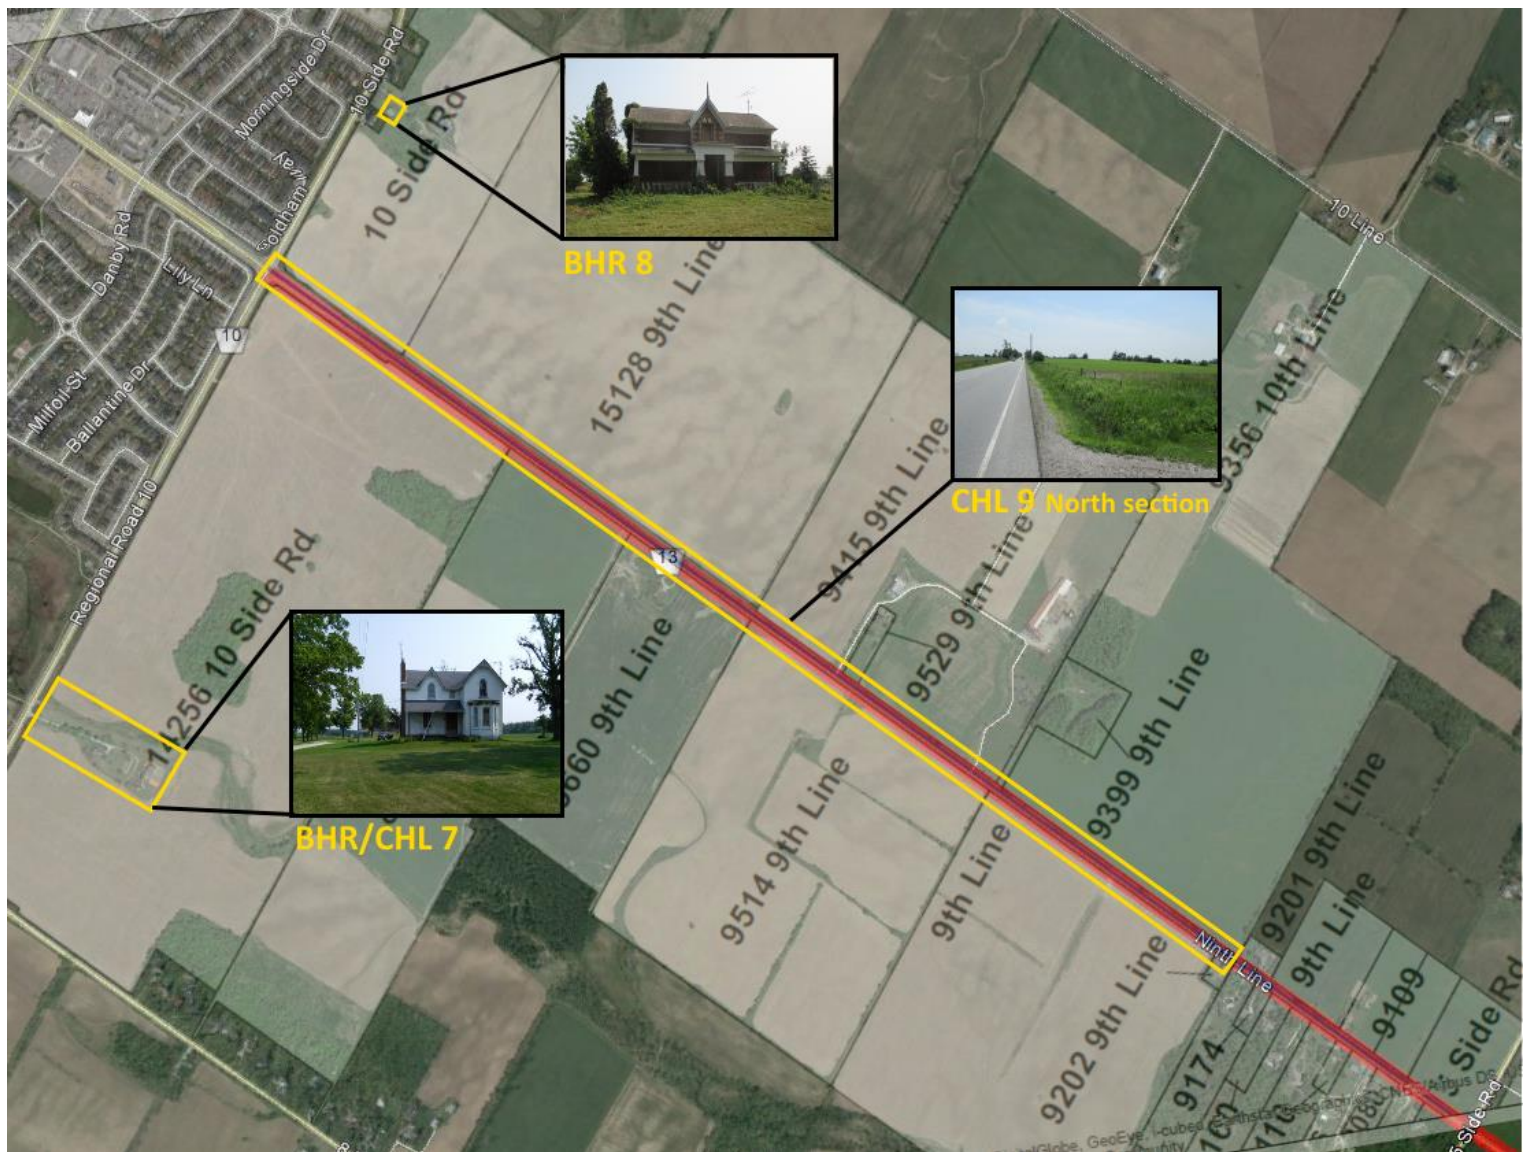
### Map 4. Cultural Heritage Resources (North Section)

- North Section (From 10 Side Road to 9201 Ninth Line
- Central Section from to 8464 Ninth Line
- South Section from 8344 Ninth Line to the current construction near 8040 Ninth Line.
