**PRELIMINARY PAVEMENT ENGINEERING
REPORT INVESTIGATION FOR THE CLASS
ENVIRONMENTAL ASSESSMENT STUDY
OF BURNHAMTHORPE ROAD AT
NEYAGAWA BLVD AND NINTH LINE,
PROJECT #08-0005**

REPORT

Report Number: 08-1181-0005

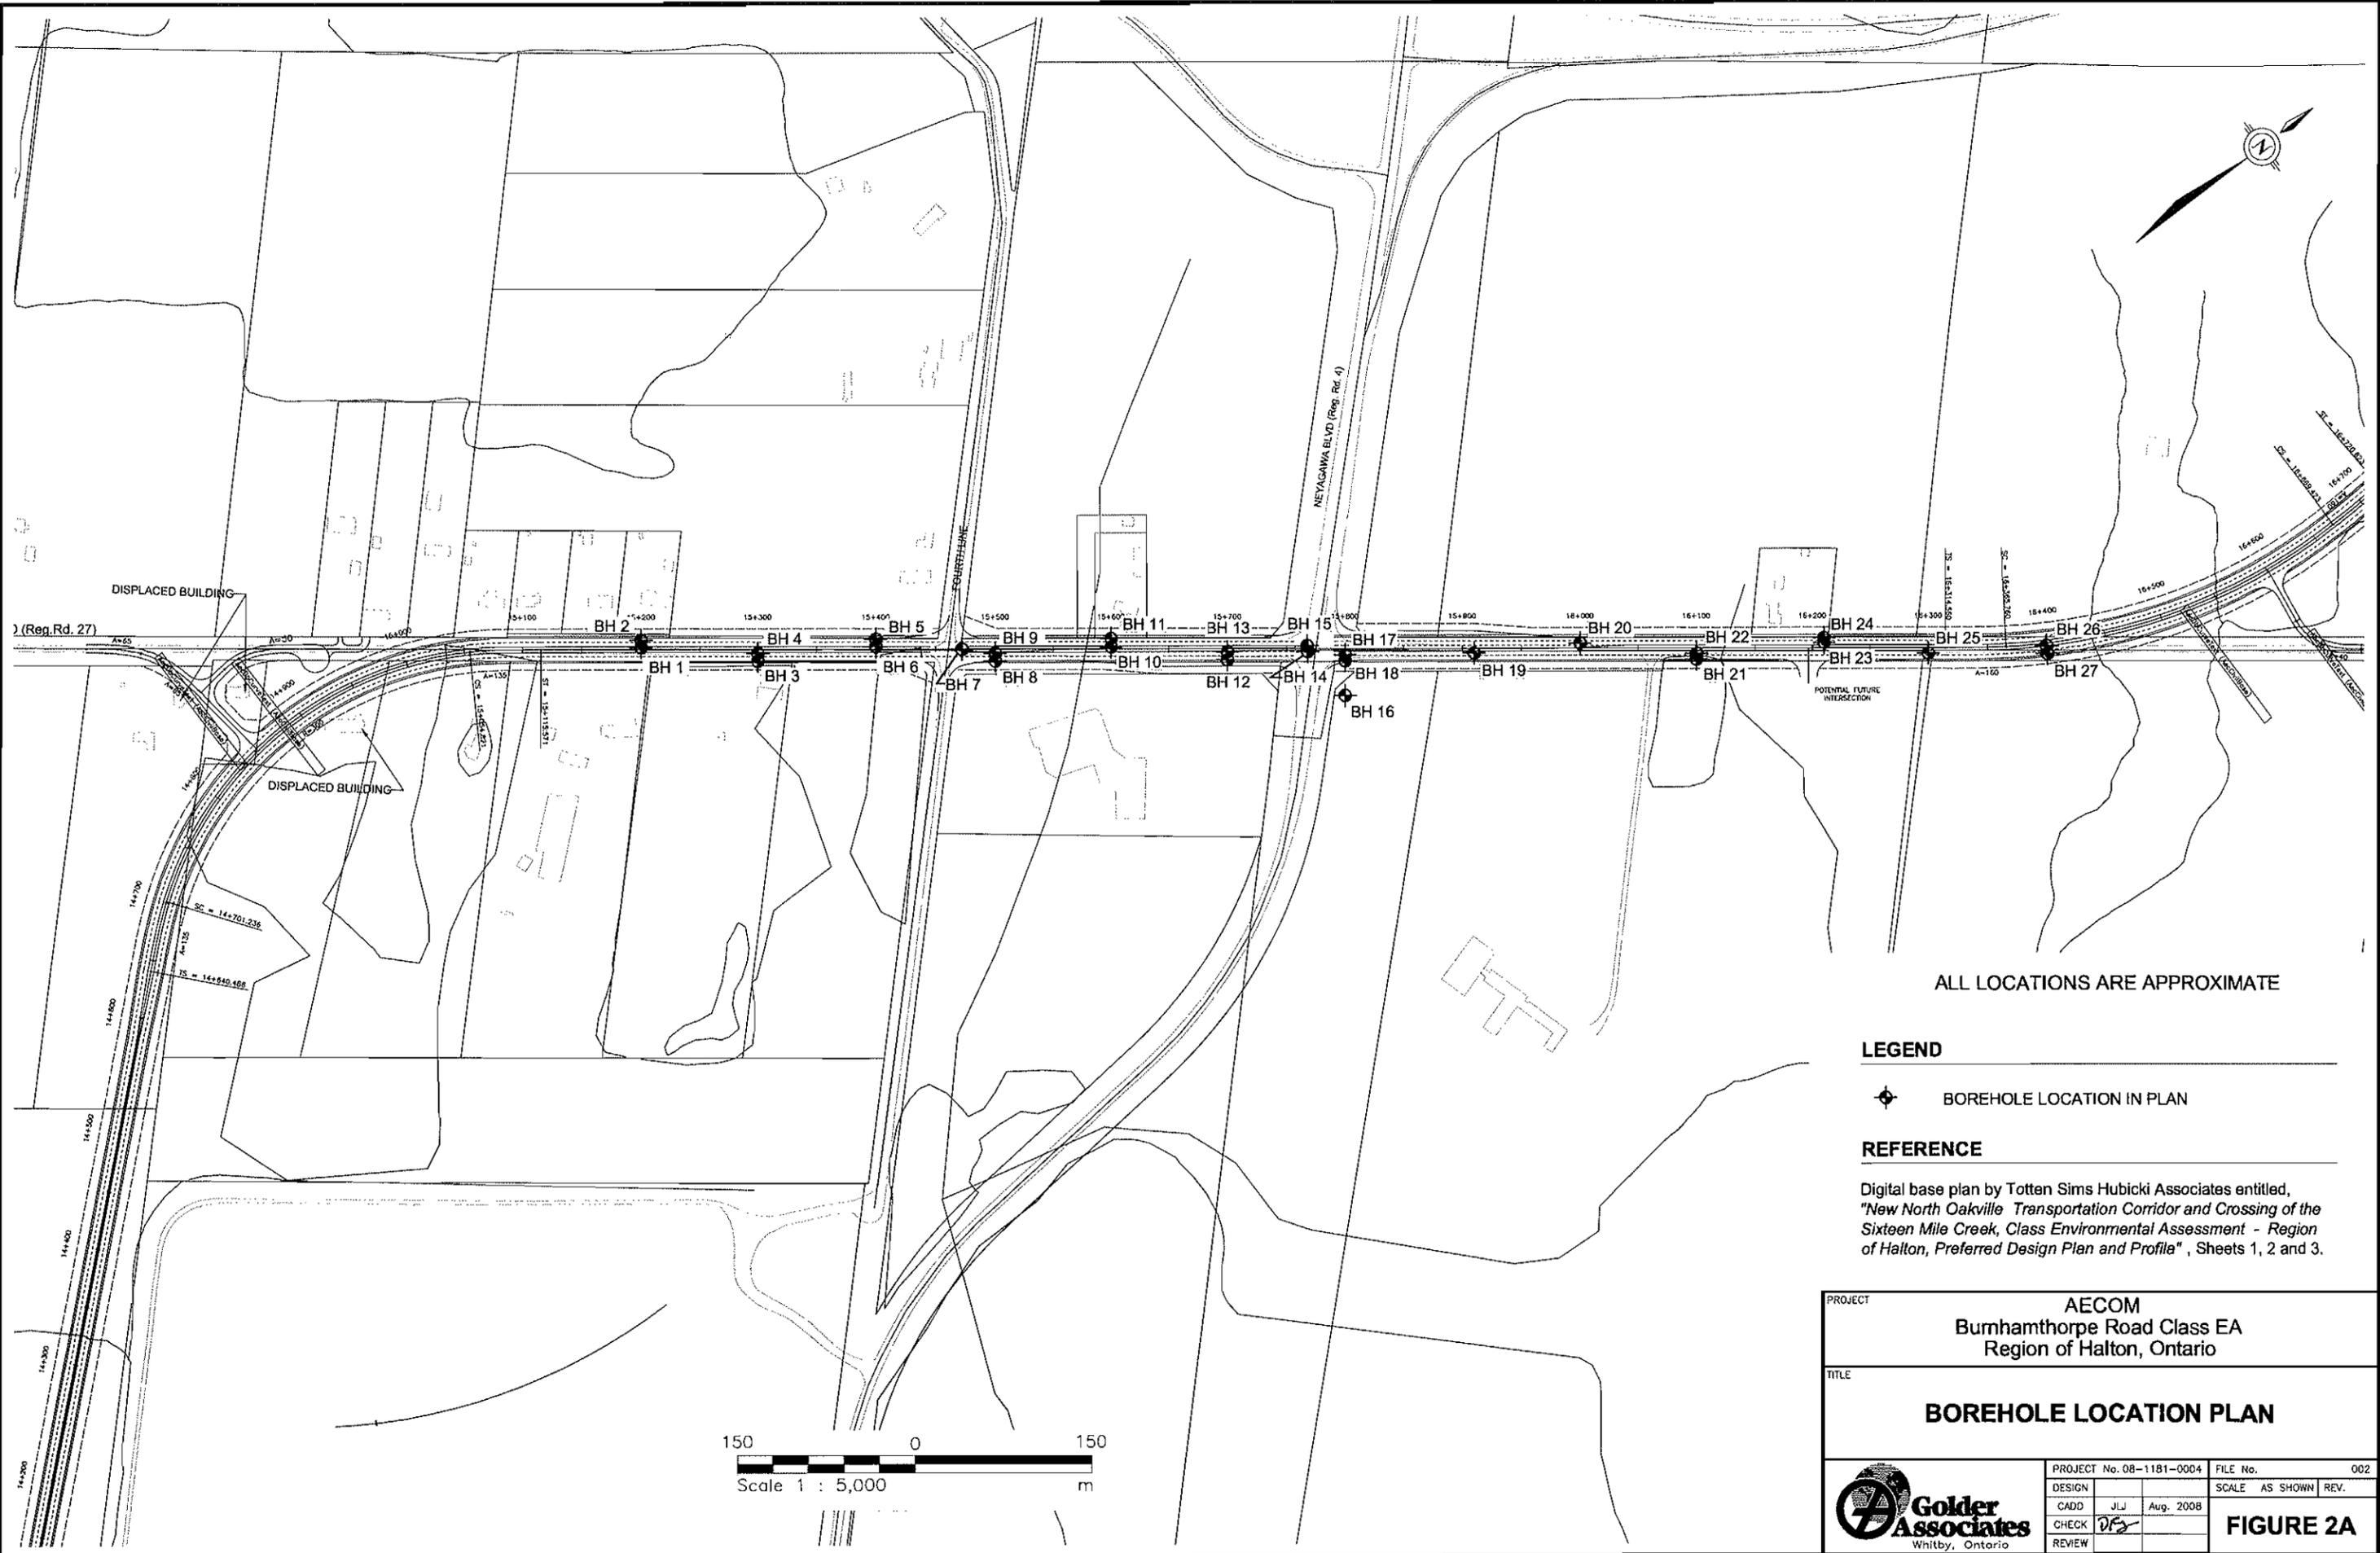
Golder Associates Whitby, Ontario		FIGURE 2A

The field work was carried out in July 2008 and consisted of 38 boreholes, generally advanced to a depth of 1.5 m. The borehole locations are shown on the Borehole Location Plan (Figures 2A and 2B) and borehole logs are provided in Appendix C. The asphalt and granular layer thicknesses were noted in each of the boreholes drilled through the existing pavement and representative samples of the granular base, subbase and underlying soils were obtained from selected boreholes. All the samples were brought to Golder's CCIL certified laboratory in Whitby for further inspection and limited laboratory testing.

The purpose of this investigation is to determine the condition and adequacy of the existing pavement structure, assess the subsurface soil and groundwater conditions along the alignment, evaluate feasible pavement design alternatives, and provide pavement recommendations for the most cost-effective rehabilitation / reconstruction of the existing lanes and new pavement structures for the proposed widening and urbanization of Burnhamthorpe Road. The project limits are shown on the Borehole Location Plan, Figures 2A and 2B attached to this report.

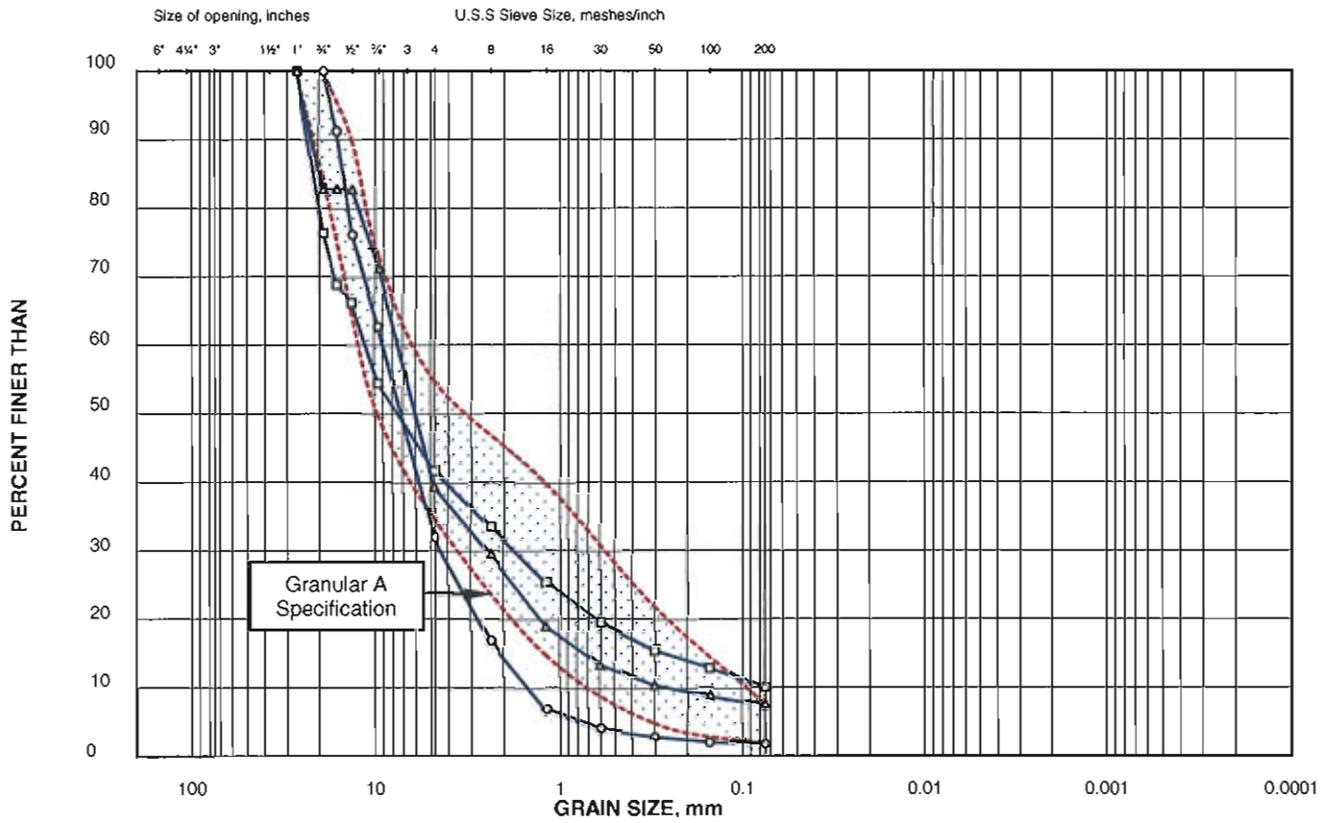
FIGURE D1

TYPICAL GRANULAR BASE MATERIAL

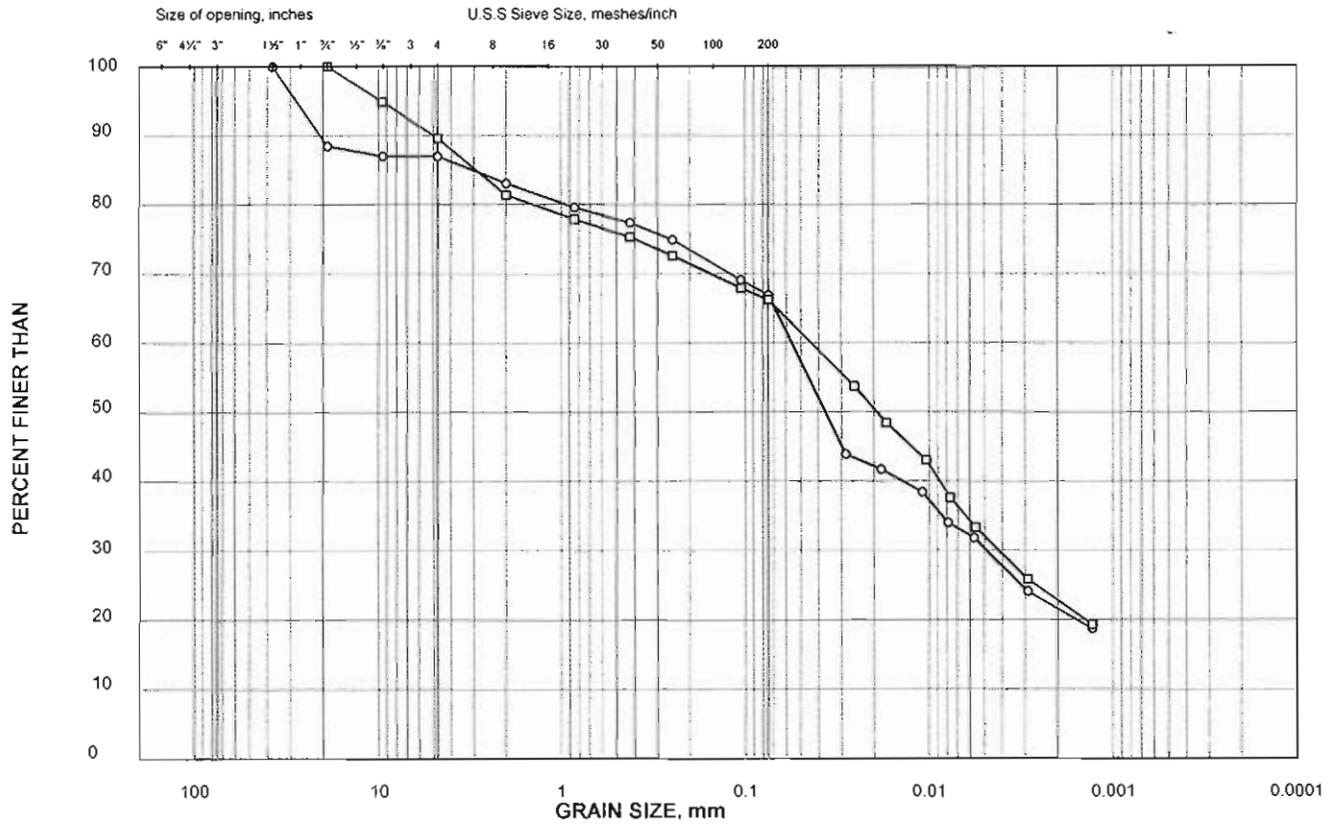
FIGURE D2

TYPICAL SILTY CLAY SUBGRADE

LEGEND					
SYMBOL	BORE HOLE #	STATION	OFFSET	SAMPLE #	DEPTH (m)
○	11	15+600	3.8 M N of C/L	1	1.2-1.5
□	22	16+100	4.3 M S of C/L	1	1.2-1.5

Laboratory testing was also carried out on selected samples of the native silty clay subgrade material. The results indicate that the average in-situ moisture of the subgrade material was 24.5 percent. The subgrade soils tested generally have a low (LSFH) to moderate (MSFH) susceptibility to frost heave. Typical gradation test results for the subgrade samples are shown on Figure D2 (Appendix D).

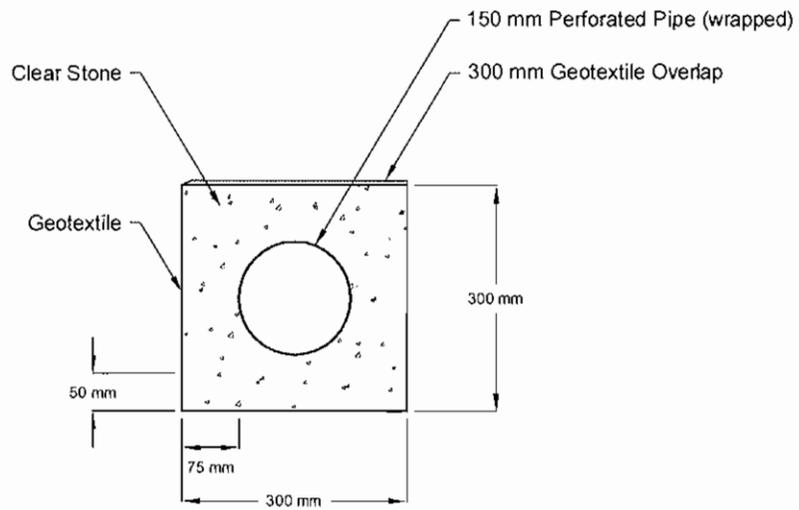
PROJECT		Preliminary Pavement Engineering Investigation for Class Environmental Assessment Study of Burnhamthorpe Road at Neyagawa Boulevard and Ninth Line		
TITLE		SUBDRAIN DETAIL		
PROJECT No 08-1181-0005		FILE No 003		
DESIGN		SCALE NTS RELV		
CADD	JLJ Aug. 2008	FIGURE F1		
CHECK	DS			
REVIEW

We understand that Burnhamthorpe Road within the project limits will be reconstructed and urbanized. As such, a subdrain system is necessary to provide proper drainage of the pavement. The drainage system should consist of a 150 mm diameter perforated pipe, placed inside a trench and surrounded by clear stone or concrete sand. The trench should be lined with a suitable geotextile prior to placing the clear stone/concrete sand. At the top of the trench, the geotextile should overlap a minimum of 100 mm. The geotextile shall conform to OPSS 1860, Class 1 and be non-woven with a F.O.S. in the range of 75 to 150 micron. The drain invert should be at least 1.2 m below top of finished pavement. A typical subdrain detail is shown on Figure F1, Appendix F.
