**Cultural Heritage Assessment
Report, Regional Road 25
Transportation Corridor
Improvements from Steeles
Avenue to 5 Side Road**

Prepared by:
Stantec Consulting Ltd.
300W-675 Cochrane Drive
Markham, ON
L3R 0B8

File No. 165010586
December 5, 2017

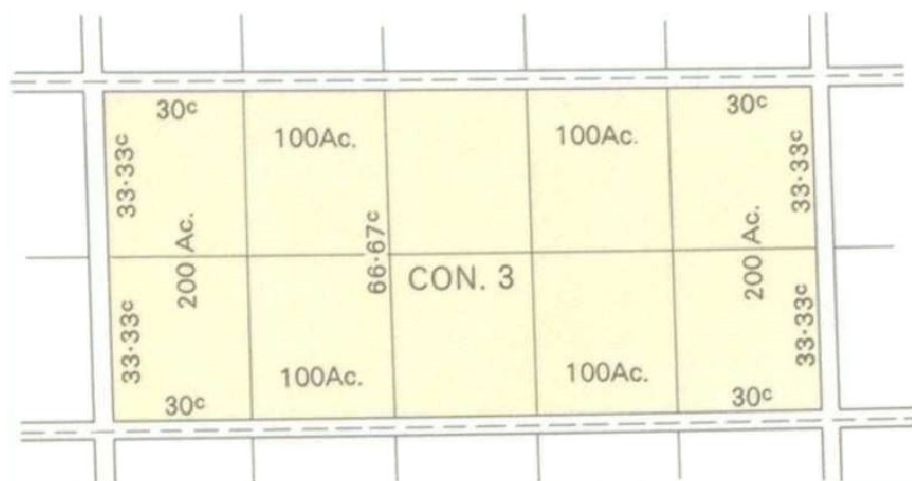
Plate 1: Double-Front Survey System (Dean 1969)

block of land was set aside in the southwest corner of township within the study area, known as the Scottish Block for a group of new immigrants from Perthshire, Scotland. The block was granted by the Upper Canada government following a petition in 1819 from John and James Stewart (McDonald 2011: 222).

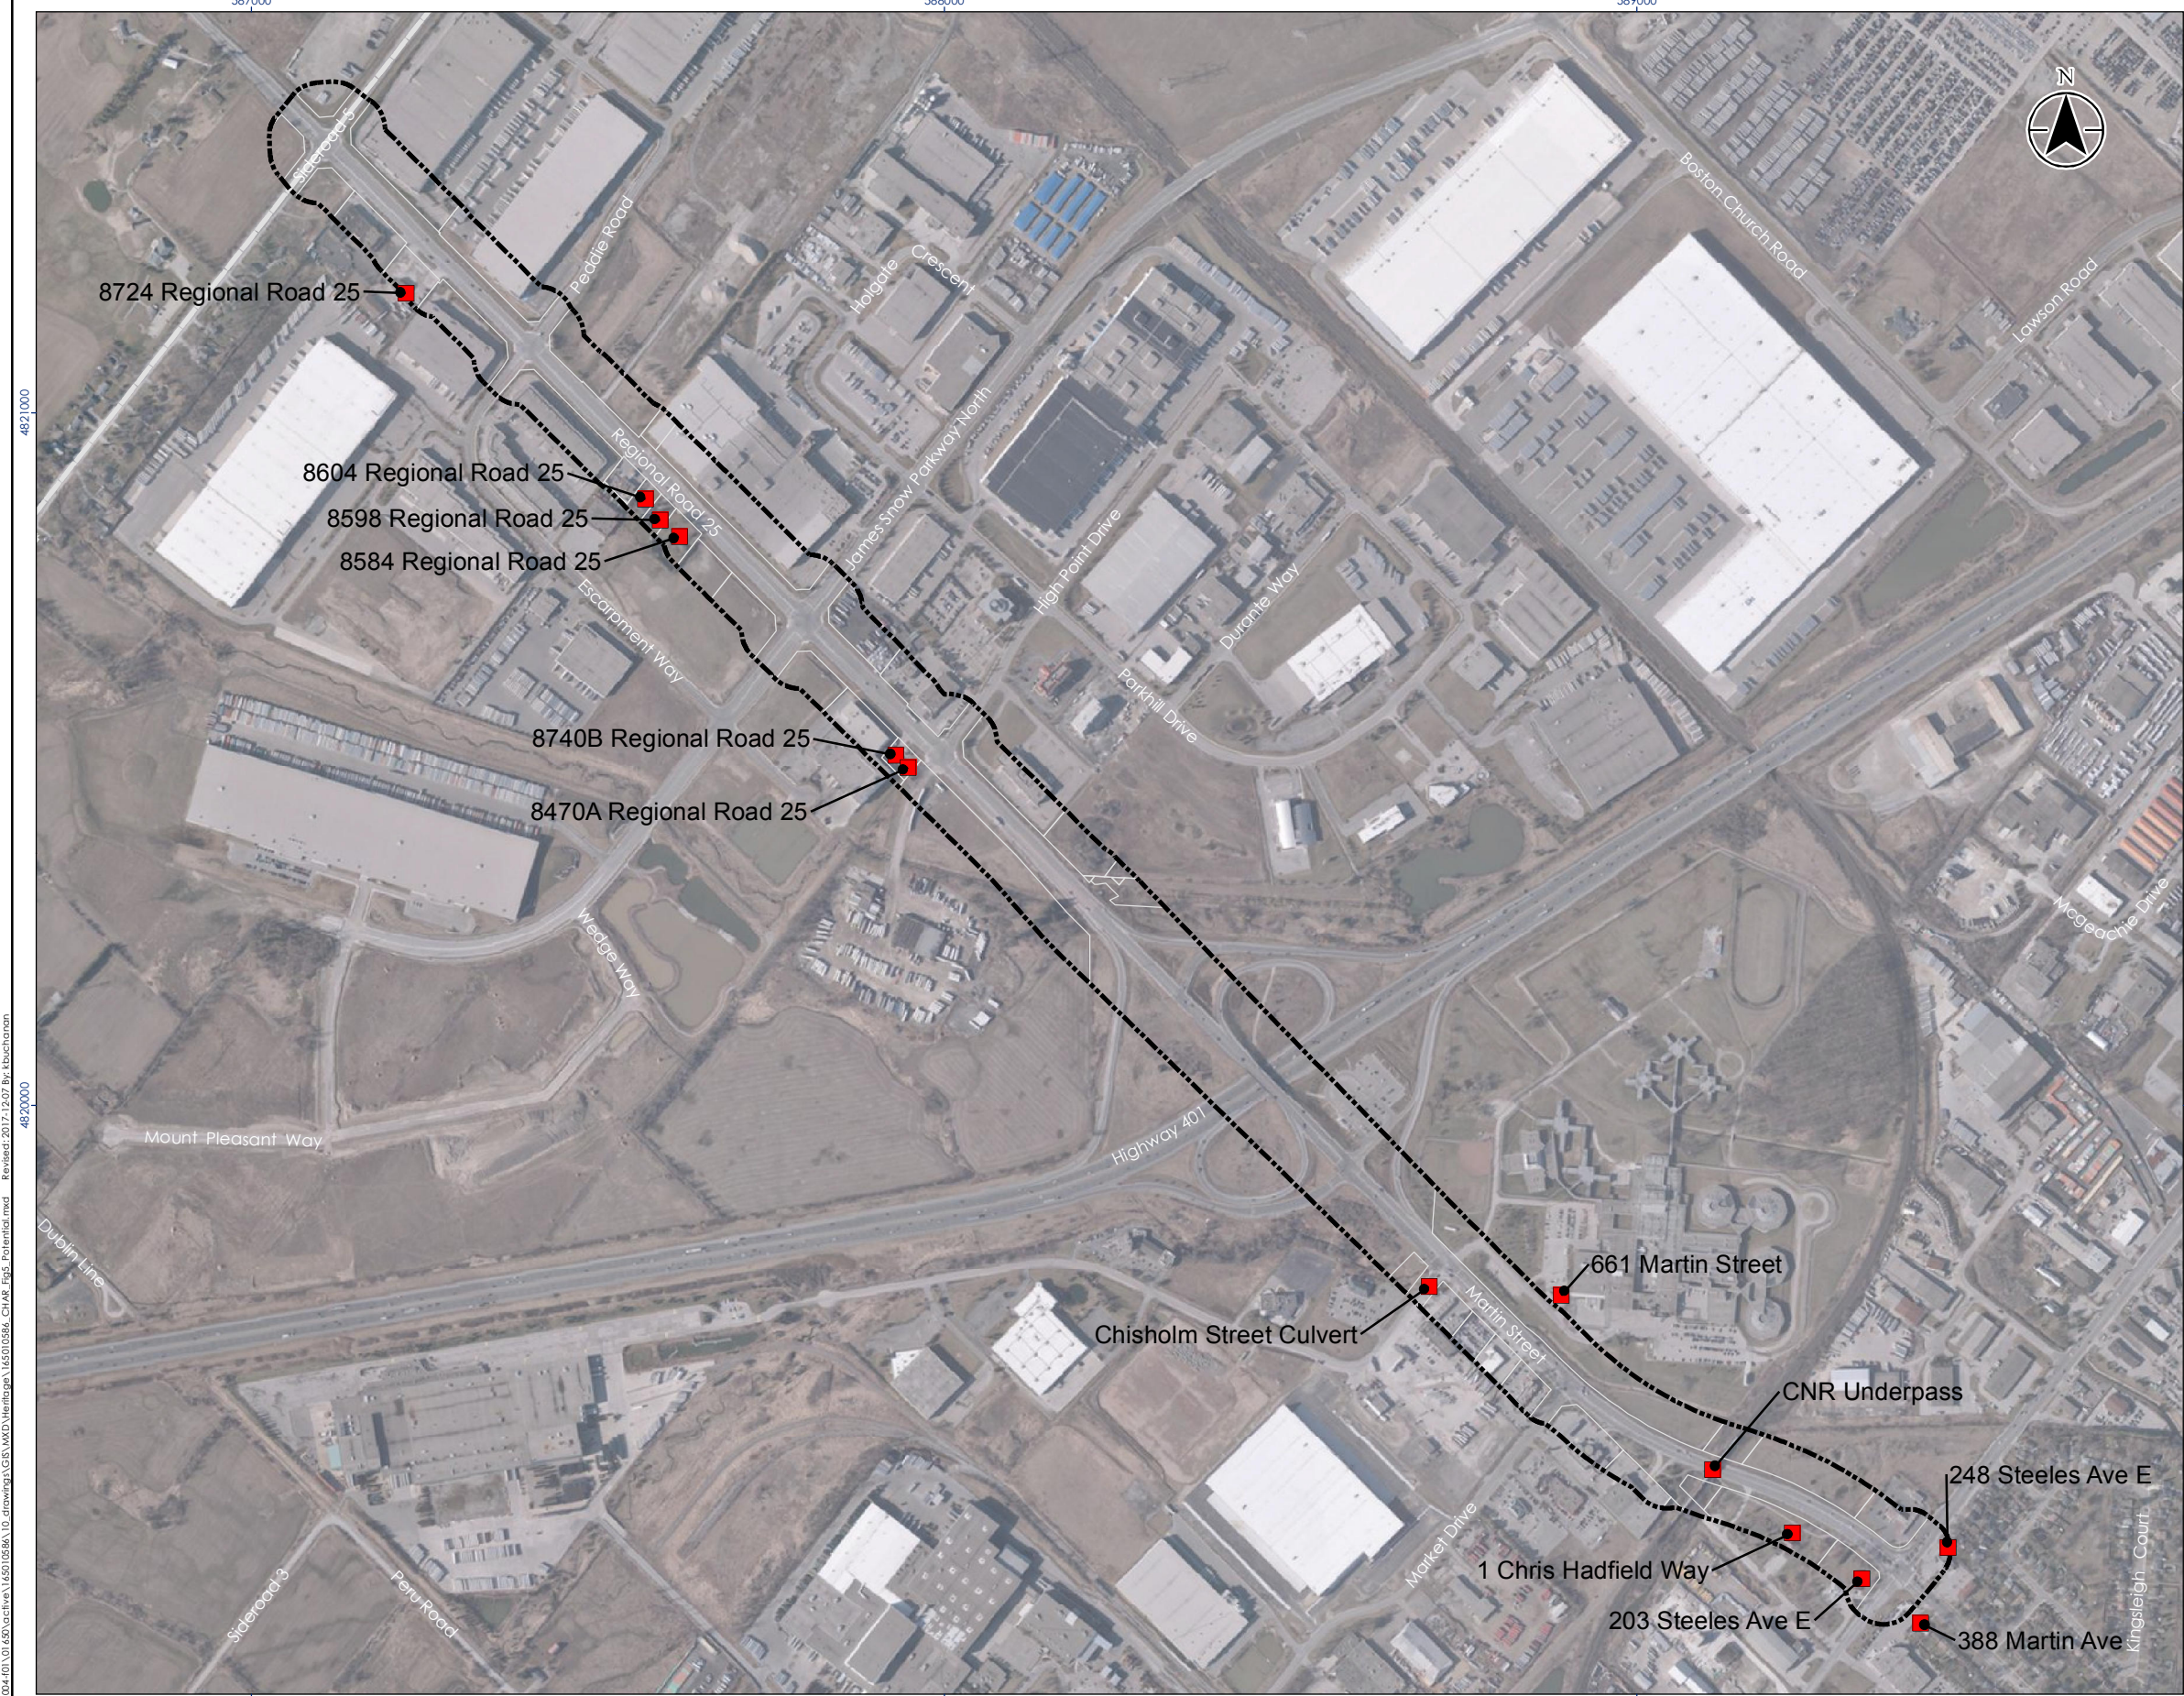
During the course of the survey, a total of 13 individual sites were identified as containing potential heritage resources (Figure 5), including:

- One bridge
- One train station (listed on the Town of Milton's Heritage Inventory as a 'listed' property)
- One culvert
- Two civic buildings
- Two commercial buildings
- Six residences that date to the mid- 20th century

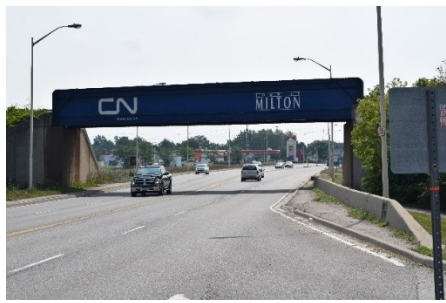
Municipal Address	Category	CHVI	CHR Number	Photo
Martin Street, 300 metres north of Steeles Avenue East	Bridge (CNR Underpass)	No	N/A

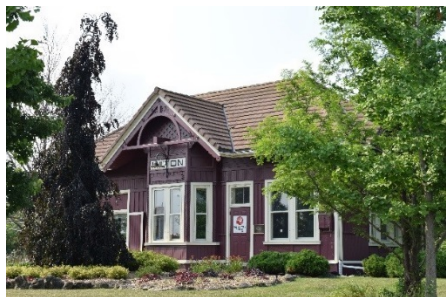
1 Chris Hadfield Way	Train Station	Yes	CHR 1

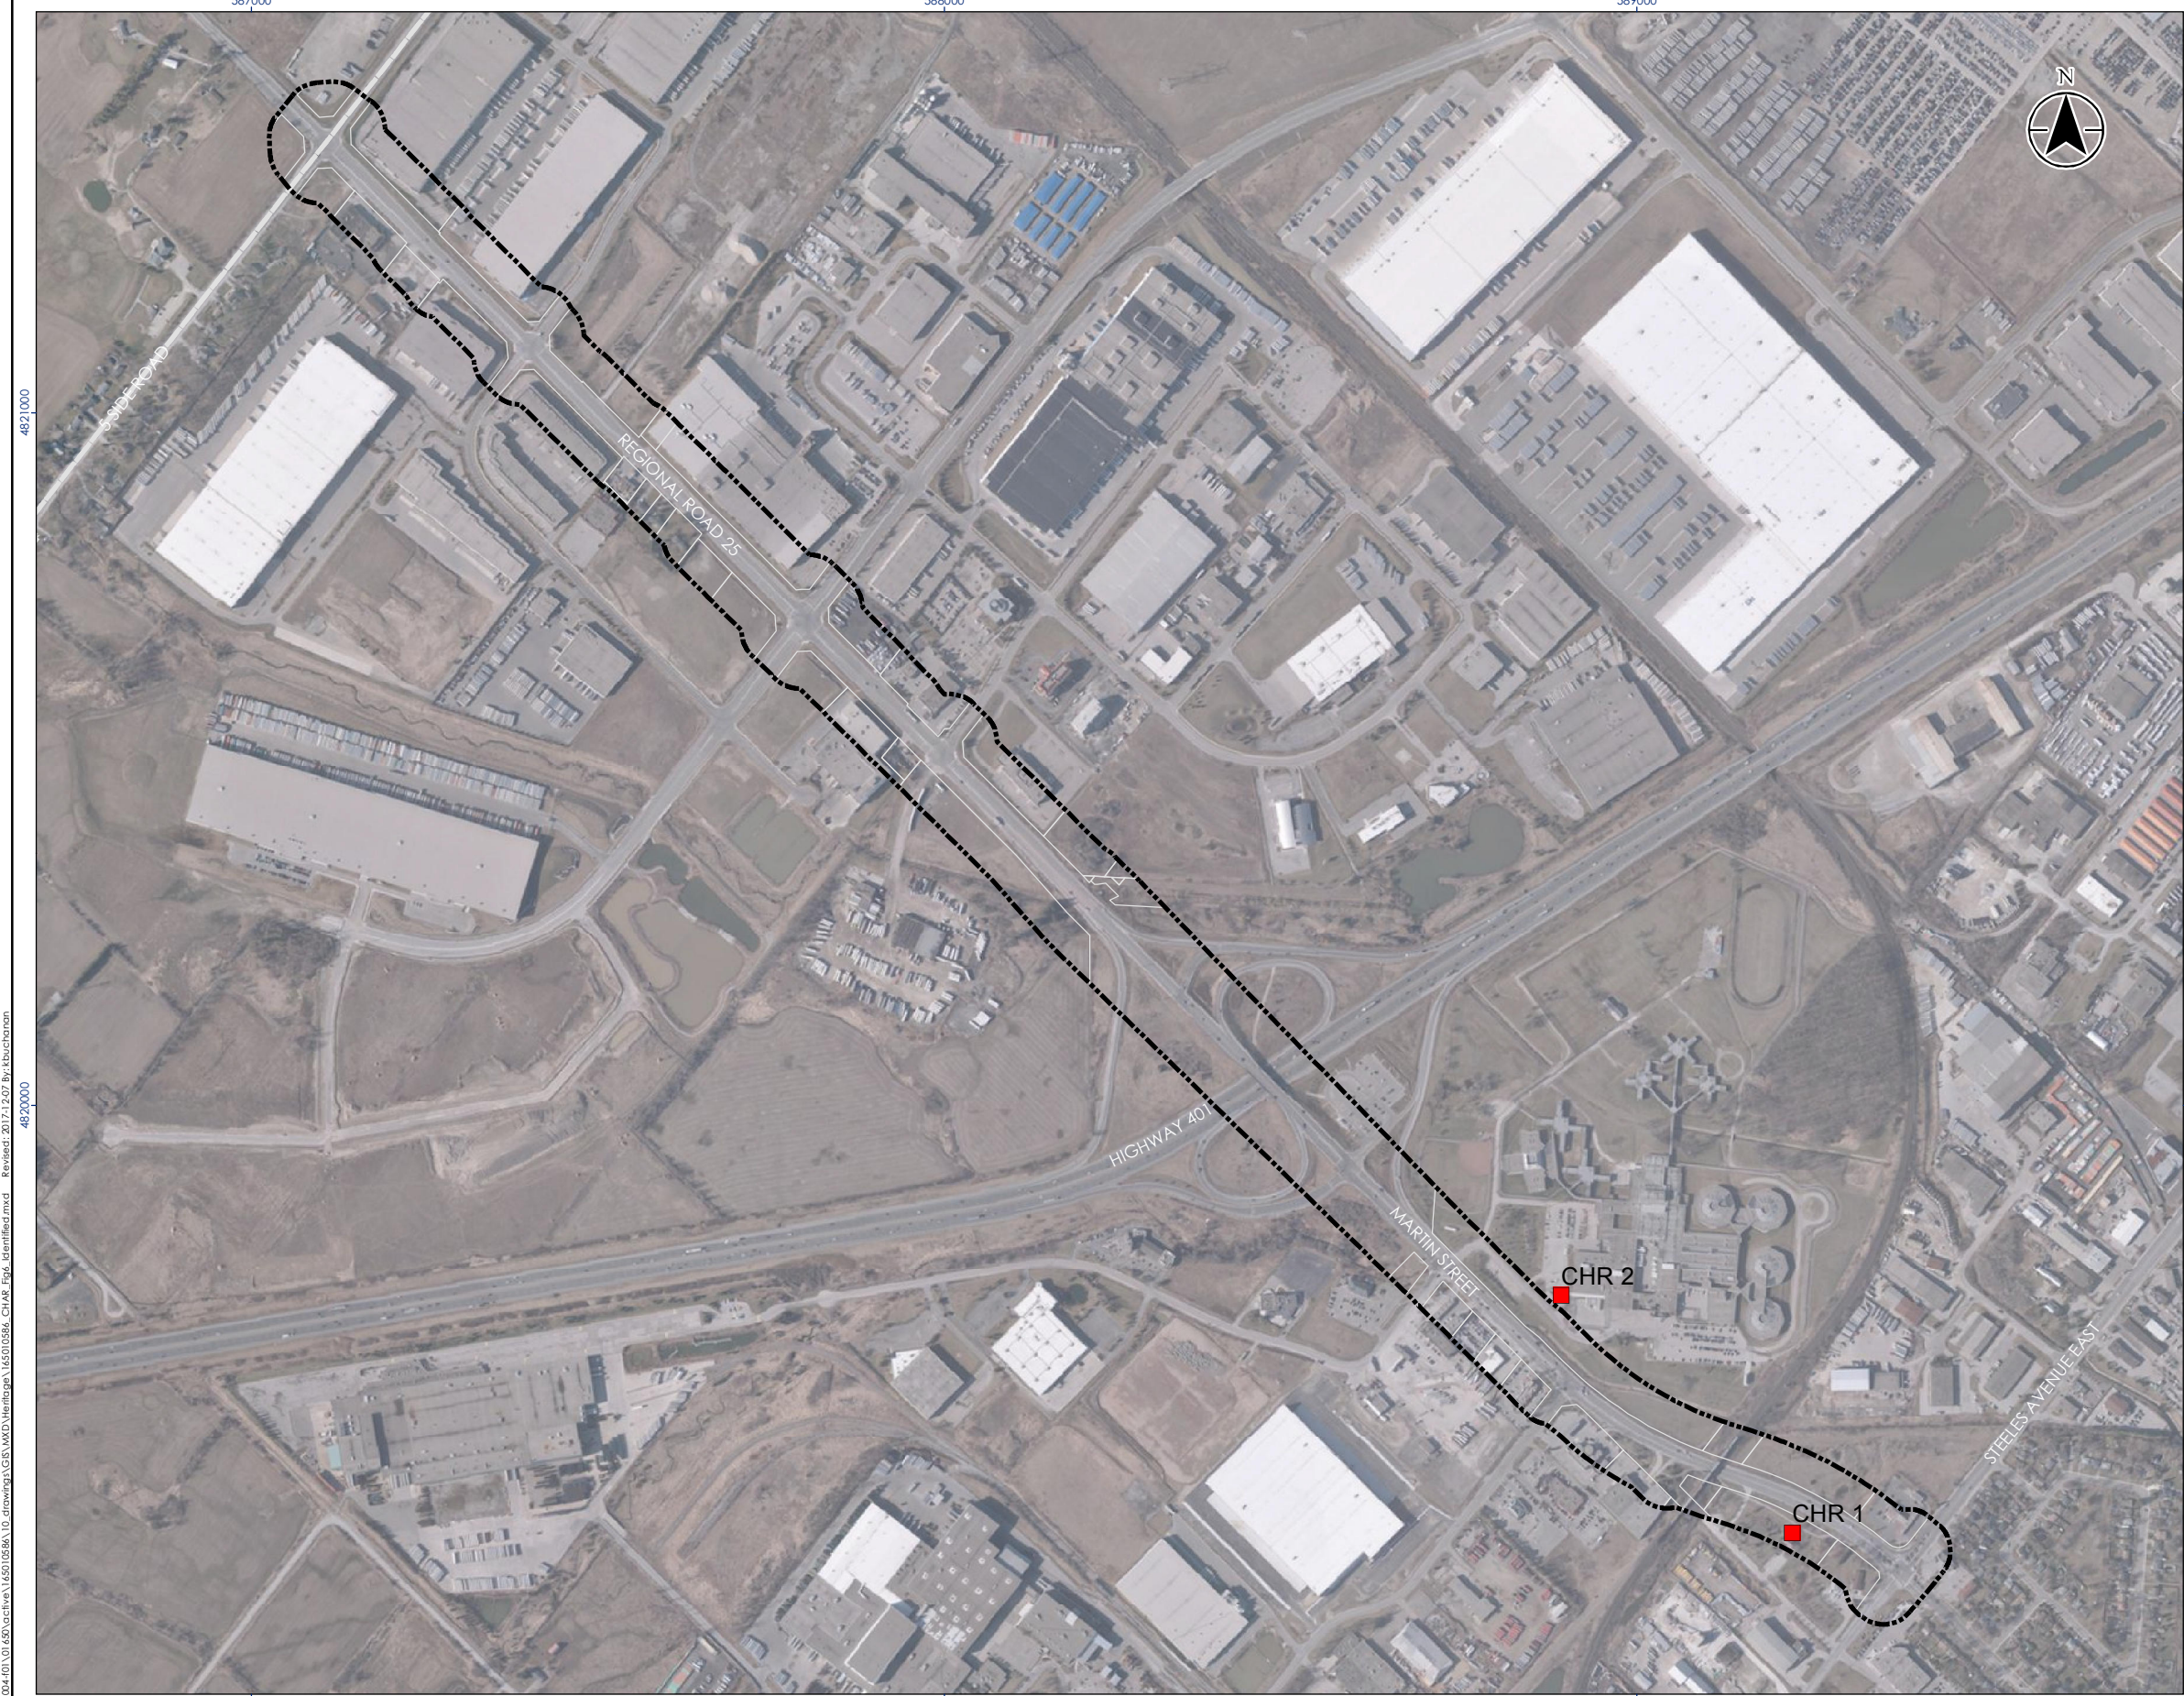
Following evaluation, two cultural heritage resources were identified within, or adjacent to, the study area (Figure 6). The two properties found to have CHVI include:

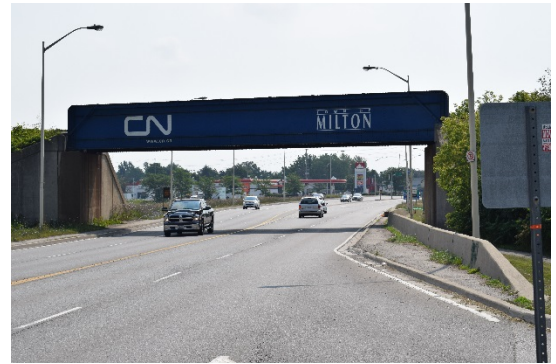
Description: Steel half-through plate girder railway bridge that takes the CN over Regional Road 25. Concrete abutment and wing walls. Date stamp of 1963 on each side. Painted blue with CN logo and Town of Milton wordmark.

Design or Physical Value: This bridge is a steel half-through plate girder rail subway that carries the CN railway over Martin Street. The bridge was built in 1963 and is oriented in a general north-south direction. The bridge is painted blue and includes the CN and Town of Milton logos. This bridge is a utilitarian structure that does not display a high degree of craftsmanship/artistic merit or technical/scientific achievement.

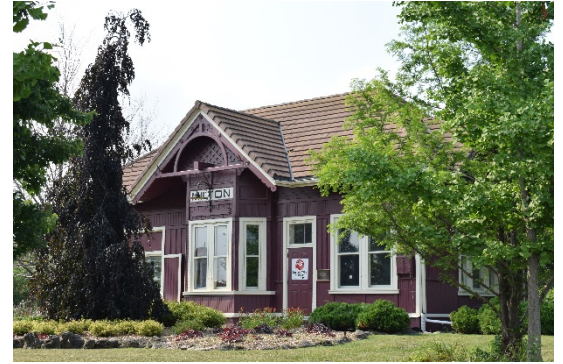
Description: Milton Train Station. One storey building with hip roof and asphalt shingles. Decorative wood work in gable peak. Wooden exterior. Signs for Milton on each elevation. Station moved to this location in 1970s.

Design or Physical Value: The Milton Train Station is a one storey structure with a rectangular plan, hipped roof, and central gable with bay. The exterior cladding is board-and-batten siding and the central gable features decorative vergeboard and lattice work. Signs for 'MILTON' are located on each building elevation. This train station was constructed between the late 19th century and early 20th century. This train station is unique one of the remaining, original training stations in Milton and features a high degree of craftsmanship due to the decorative architectural elements on the building exterior. It does not display a high degree of technical or scientific achievement.

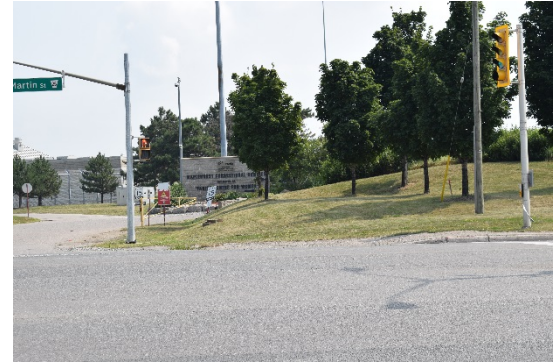
Description: Maplehurst Correctional Complex and Vanier Centre for Women. Various concrete structures, surrounded by barbed wire and fields, including baseball field. Landscaped grounds with ornamental trees and shrubs.

Design or Physical Value: The Maplehurst Correctional Complex was constructed in 1974. At the time of its construction, it was considered a 'state-of-the-art' facility and used a pod design to house inmates. It is one of the first "super jails" constructed in Ontario. The Maplehurst Correctional Complex is an innovative facility and may display a high degree of design in the layout of the facility. It is not known to display a high degree of scientific or technical achievement.

Historical or Associative Value: The Maplehurst Correctional Complex is associated with the history of correctional facilities in Ontario. It was constructed in 1974 to replace several older facilities, including the Milton Jail, Halton County Jail, and the Mimico Correctional Centre. A riot and prisoner escape occurred at the facility in 1979. This property has the potential to yield information that contributes to an understanding of correctional facilities in Ontario.

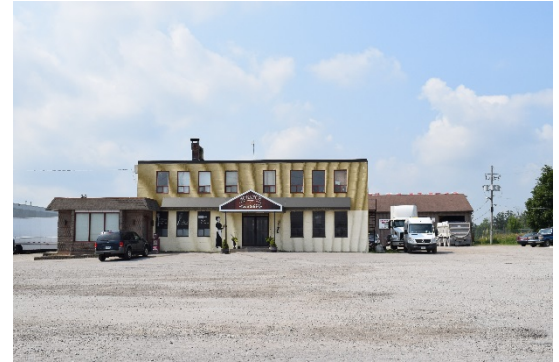
Description: Two storey commercial building. Flat roof. Modern siding and windows. Pediment centre entrance, symmetrical exterior and modern one storey addition.

Design or Physical Value: None Identified

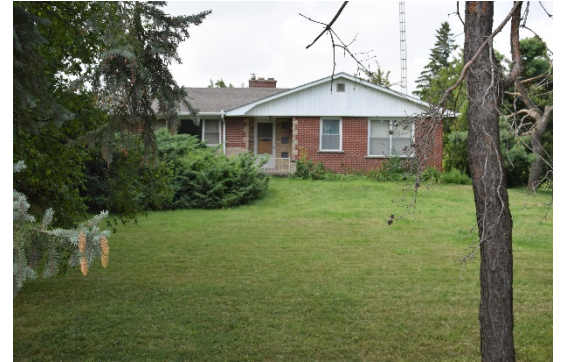
Description: One store medium pitched roof with front gable. Asphalt shingles and brick chimney. Clad in red brick and faux stone. Modern windows, concrete window sills and partial entrance porch. Asymmetrical exterior. Attached one car garage, concrete foundation. Basement.

Design or Physical Value: None Identified

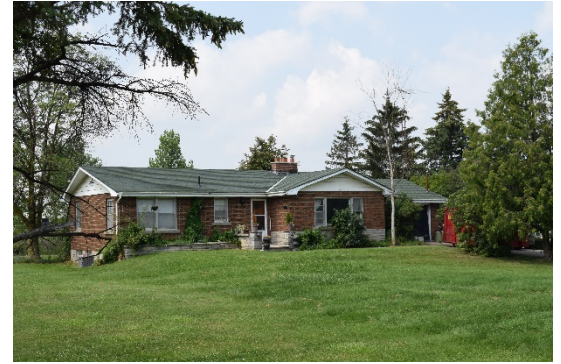
Description: One storey residence. Medium pitched side gable roof clad in modern asphalt shingles. Clad in brick and faux stone. Brick chimney. Asymmetrical exterior. Attached one car garage. Concrete foundation with basement.

Design or Physical Value: None Identified

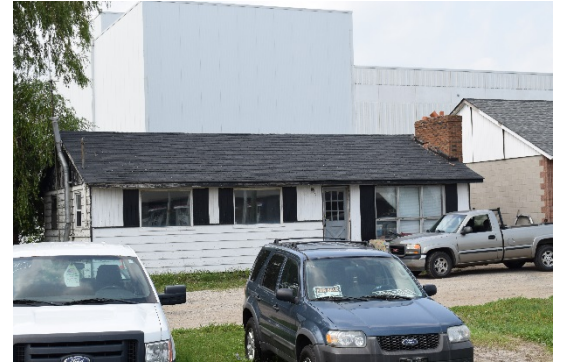
Municipal Address: 8470A Regional Road 25

Description: Residence: One storey residence with medium pitched side gable roof. Large brick chimney. Horizontal wood siding. Modern windows and concrete block foundation.

Design or Physical Value: None Identified
