STEELES AVENUE CORRIDOR IMPROVEMENTS  
CLASS ENVIRONMENTAL ASSESSMENT  
(TREMAINE ROAD TO INDUSTRIAL DRIVE,  
MILTON)  
HYDROGEOLOGICAL ASSESSMENT

STEELES AVENUE  
CORRIDOR  
IMPROVEMENTS CLASS  
ENVIRONMENTAL  
ASSESSMENT  
(TREMAINE ROAD TO  
INDUSTRIAL ROAD,  
MILTON)  
HYDROGEOLOGICAL  
ASSESSMENT

PROJECT NO.: 17M-00979-00  
DATE: MAY 03, 2022

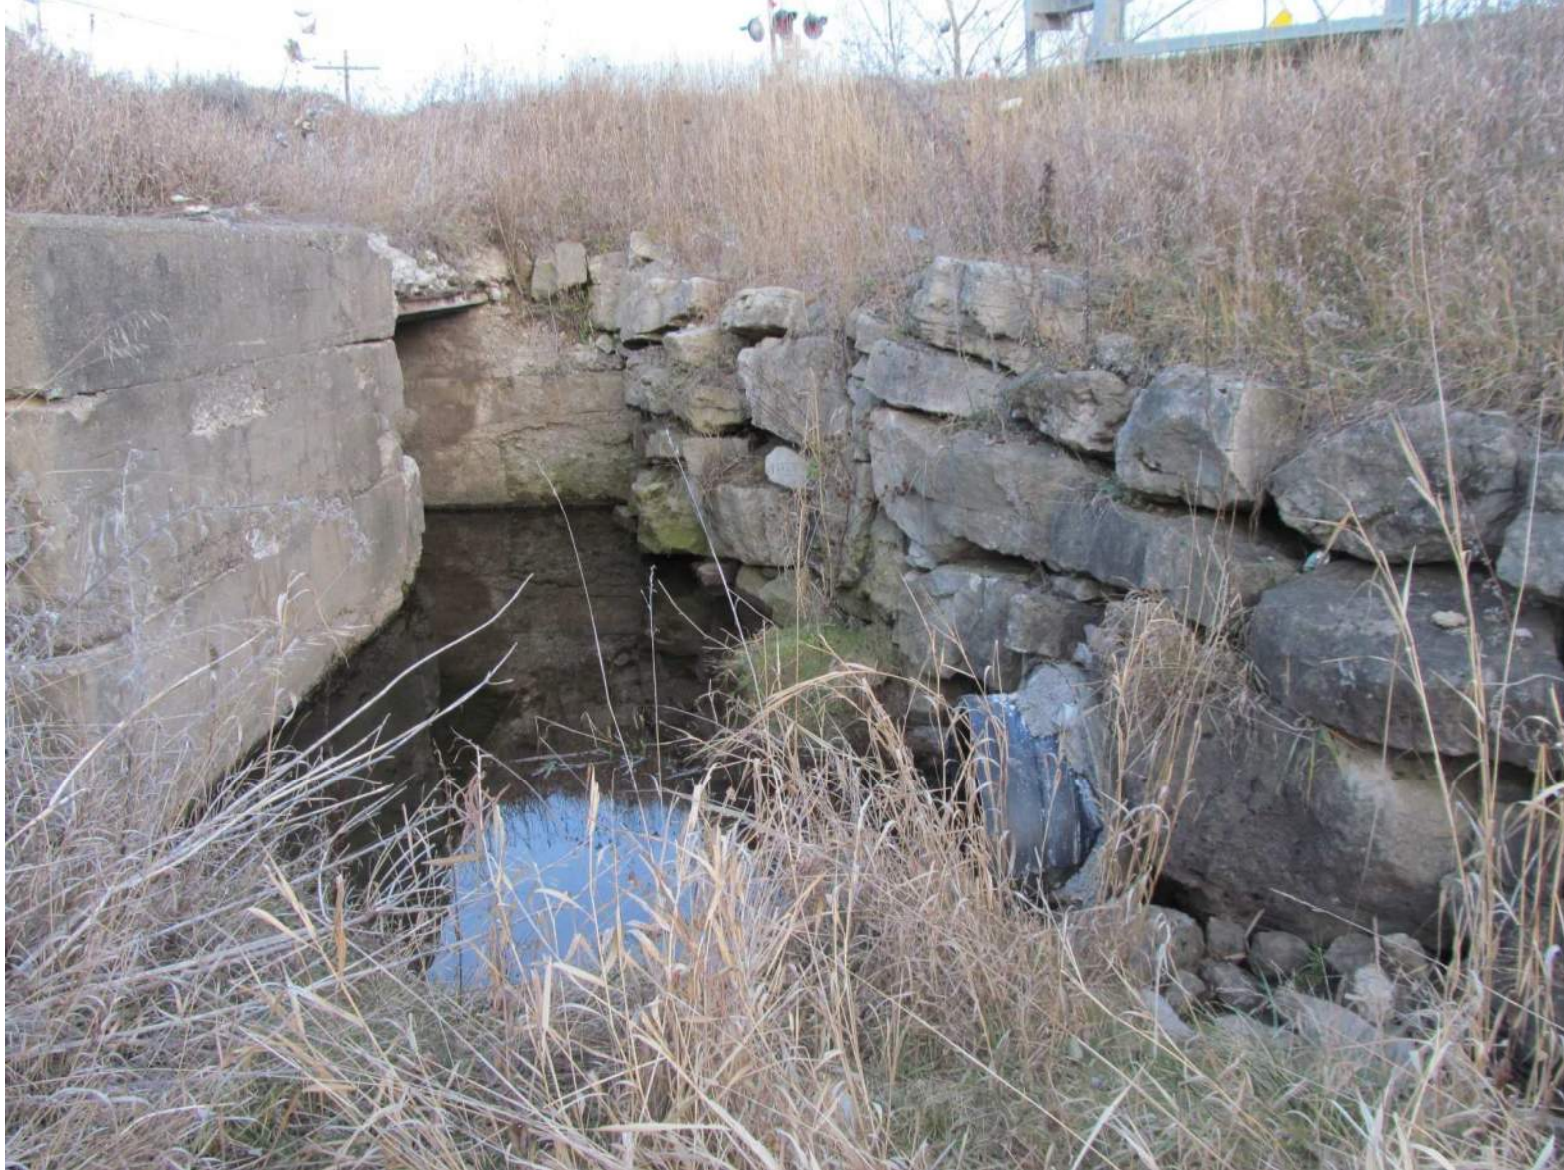
Photograph 10: Confluence of Unnamed Tributary and NW1-E Tributary, north of Steeles Ave and immediately west of CP Rail crossing, Dec. 1, 2017. Source: WSP site visit.

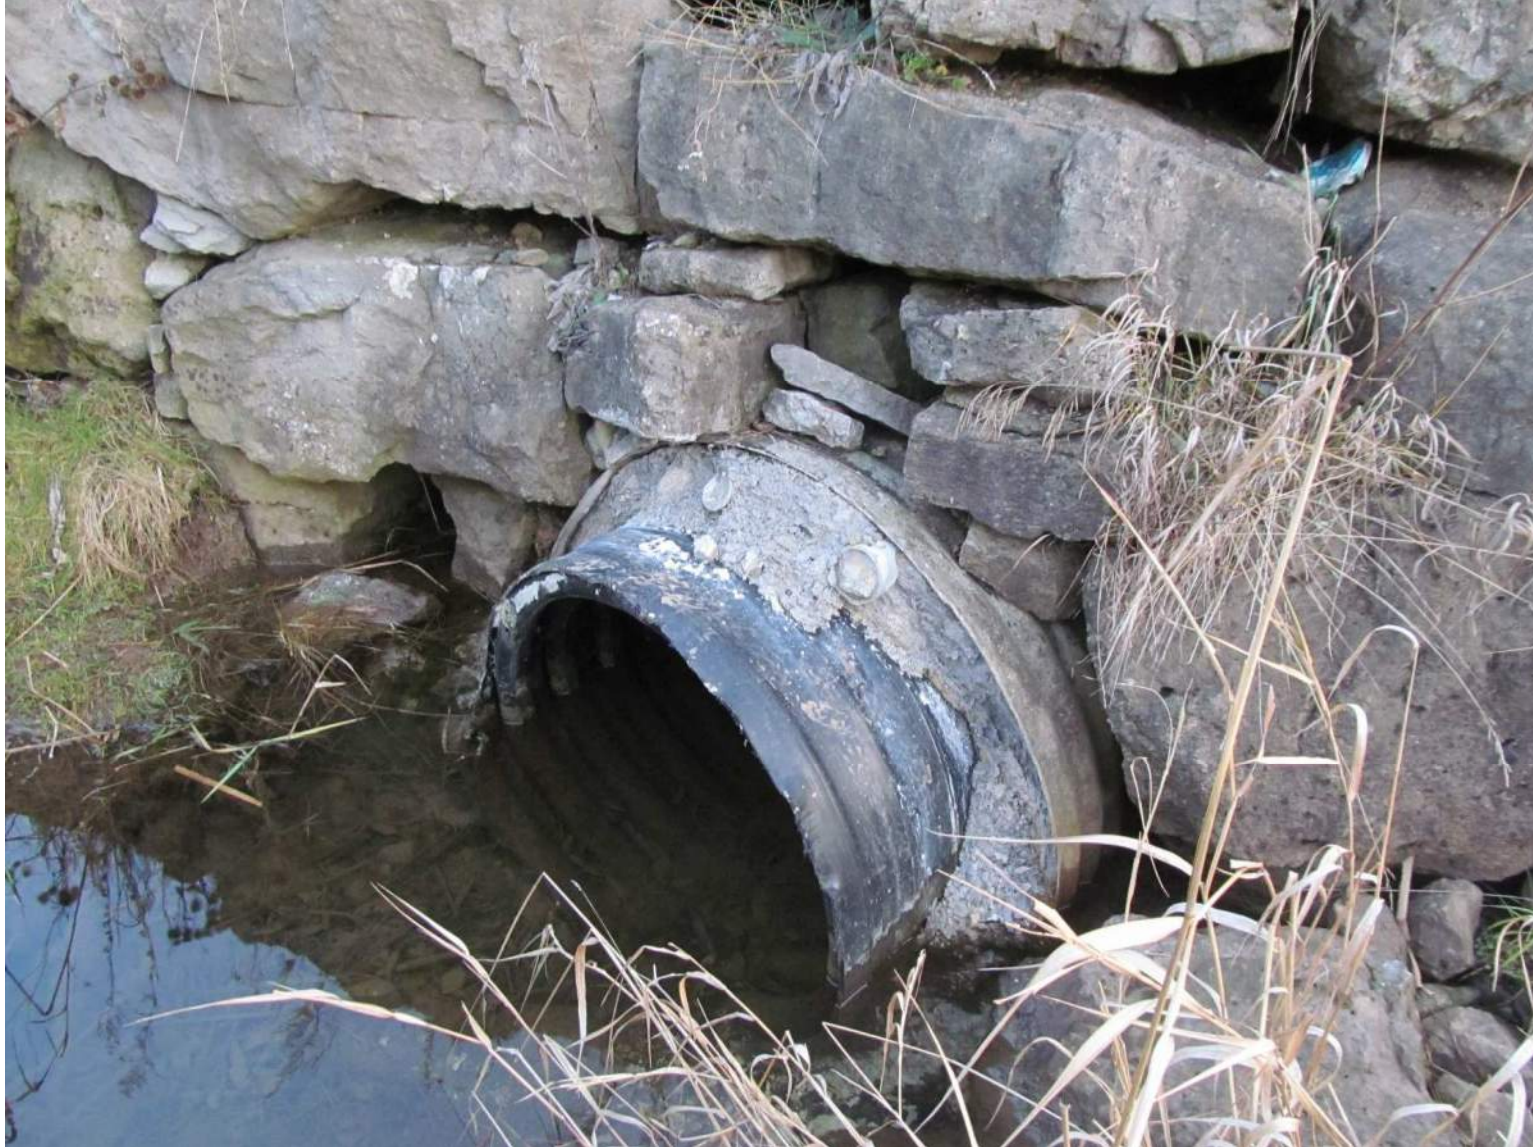
Photograph 11: Outfall of NW1-E Tributary culvert crossing of Steeles Ave, north side of Steeles Ave, Dec. 1, 2017. Source: WSP site visit.

Although the preferred road alignment option has not yet been selected, it is anticipated that both culverts will need to be replaced as part of this project, as well as the Sixteen Mile Creek bridge. Option 2 would require replacing the Sixteen Mile Creek Bridge, and the culvert for Tributary NW-1-E at a new location.

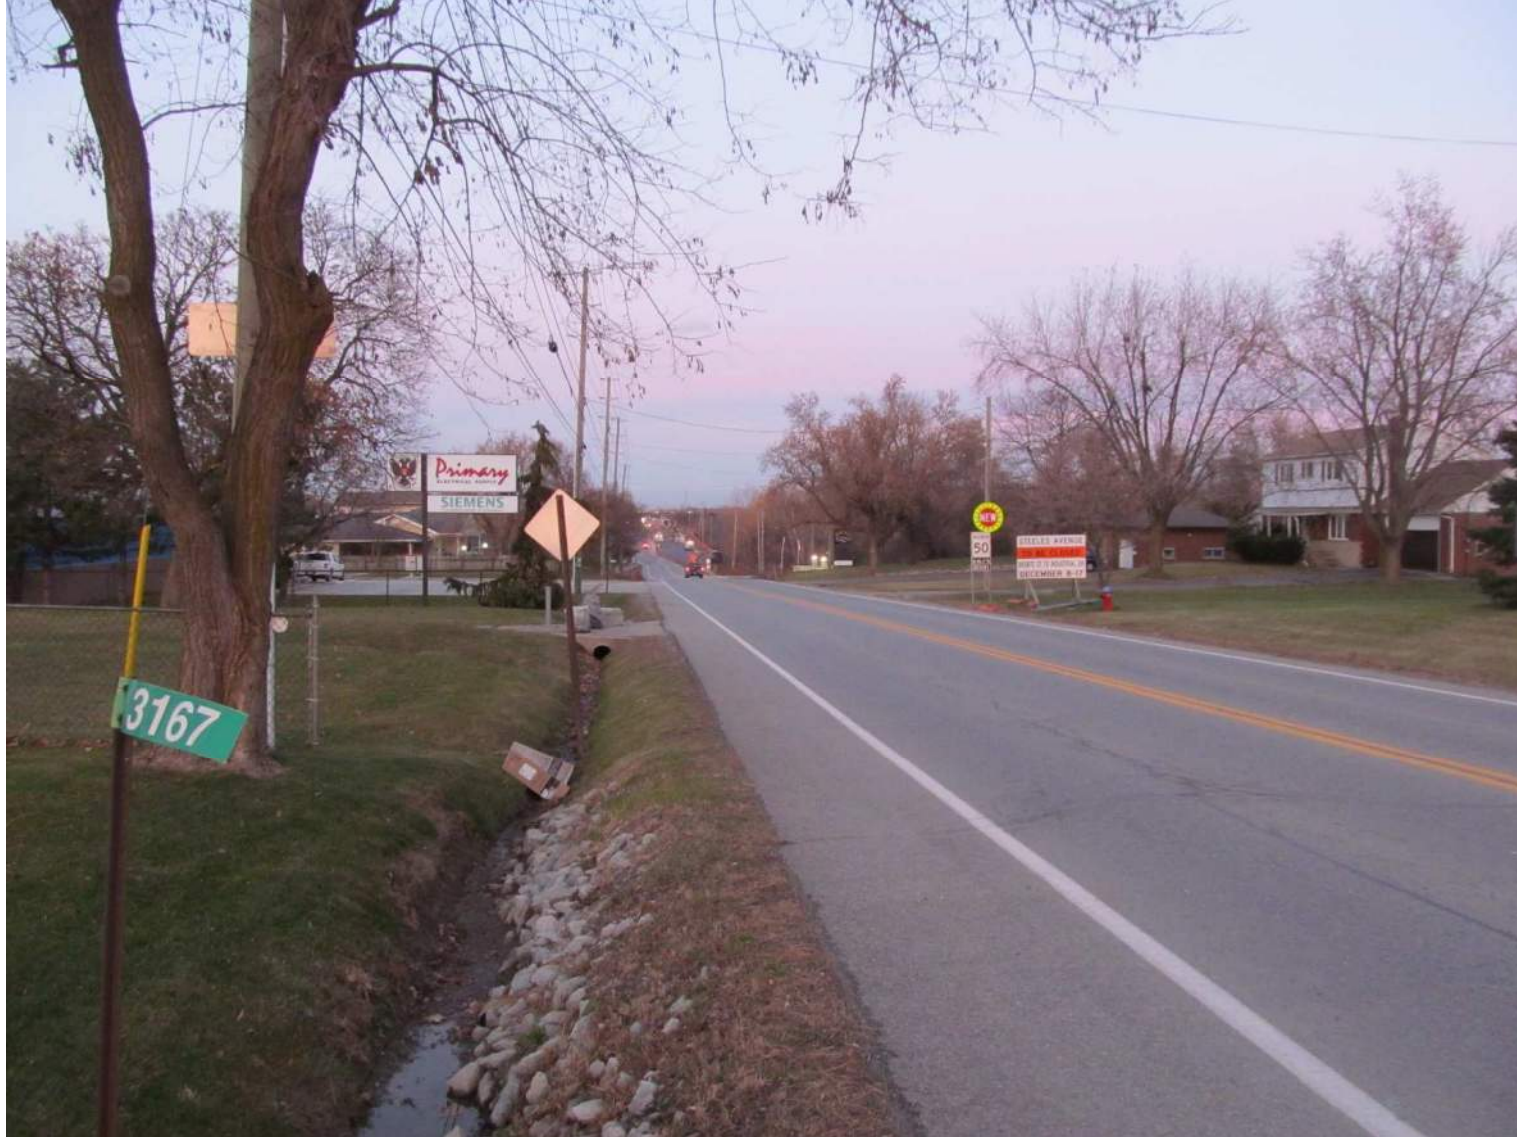
Photograph 16: North ditch along Steeles Avenue east of the CPR tracks, looking east, Dec. 1, 2017. Source: WSP

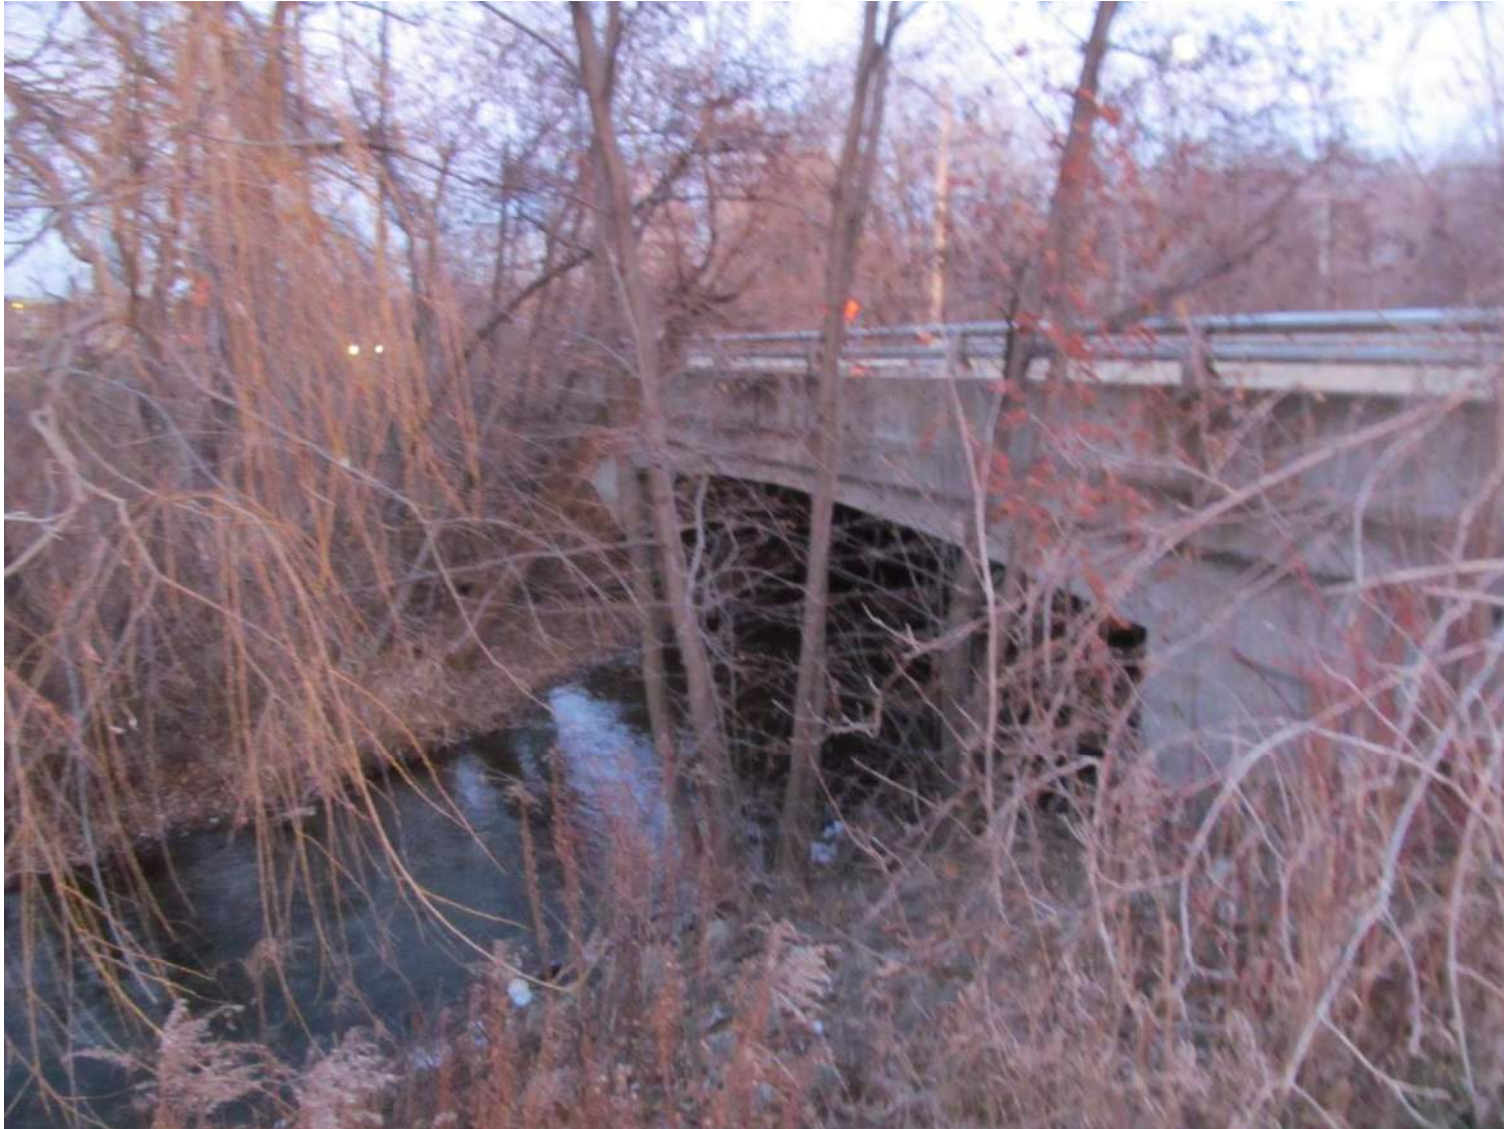
Photograph 21: North face of Sixteen Mile Creek bridge, Dec. 1, 2017. Source: WSP

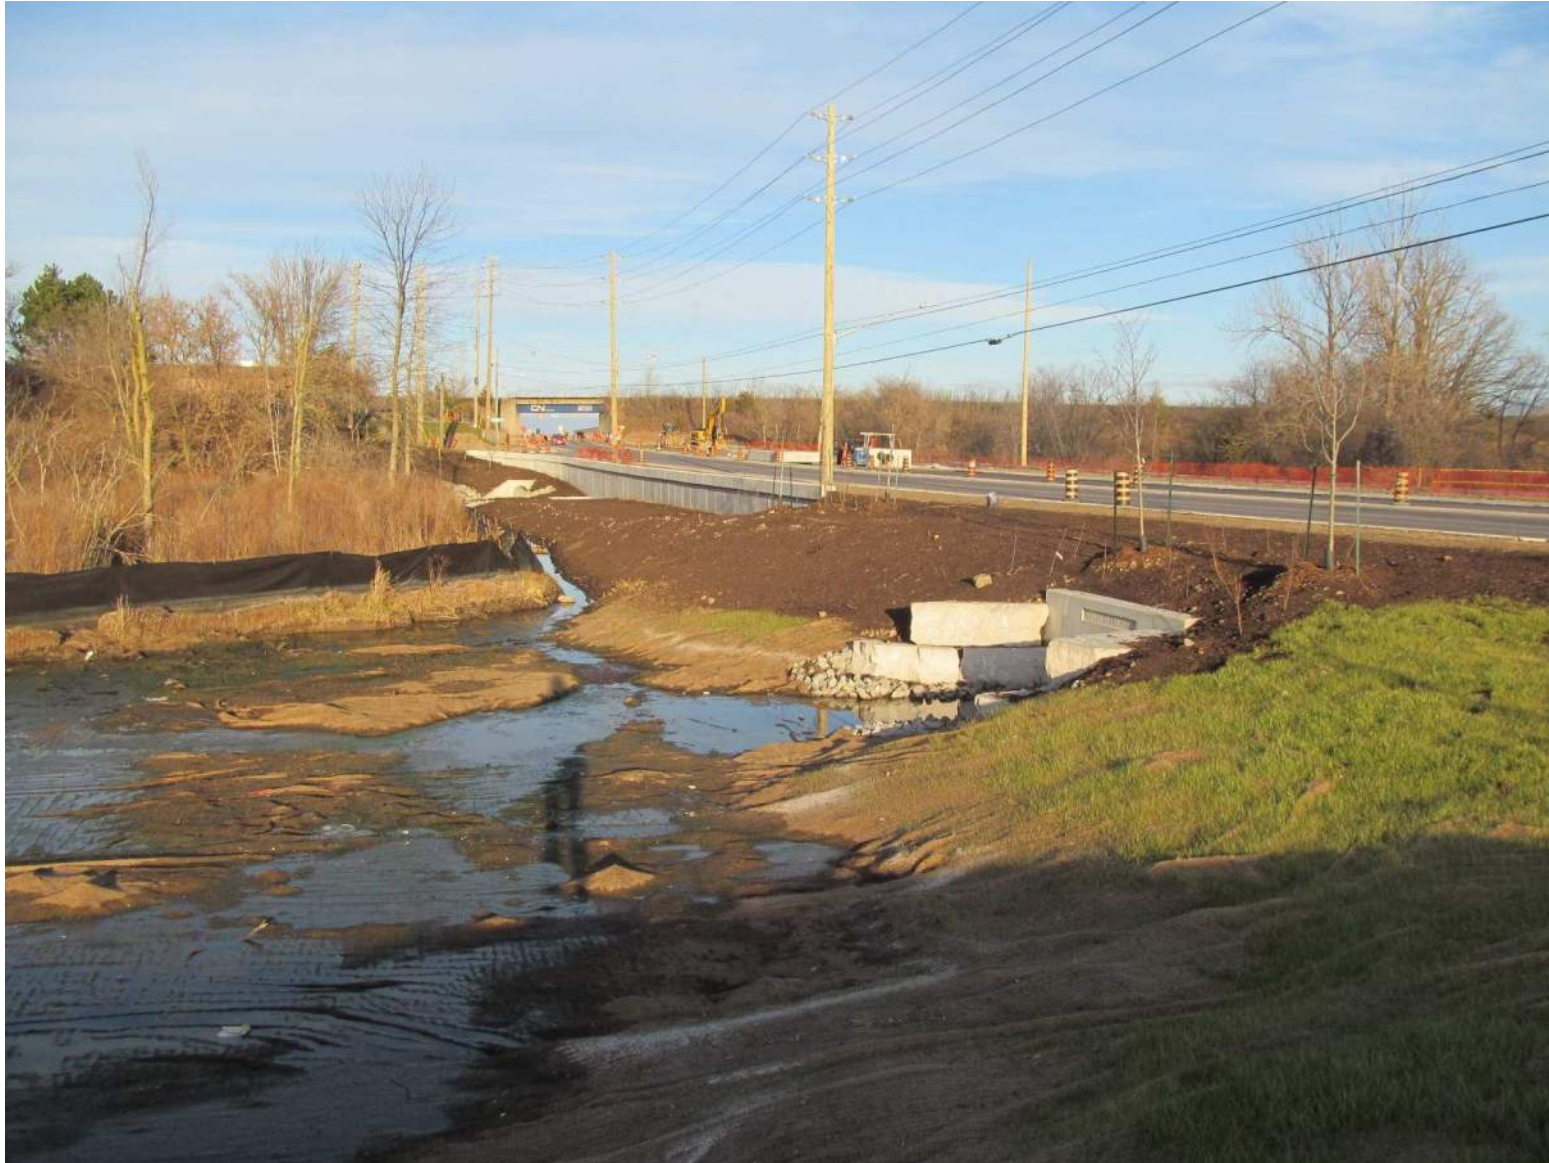
Photograph 24: SWM pond and drainage culvert looking east, Dec. 1, 2017. Source: WSP

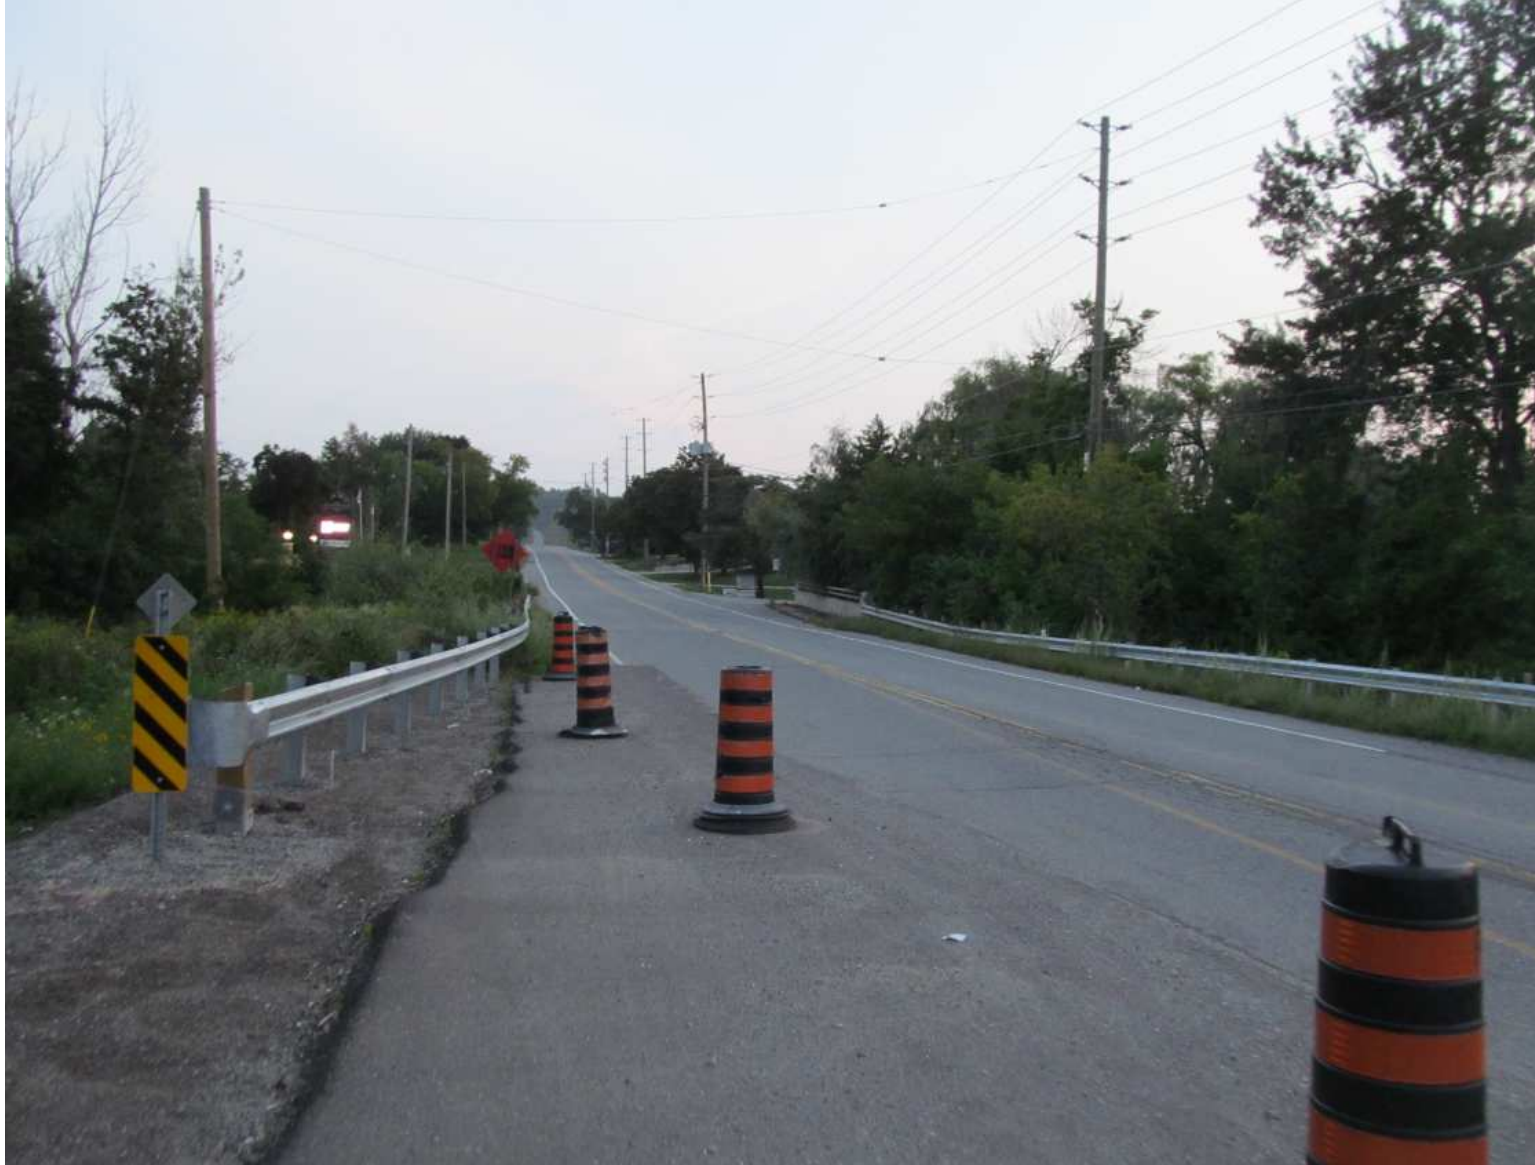
Photograph 35: **View of the Steeles Avenue bridge over Sixteen Mile Creek**, August 26, 2018. Source: WSP

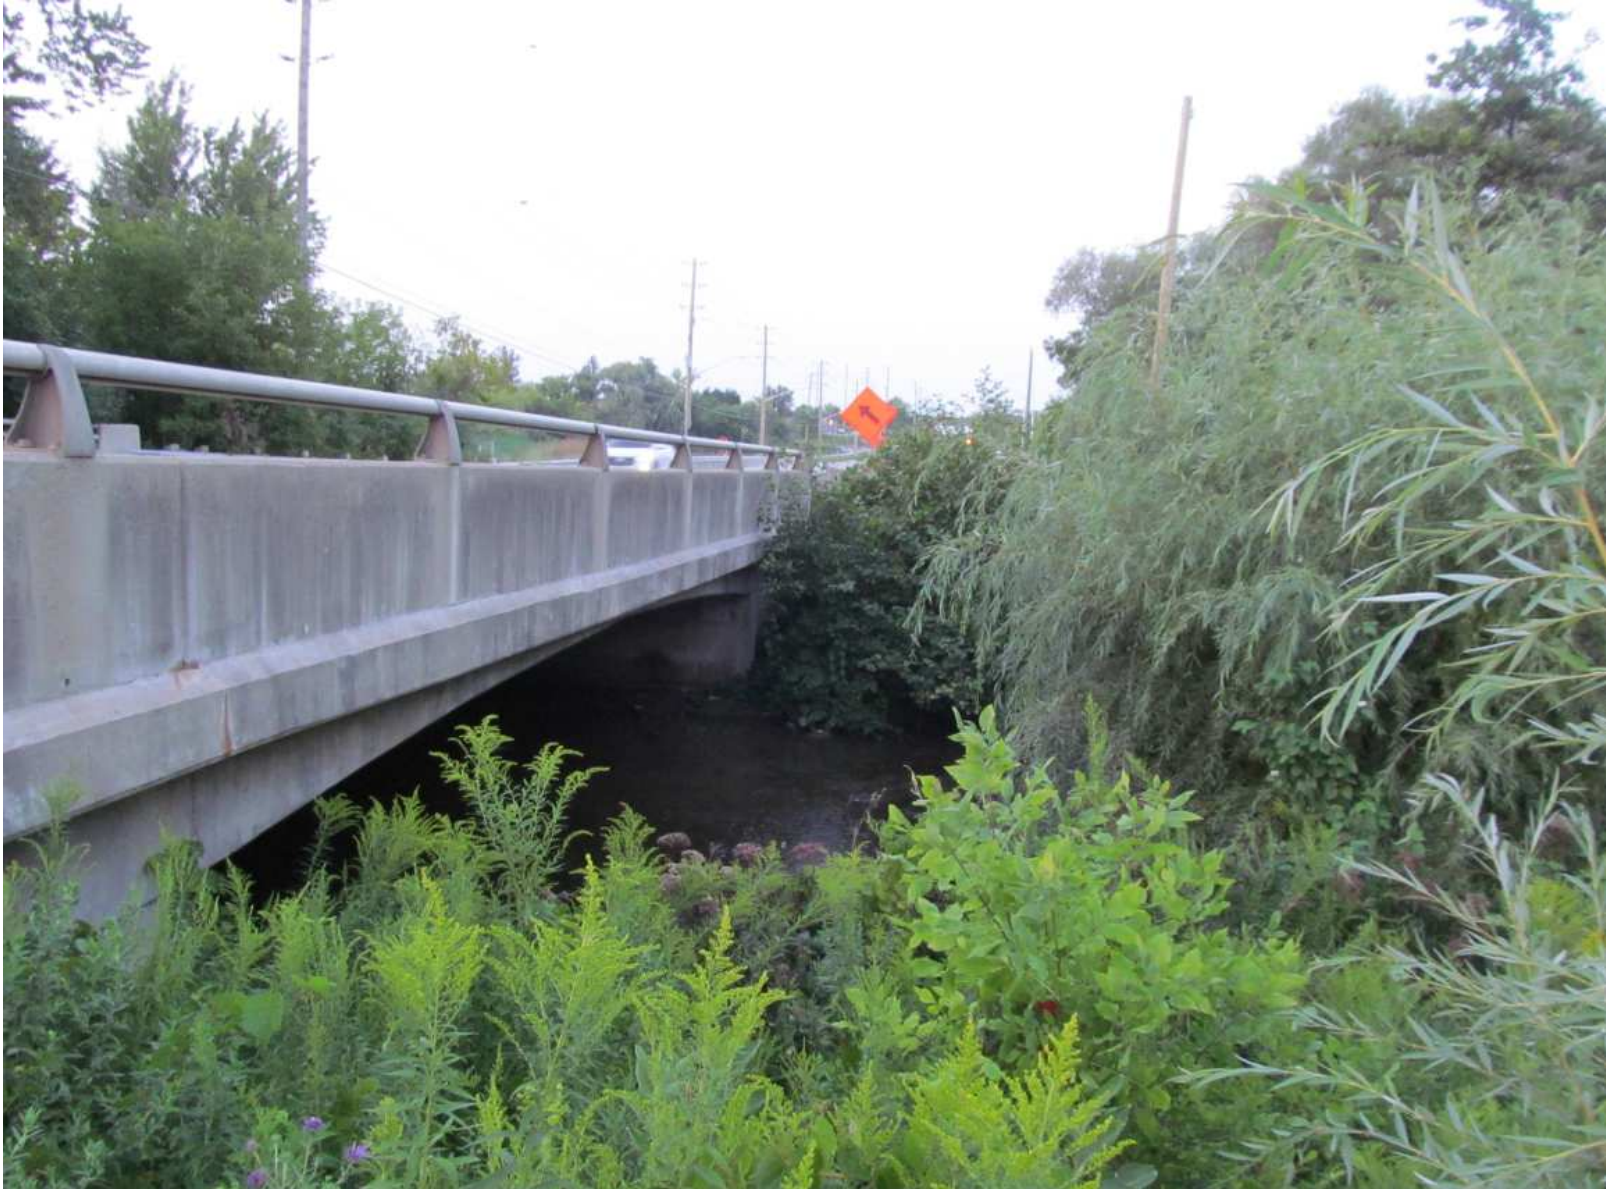
Photograph 38: View of the Steeles Avenue Bridge over Sixteen Mile Creek, showing the south side of the bridge, August 26, 2018. Source: WSP
