**FOURTH LINE WELL FIELD EXPANSION, ACTON, MUNICIPAL CLASS ENVIRONMENTAL ASSESSMENT
STUDY – PROJECT FILE**

**Environmental Impact
Assessment Fourth Line Well
Field, Acton Ontario**

Prepared for:
Regional Municipality of Halton
1151 Bronte Road
Oakville, ON
L6M 3L1

Project No. 1611-11105

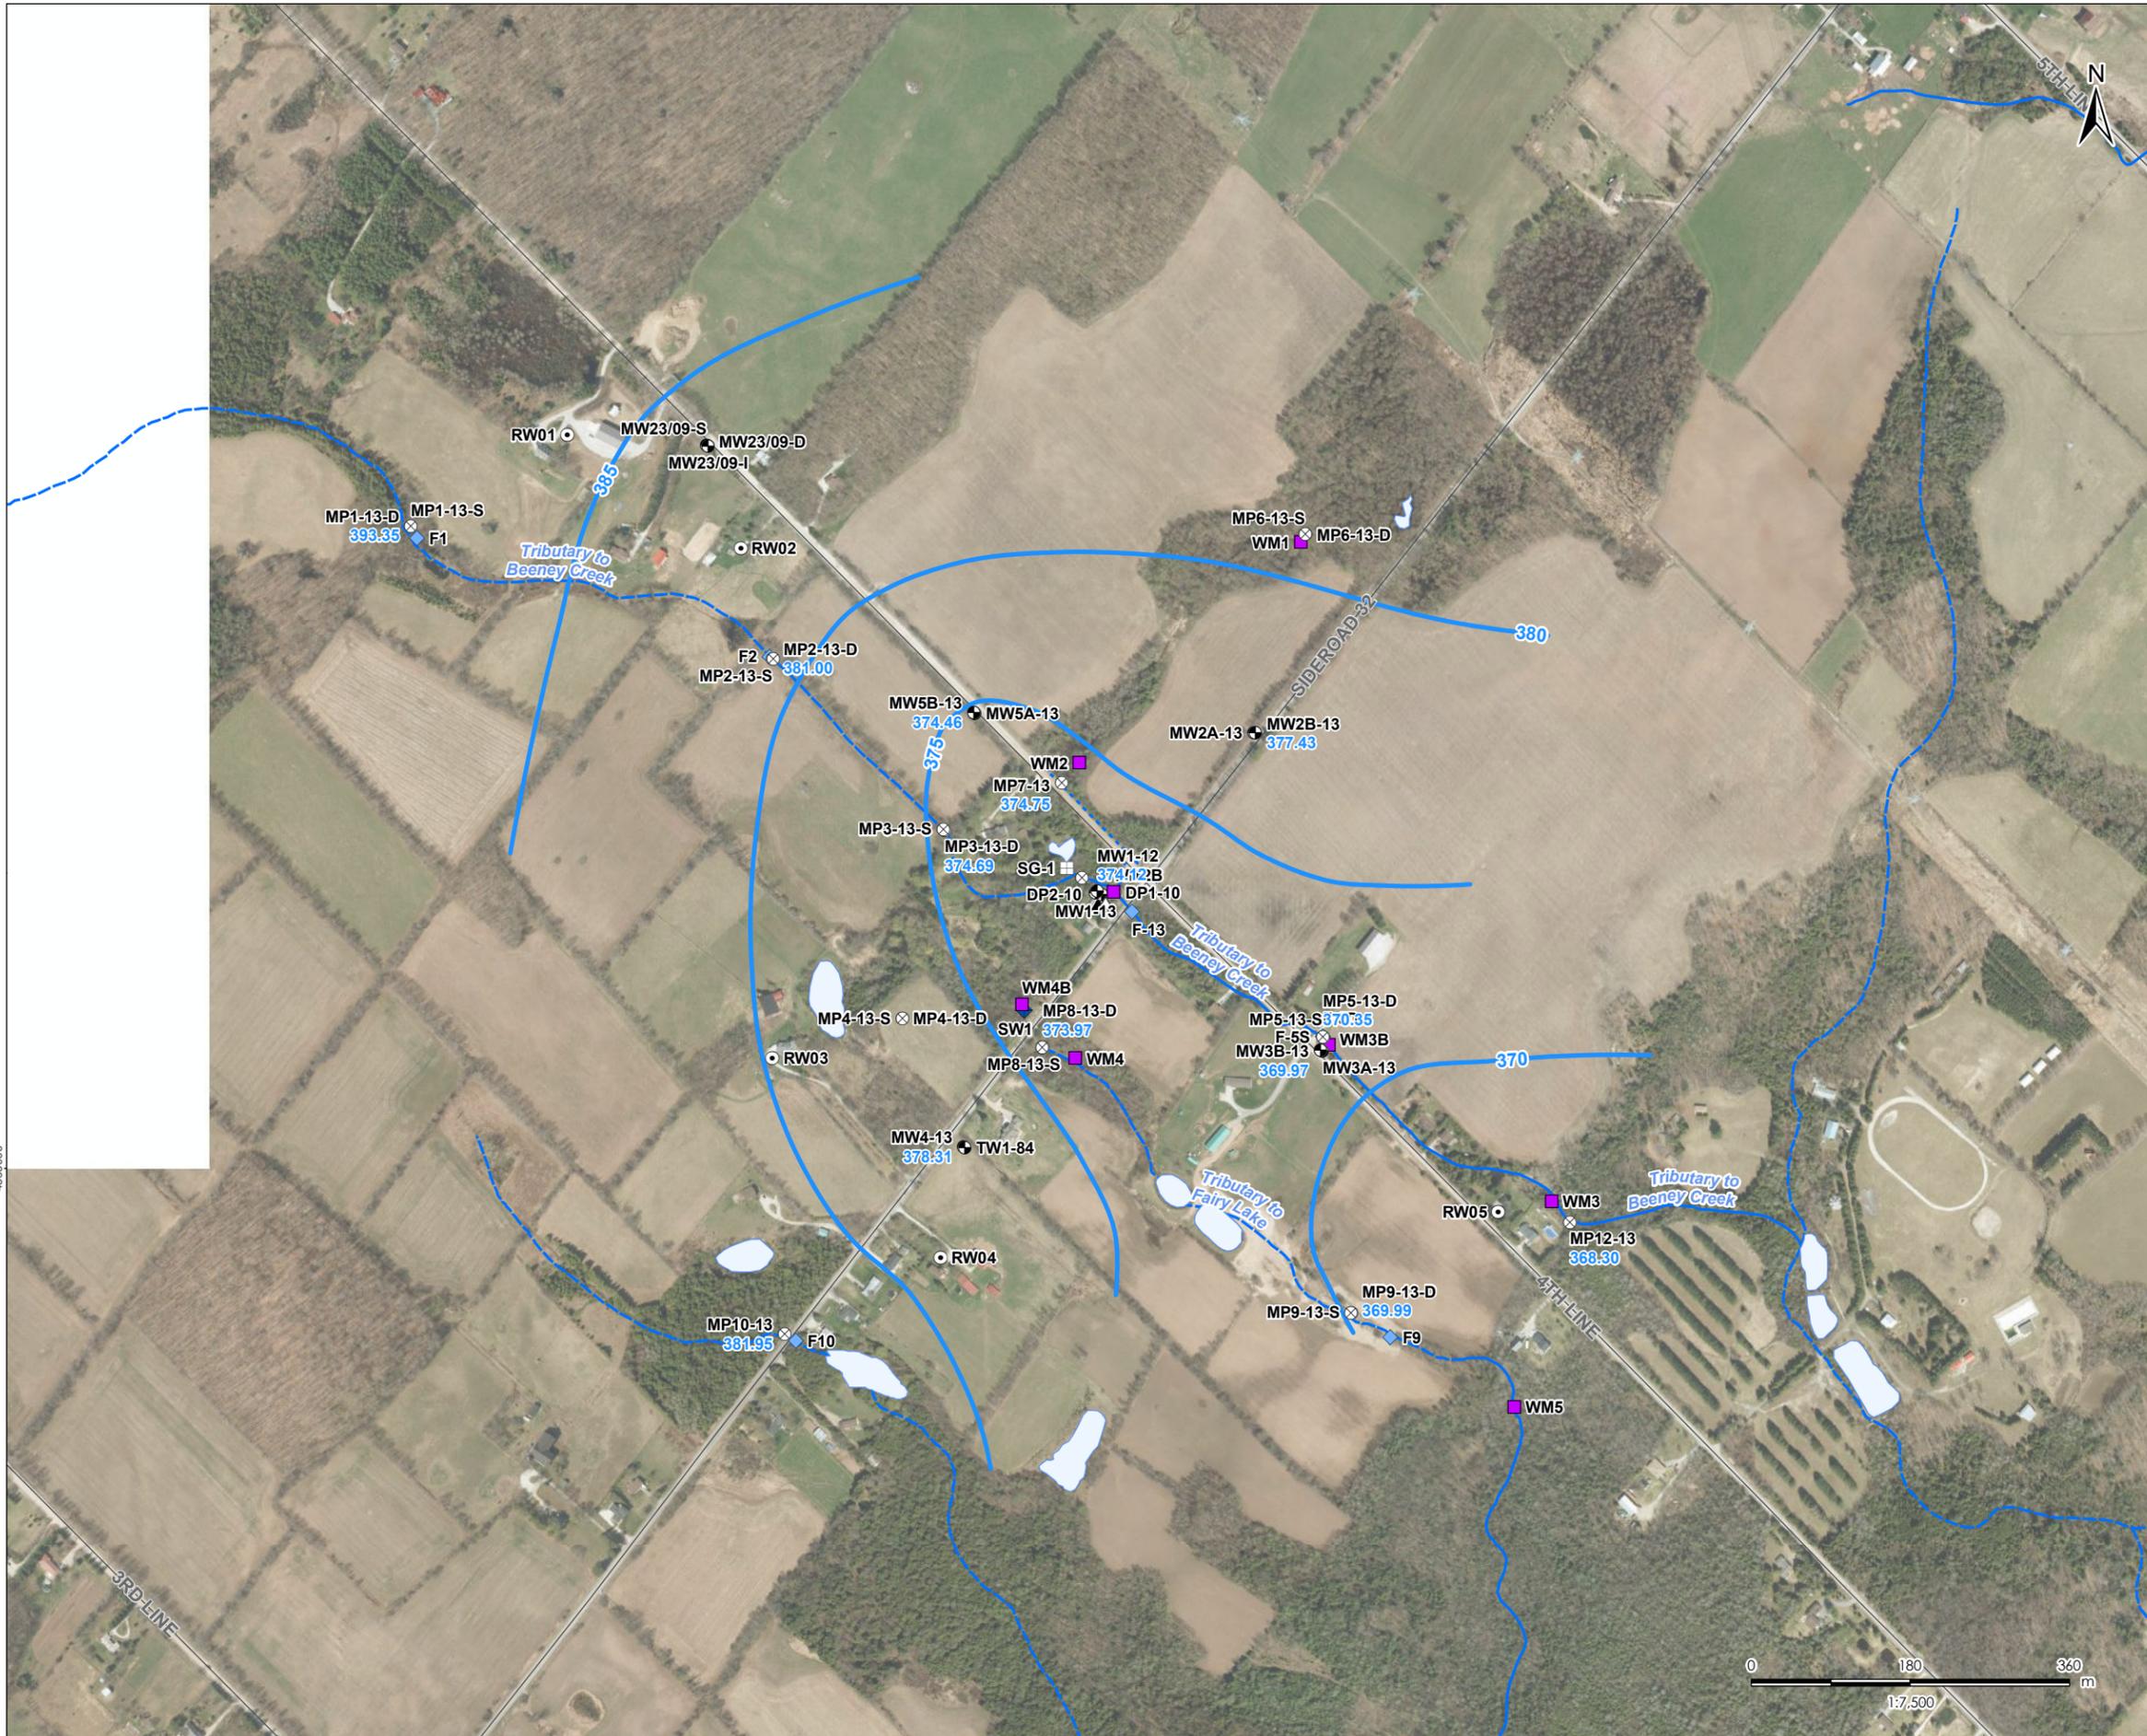
Figure No.
7a

Title
Interpreted Shallow Groundwater Flow - Overburden Stage 2 Pumping Conditions

at 15.2 L/s (Figure 7a) and the proposed increased pumping rate of 19.8 L/s (Figure 7b). These data results are further discussed in Section 4.5.

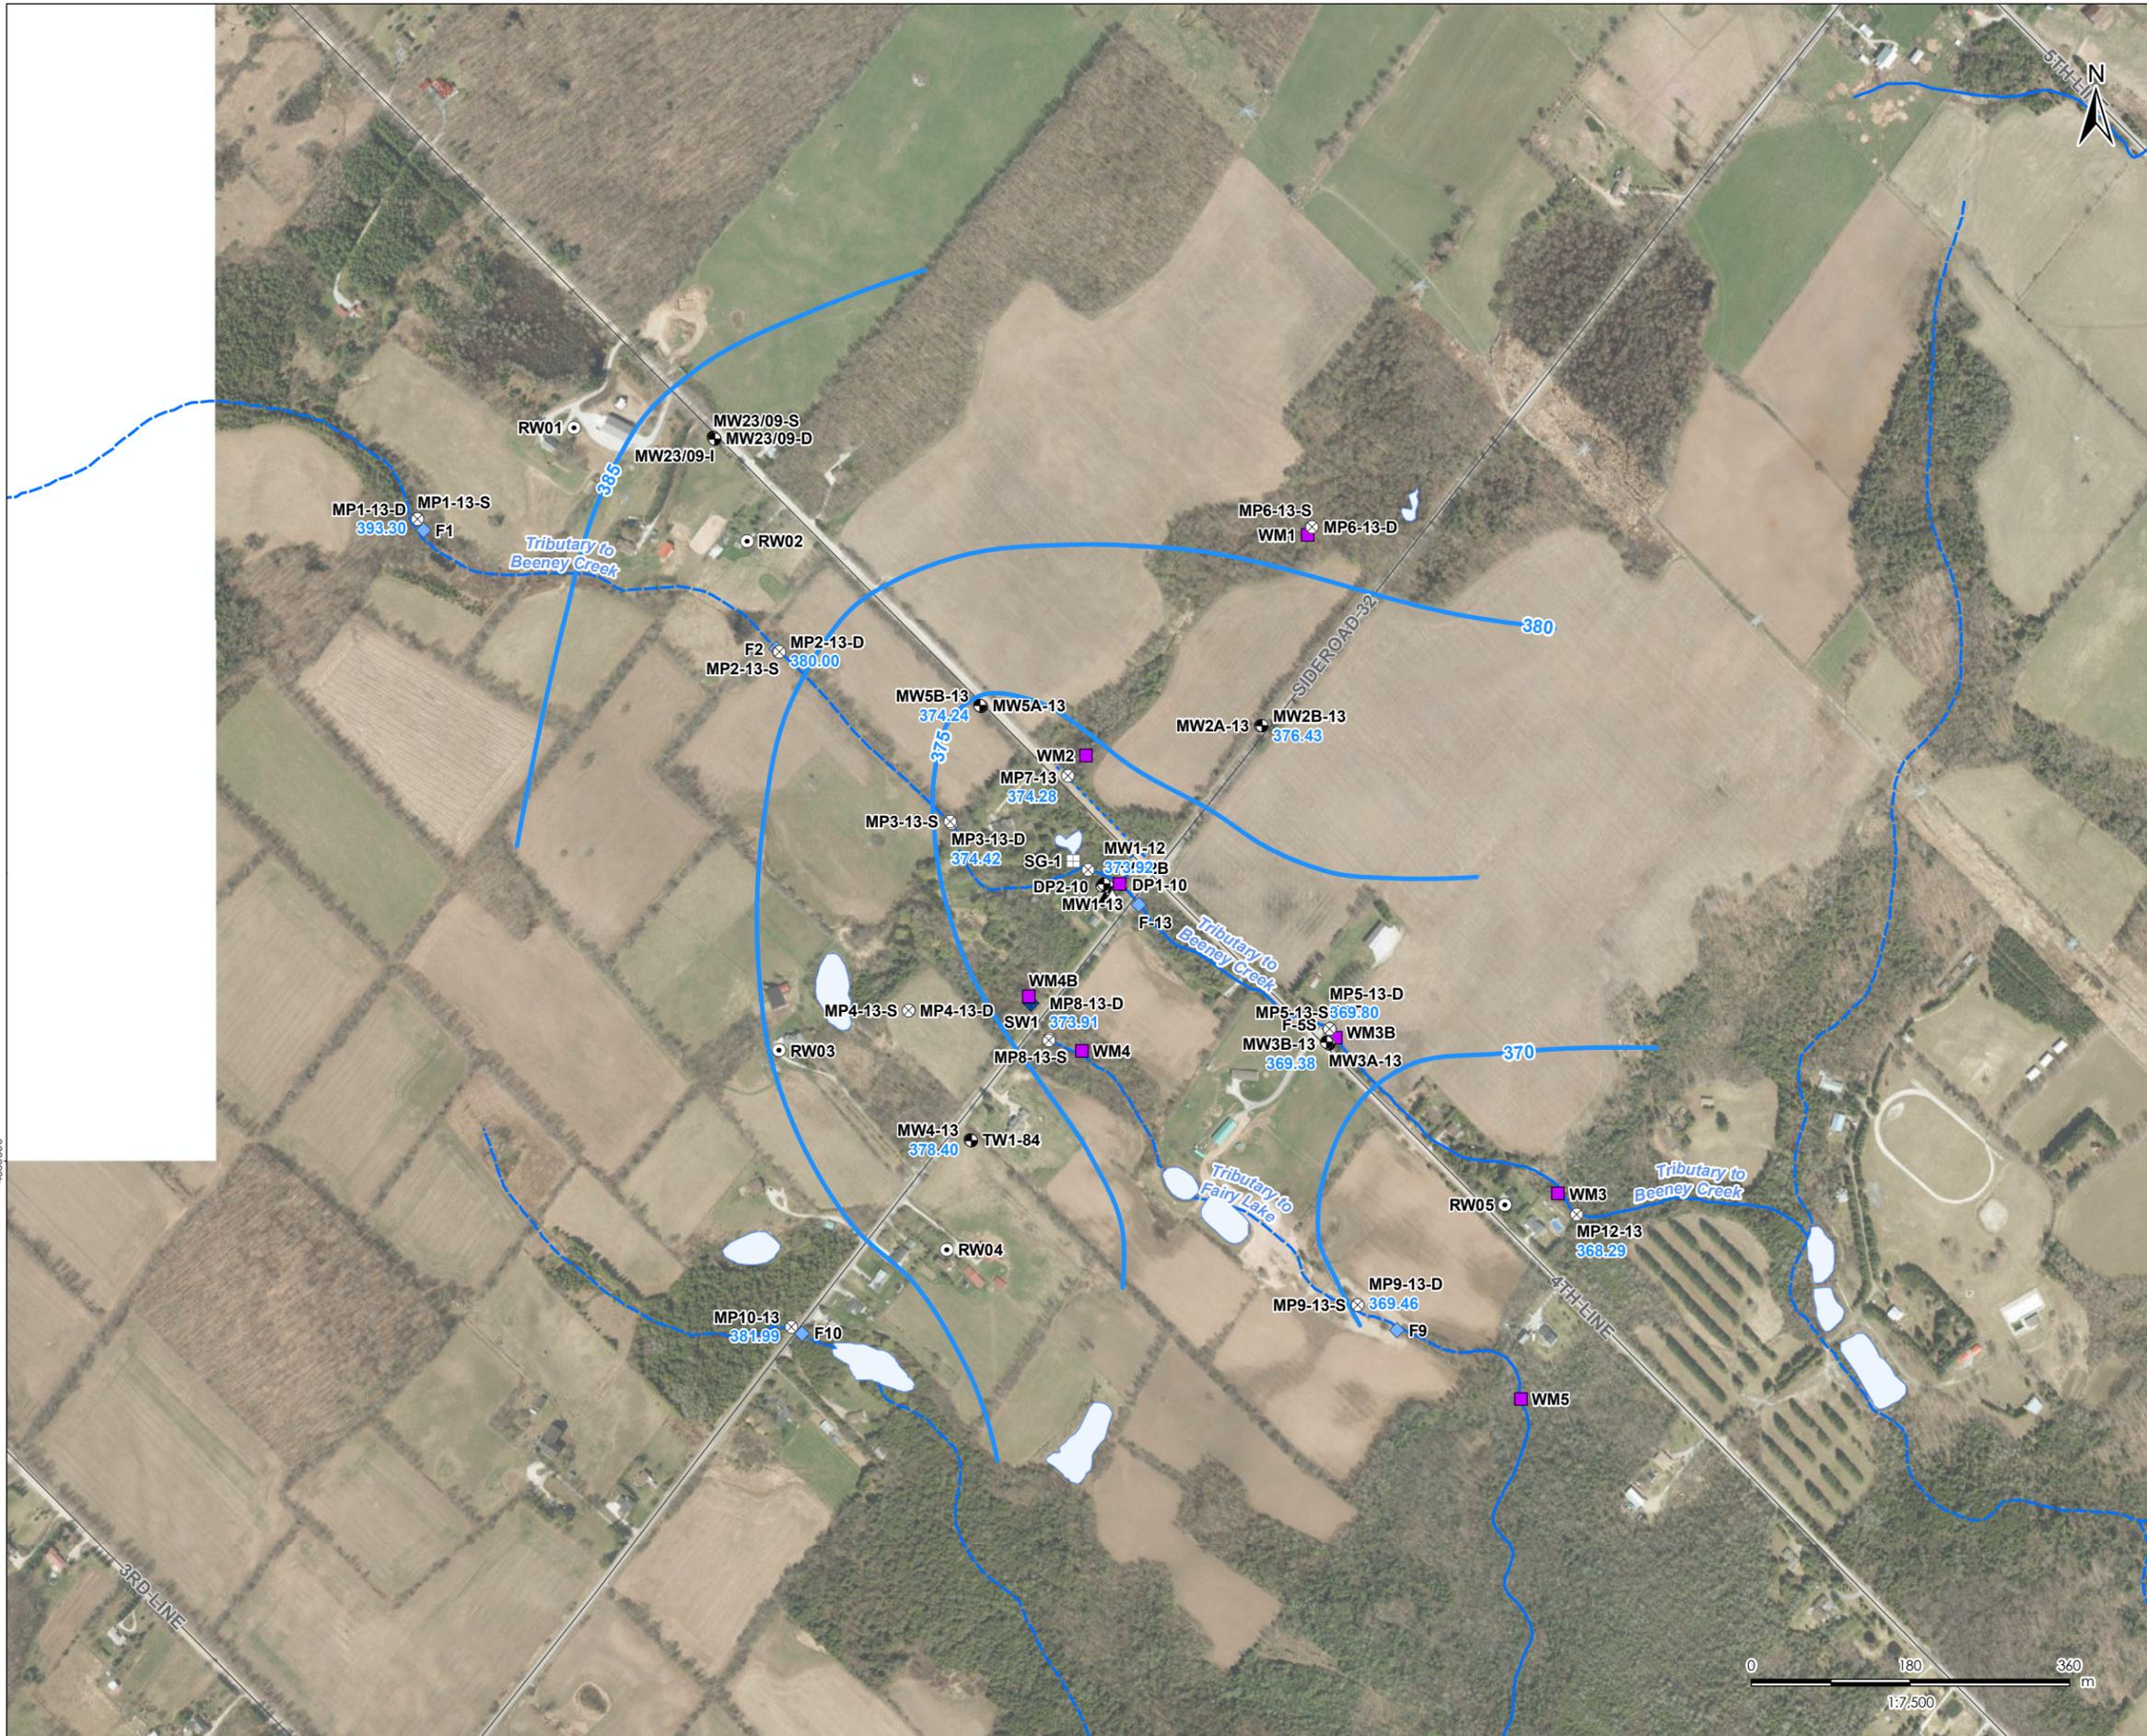
Figure No.
7b

Title
**Interpreted Shallow Groundwater
 Flow - Overburden Stage 3
 Pumping Conditions**

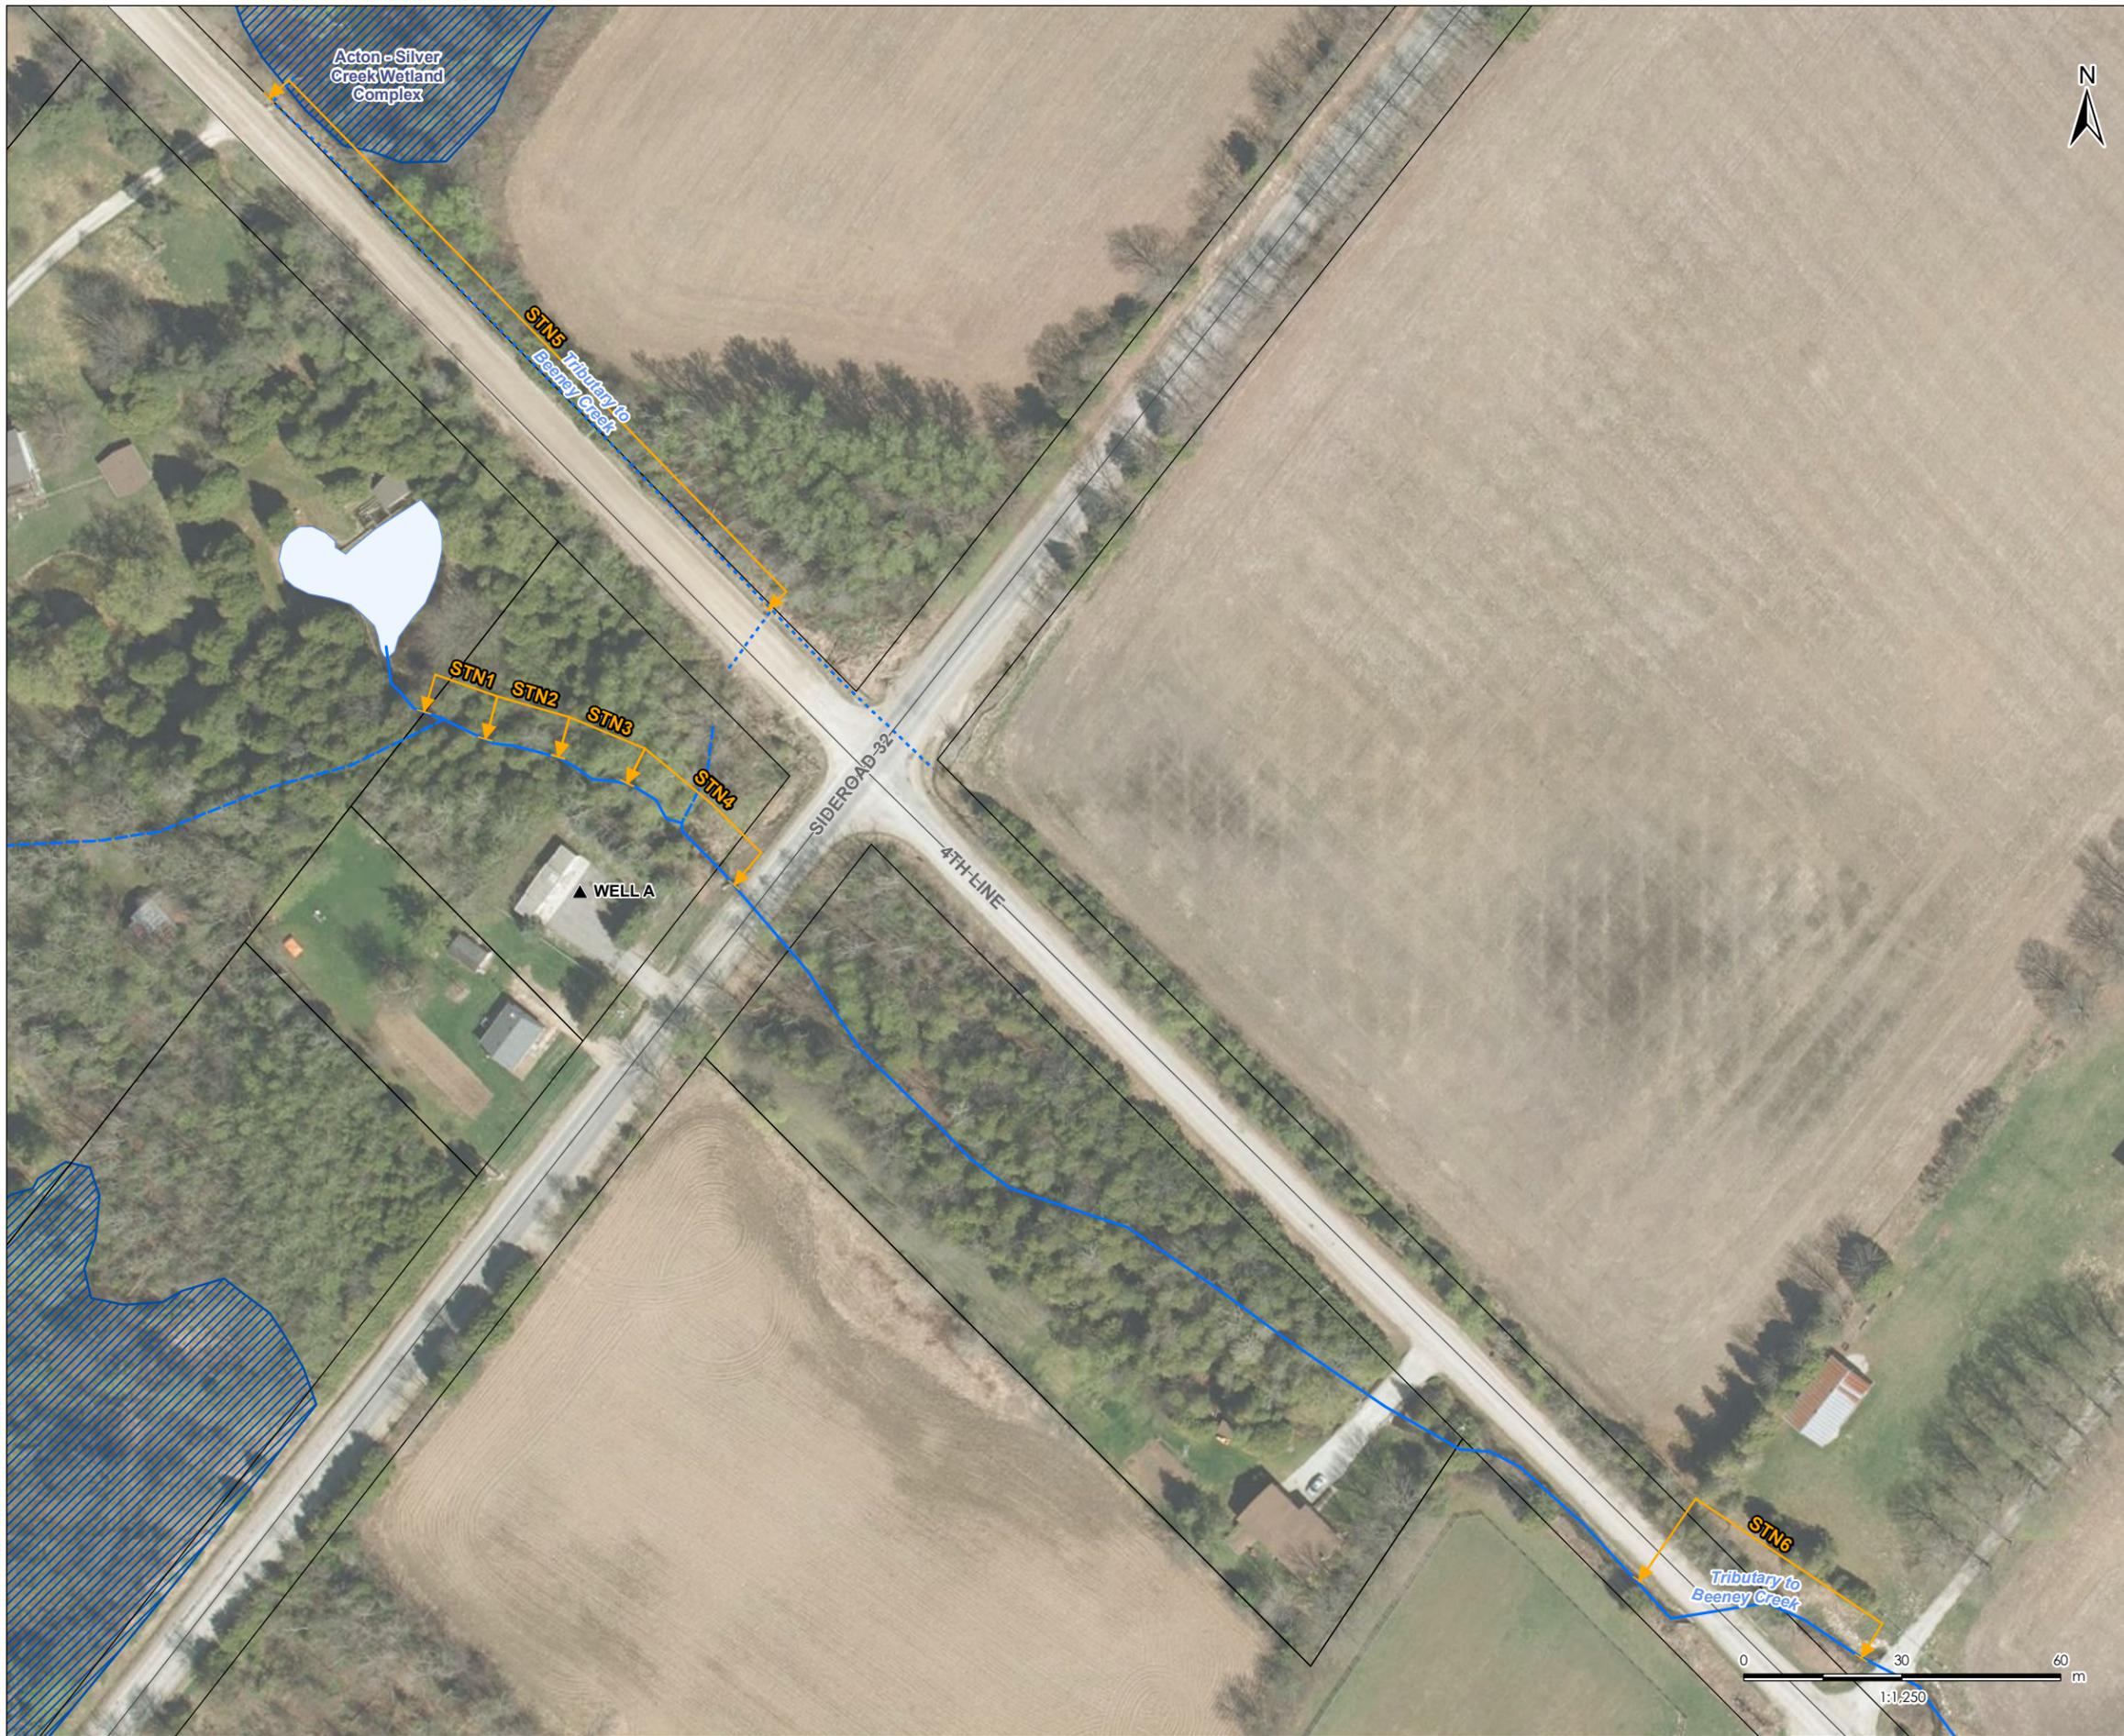
Figure No.
11

- Legend**
- ▲ Production Well
 - ↔ Aquatic Habitat Assessment Station
 - Road
 - Watercourse - Permanent
 - - - Watercourse - Intermittent
 - ⋯ Watercourse - Ephemeral Flow
 - Waterbody
- Provincially Significant Wetlands**
- ▨ Acton - Silver Creek Wetland Complex

Commencement had not been issued and permissions to enter private property had not been obtained. As a result, the only reaches that could be surveyed from locations other than road crossings was the reach of the Tributary of Beeney Creek immediately upstream of Sideroad 32 within the Region's property limits, and the reach that is parallel to Fourth Line downstream of Sideroad 32. Figure 11 provides the locations for the aquatic habitat assessment stations completed by Stantec in 2013.

Previous aquatic monitoring has been conducted by Dillon (2012a) and where applicable, Stantec's 2012 survey data are compared to historic results. Stantec's 2012 survey included the area immediately upstream and downstream of Fourth Line where it is visible from the road. Figure 11 provides the locations for the aquatics habitat assessment stations (Stn 1 through Stn 6) completed by Stantec in 2012.

The fisheries assessment station extending downstream from the northern boundary of the Fourth Line well field (Stn 1) was approximately 20 m in length (Figure 11). This reach was comprised of flat morphology, with an average wetted width of 2 m and an average depth of 10 cm. Substrates were dominated by fines such as silt (50%) and sand (10%), with coarser substrates like gravel/cobble and detritus comprising the remainder. Upstream of the property boundary, a large concrete structure in the stream channel, previously associated with an online trout pond operation (anecdotal from local landowner), is holding back flow and was full of stagnant water at the time of the field investigation. A dry tributary channel lined with cobble converged with the main tributary near DP2-10.

A Brook Trout spawning survey was completed for the section of the Tributary to Beeney Creek located on the well field property (Stations 1 through 4, Figure 11) and for the sections of the watercourse flowing adjacent and parallel to Fourth Line south of Sideroad 32. There was no evidence of Brook Trout spawning activity within the areas surveyed on November 8, 2012. At the time of the spawning survey, the following water quality measurements were recorded at the upstream end of the Sideroad 32 culvert:

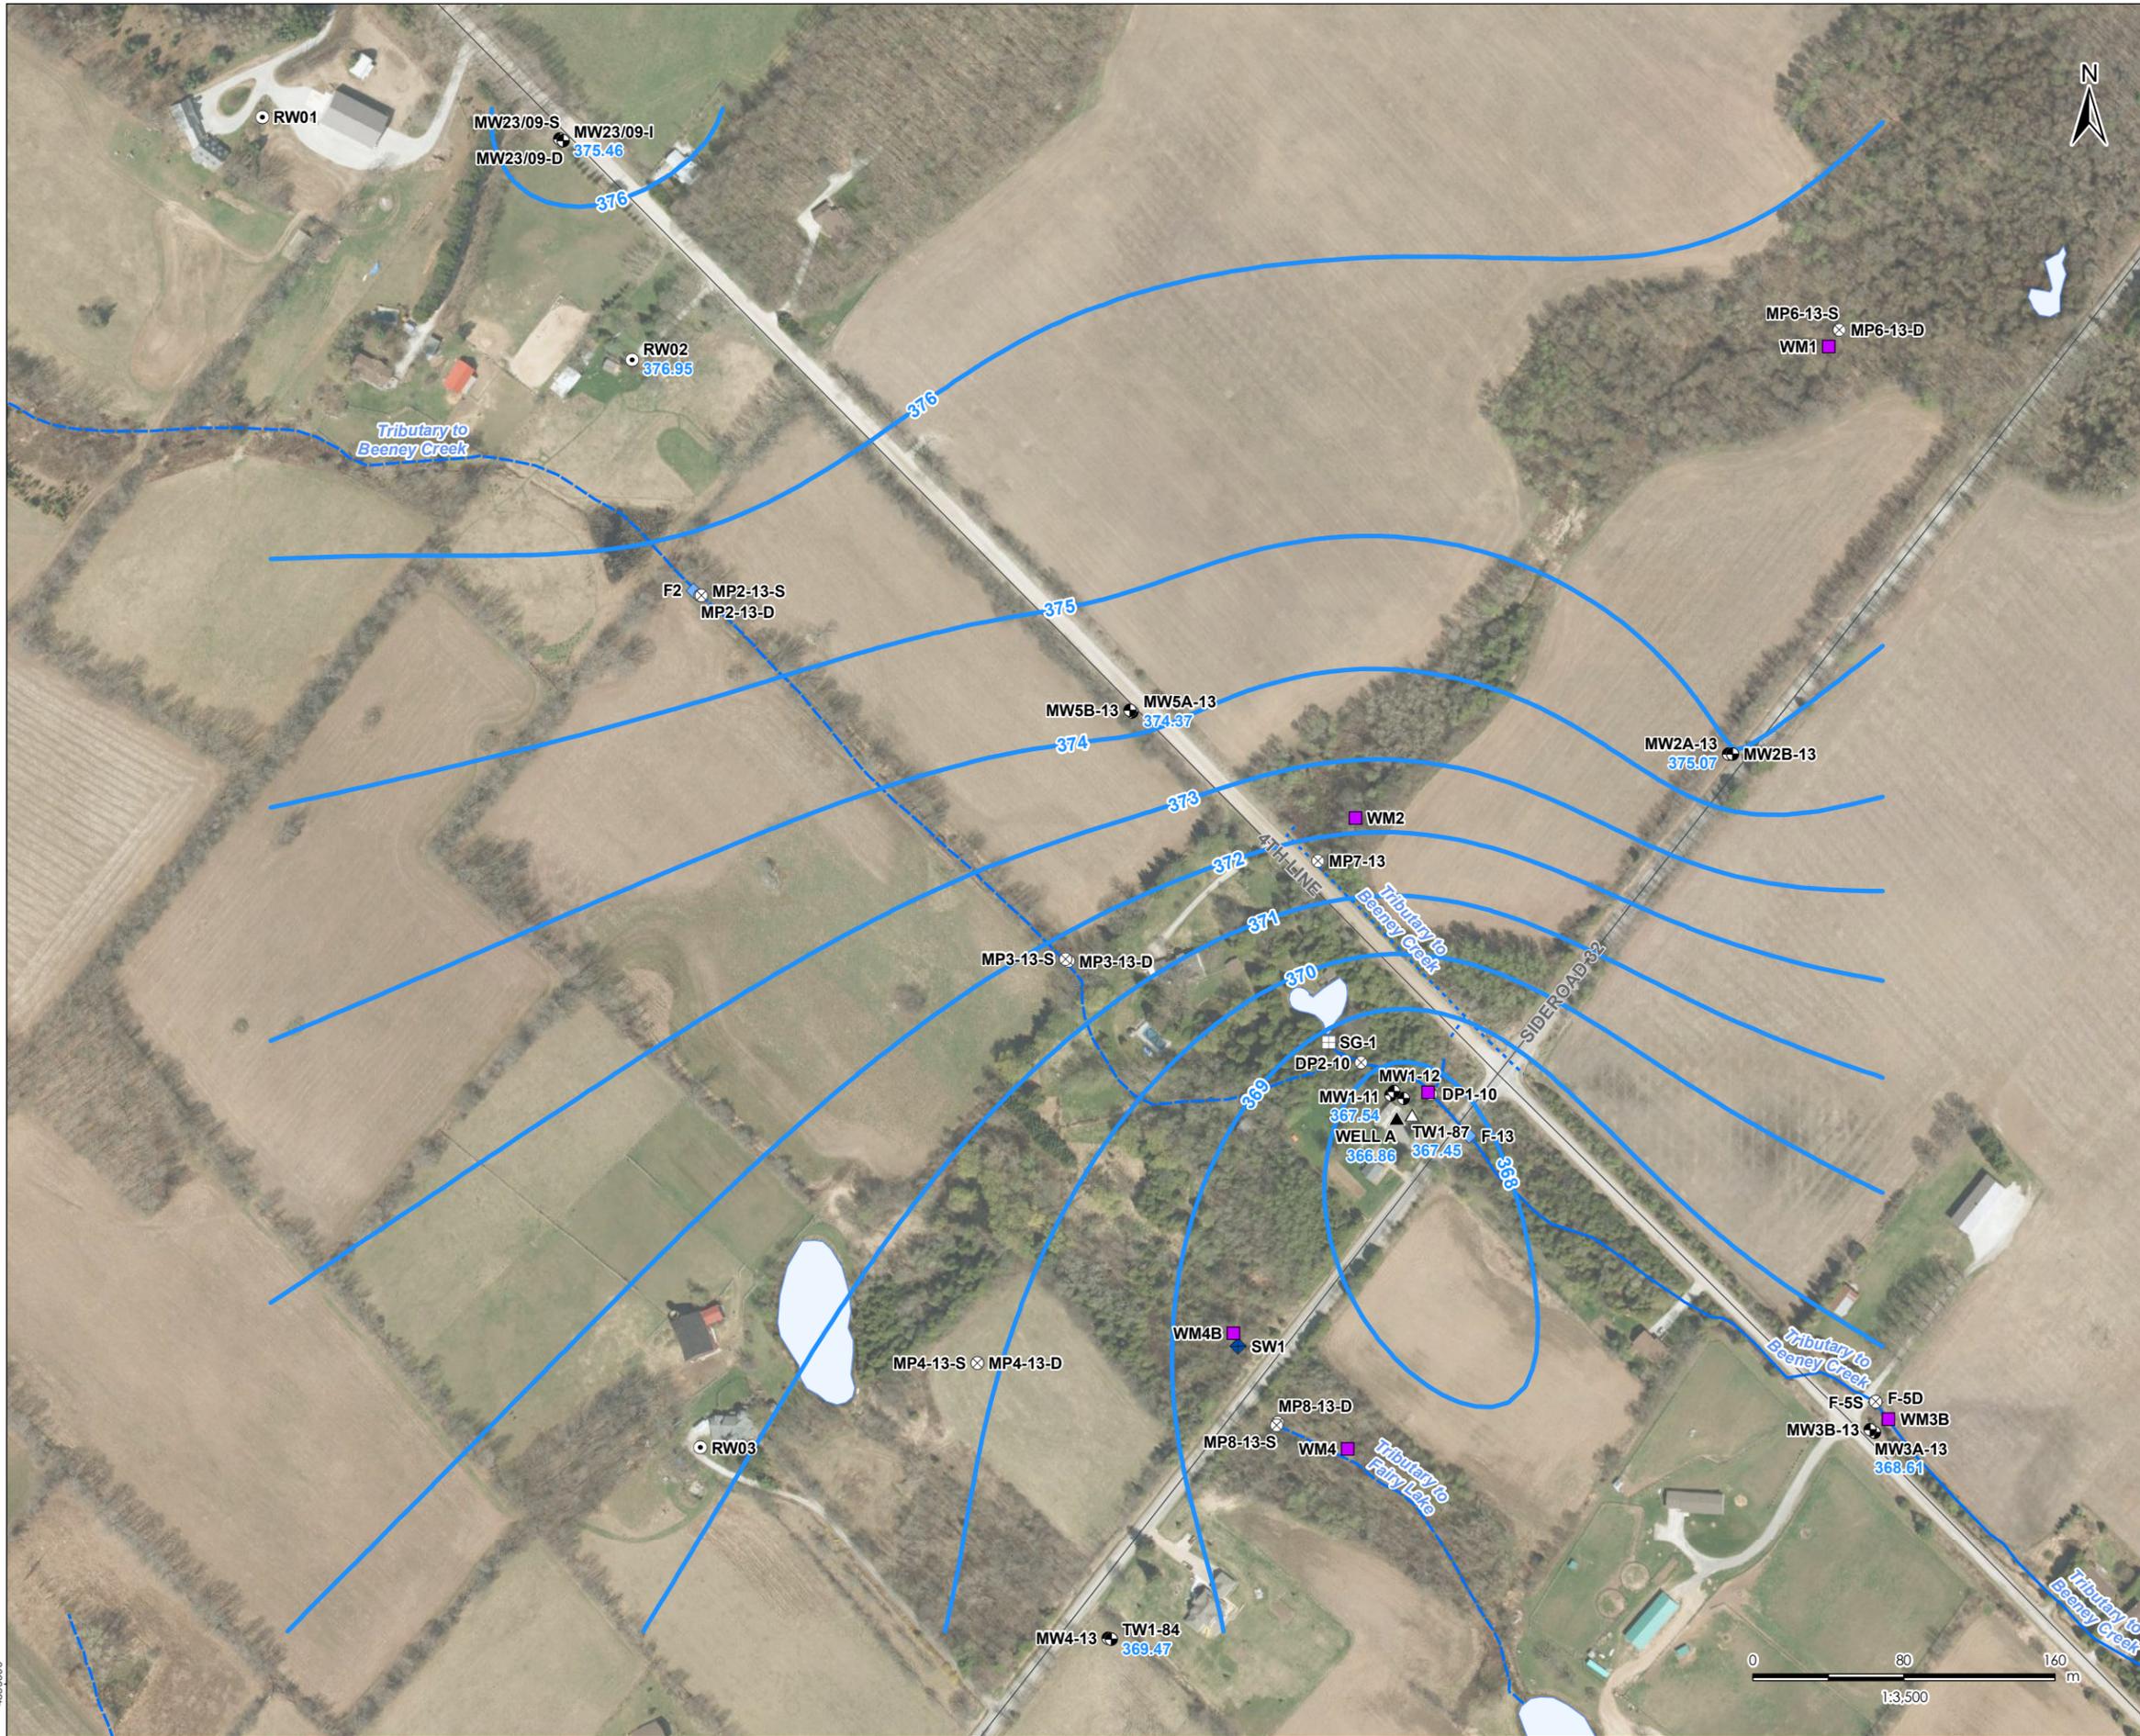
Title
**Interpreted Groundwater Flow -
 Bedrock Stage 2 Pumping Conditions**

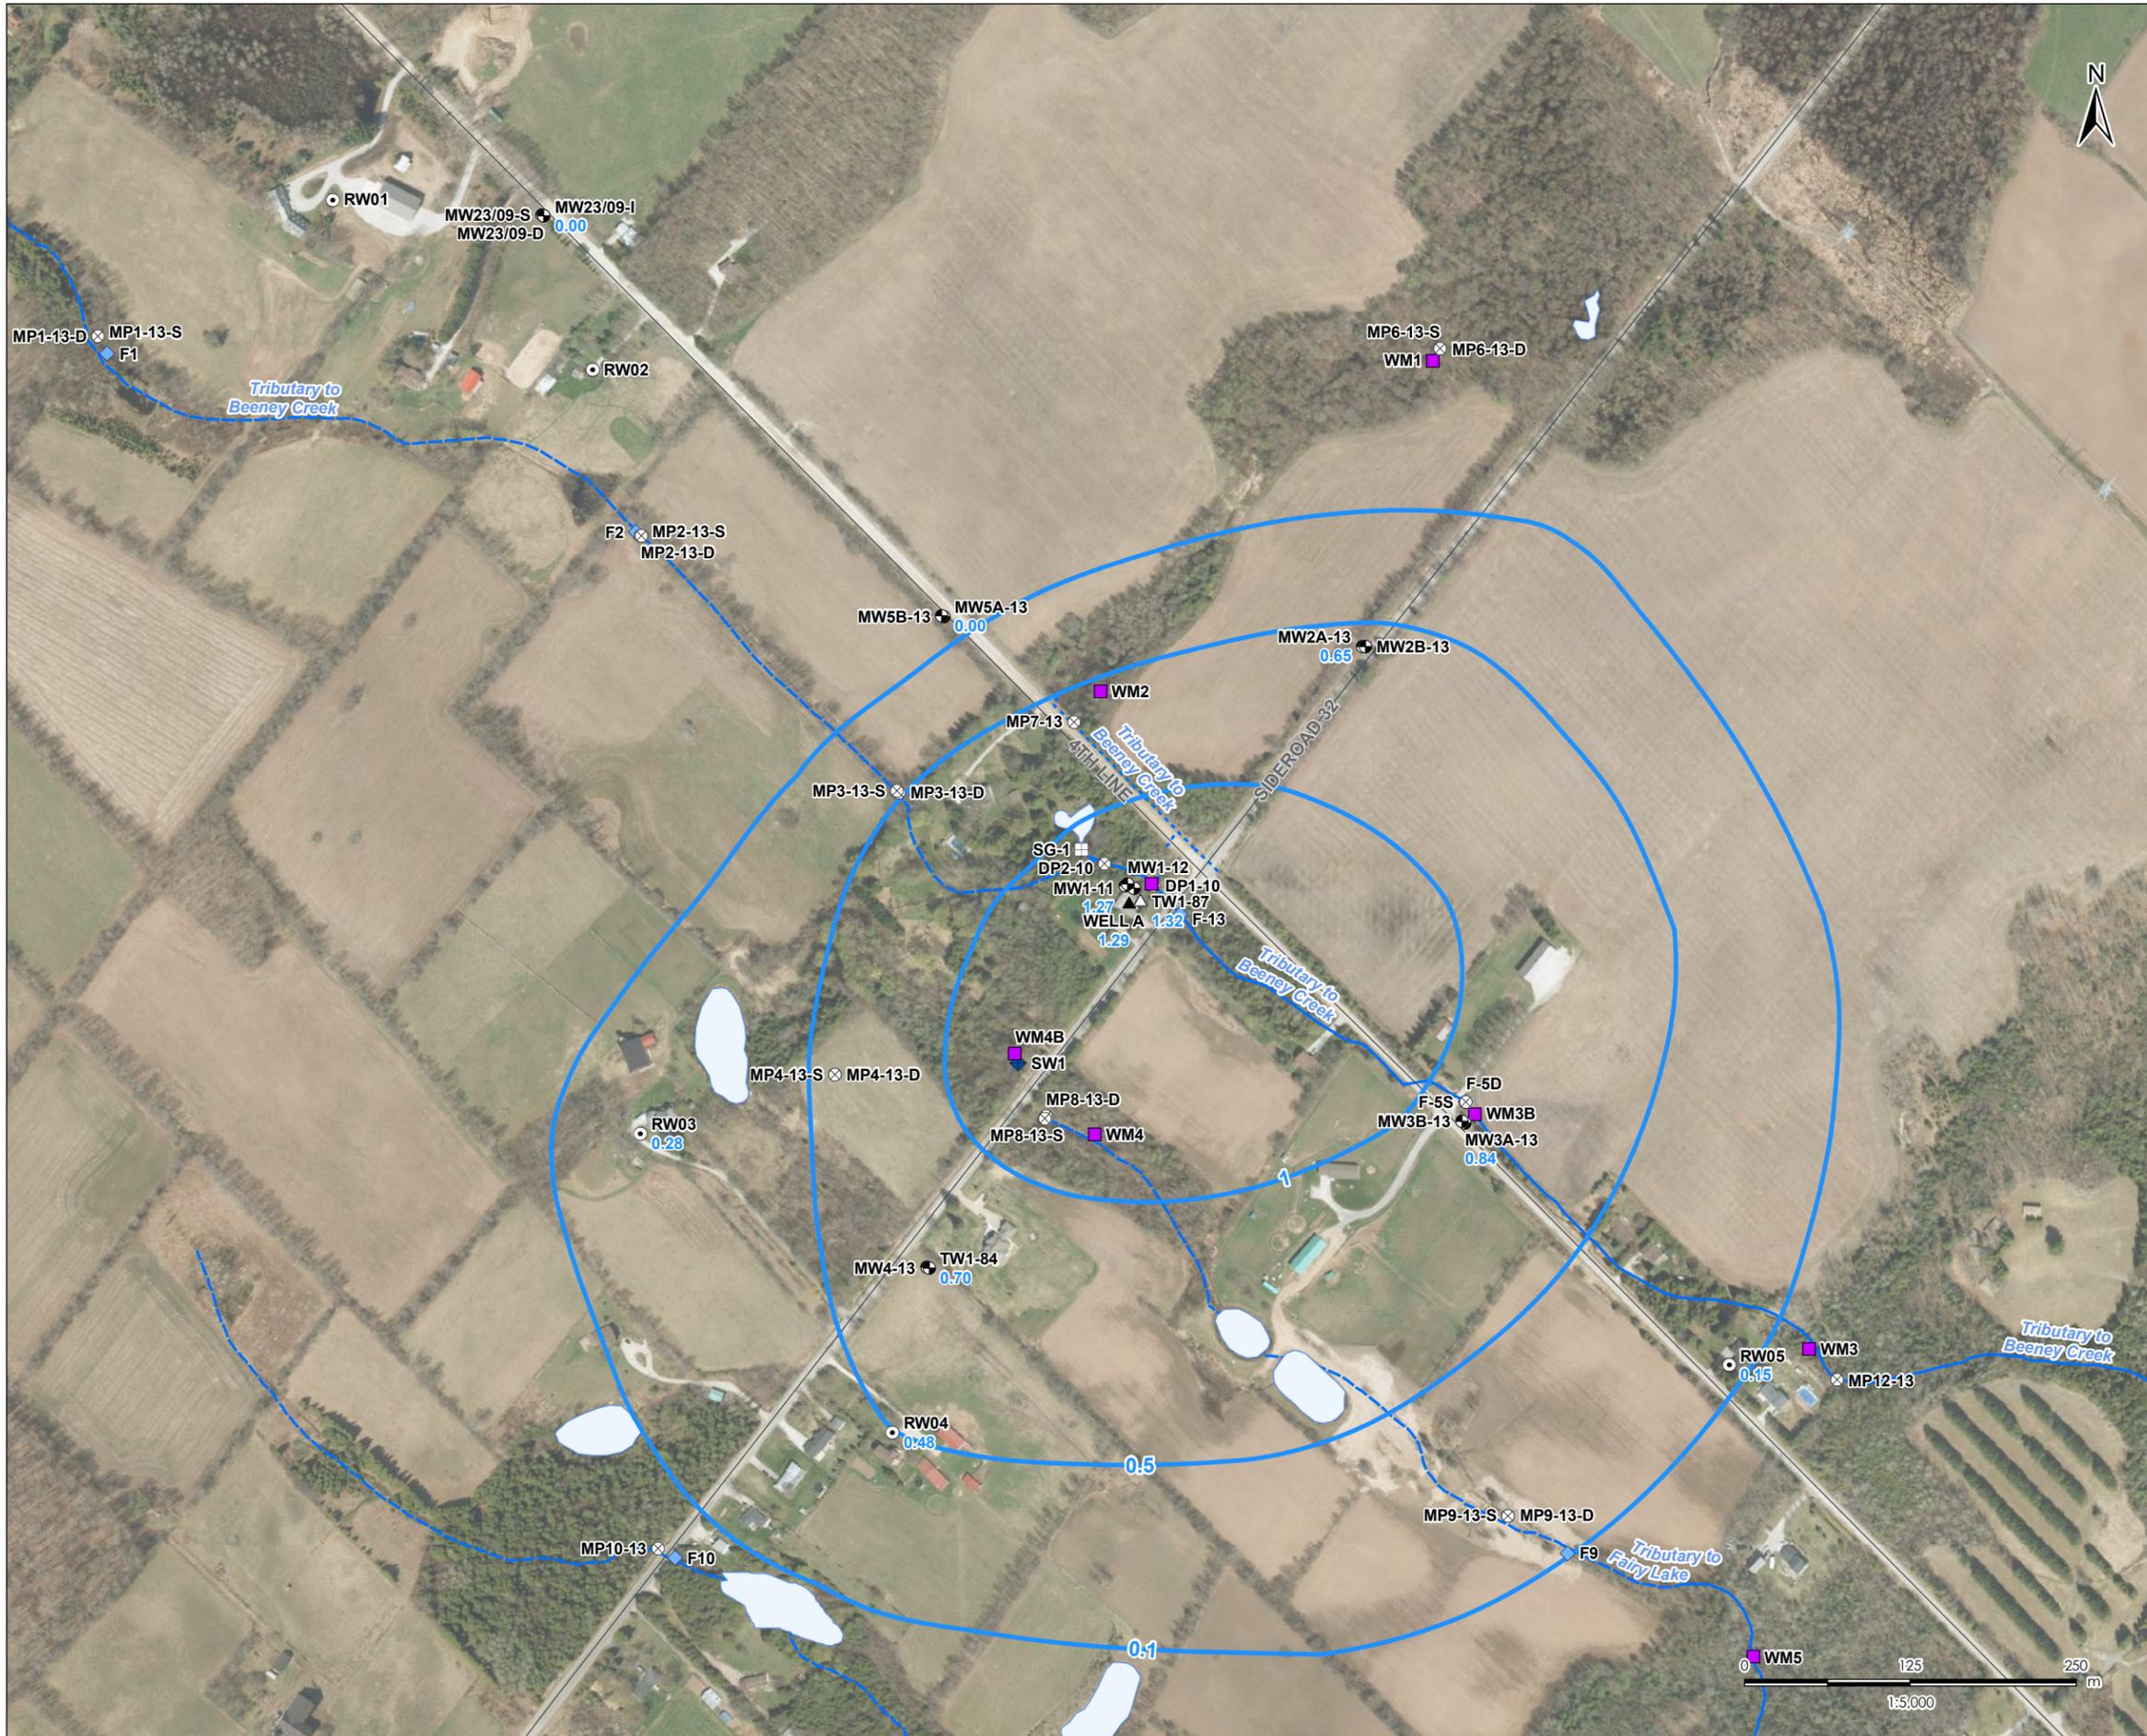
Title
**Interpreted Groundwater Flow -
 Bedrock Stage 3 Pumping Conditions**

- Legend**
- ▲ Production Well
 - △ Test Well
 - Monitoring Well
 - ⊗ Drive-Point Piezometer
 - ⊞ Staff Gauge
 - ◆ Flow Monitoring Station
 - ◆ Surface Water Monitor
 - Control Wetland Monitor/Vegetation Assessment Point
 - Wetland Monitor/Vegetation Assessment Point
 - Private Well
 - 2.5 Estimated Drawdown (m)
 - Drawdown Contour (m)
 - Road
 - Watercourse - Permanent
 - - - Watercourse - Intermittent
 - ⋯ Watercourse - Ephemeral Flow
 - Waterbody

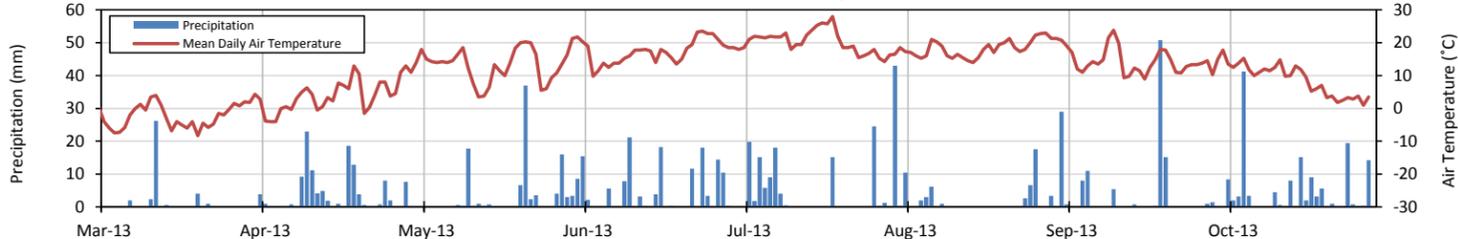
Weather Station Data - Fergus MOE Station

Notes: Dashed lines represent changes in pumping rate or regime.
Climate data from Fergus MOE Station missing for 3-Sep-13 to 8-Sep-13, supplemented with data from Elora RCS Station.
