**FOURTH LINE WELL FIELD EXPANSION, ACTON, MUNICIPAL CLASS ENVIRONMENTAL ASSESSMENT
STUDY – PROJECT FILE**

**Environmental Impact
Assessment Fourth Line Well
Field, Acton Ontario**

Prepared for:
Regional Municipality of Halton
1151 Bronte Road
Oakville, ON
L6M 3L1

Project No. 1611-11105

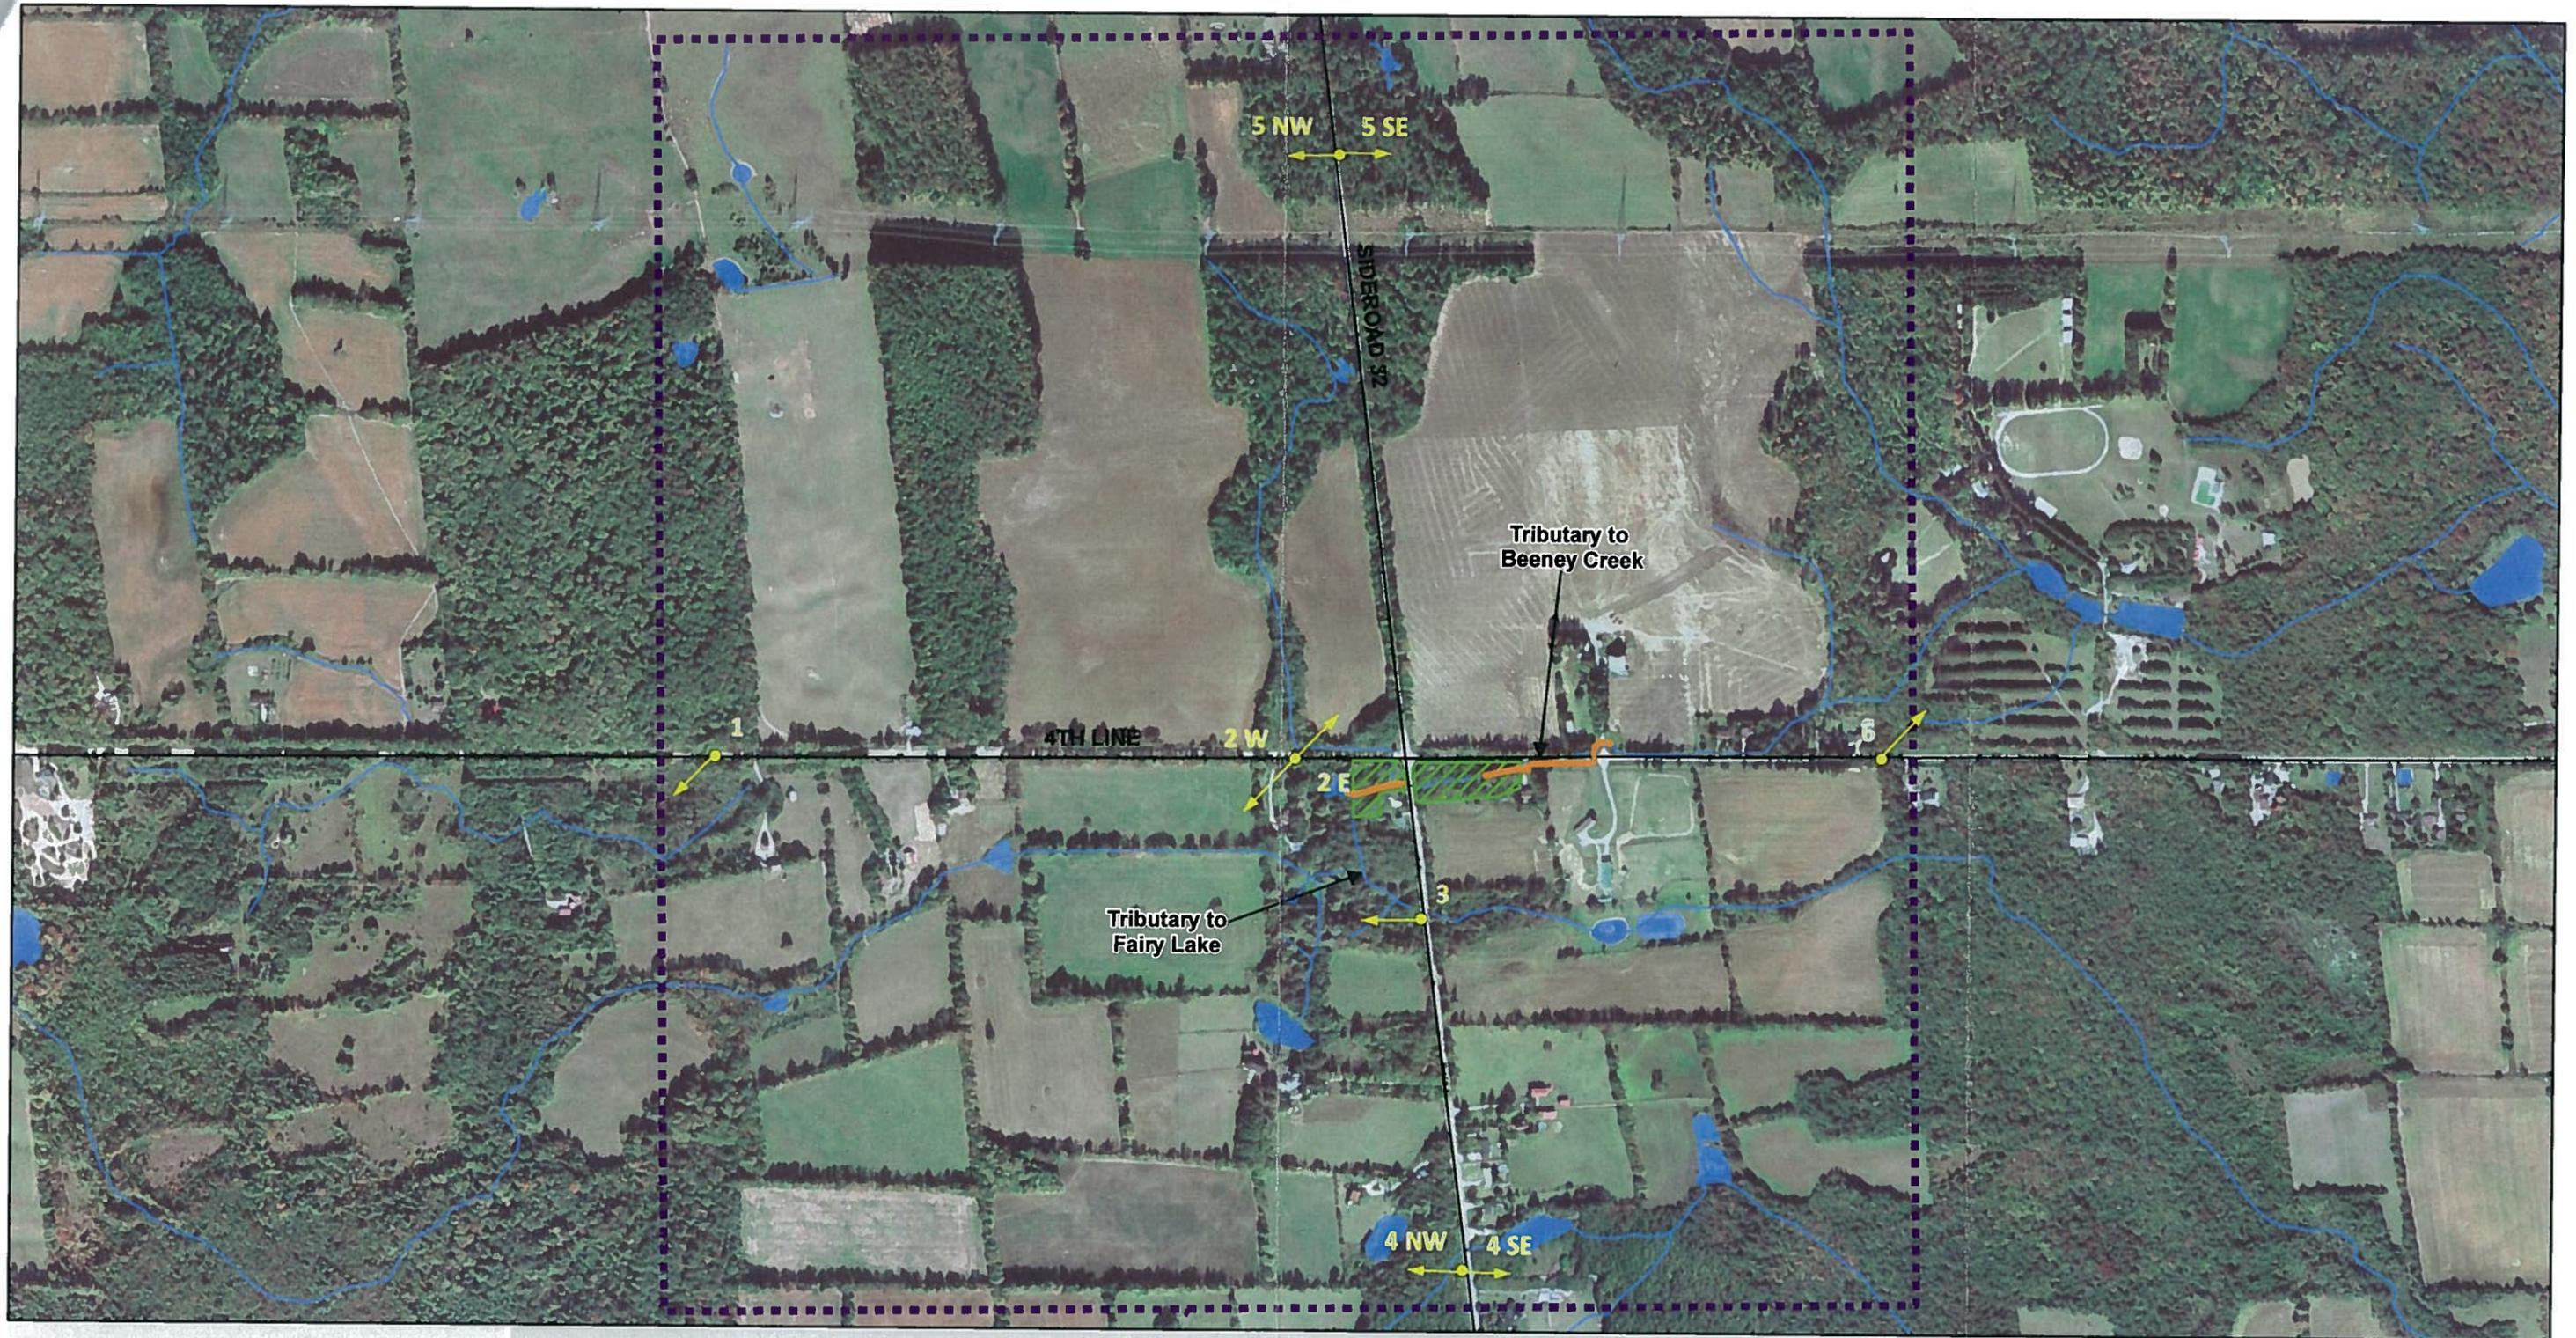
ATTACHMENT I
FIGURE 1

- Amphibian Survey Station and Direction
- Fish Survey Location
- Study Area for Field Work
- Botanical Survey
- Road
- Watercourse
- Water Body
