Regional Municipality of Halton

**Ninth Line
(Dundas Street to
407 ETR)
Environmental
Assessment
Study**
Traffic Study and Safety
Study Report

B000637

October 2017

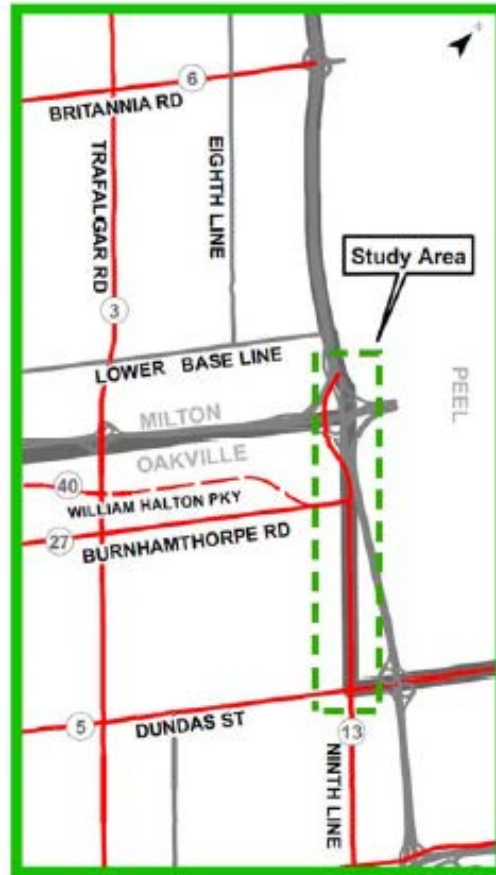
Figure 1: Study Area

The study area, which includes the intersections of Ninth Line with Dundas Street and with Burnhamthorpe Road, is shown in **Figure 1** (marked in dash green). Ninth Line is a major north-south arterial roadway between Upper Middle Road and Steeles Avenue and represents the boundary between Halton Region and Peel Region, with the Town of Oakville to the west of Ninth Line and the City of Mississauga to the east within the study limits. It is an undivided two-lane road (posted speed = 60 km/h) with a rural cross-section (narrow unpaved shoulders) and urban treatments at the signalized intersections. Burnhamthorpe Road is an undivided two-lane road, while Dundas Street is a divided six-lane road.

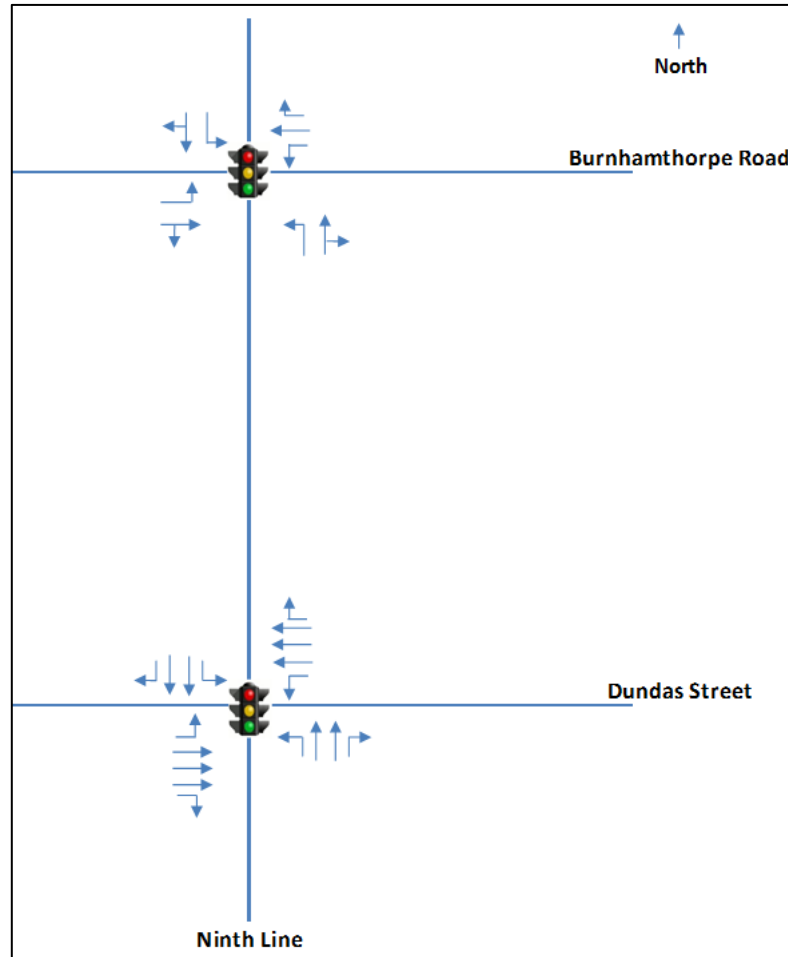
Figure 2: Existing Lane Configuration

Both intersections within the study area (at Dundas Street and Burnhamthorpe Road) are signalized. The intersection at Dundas Street has already been widened on both the Dundas (6 Lanes) and Ninth Line (4 Lanes) approaches. Ninth Line south of Dundas Street has been widened to 4 lanes. Intersection lane configurations are shown in **Figure 2**.

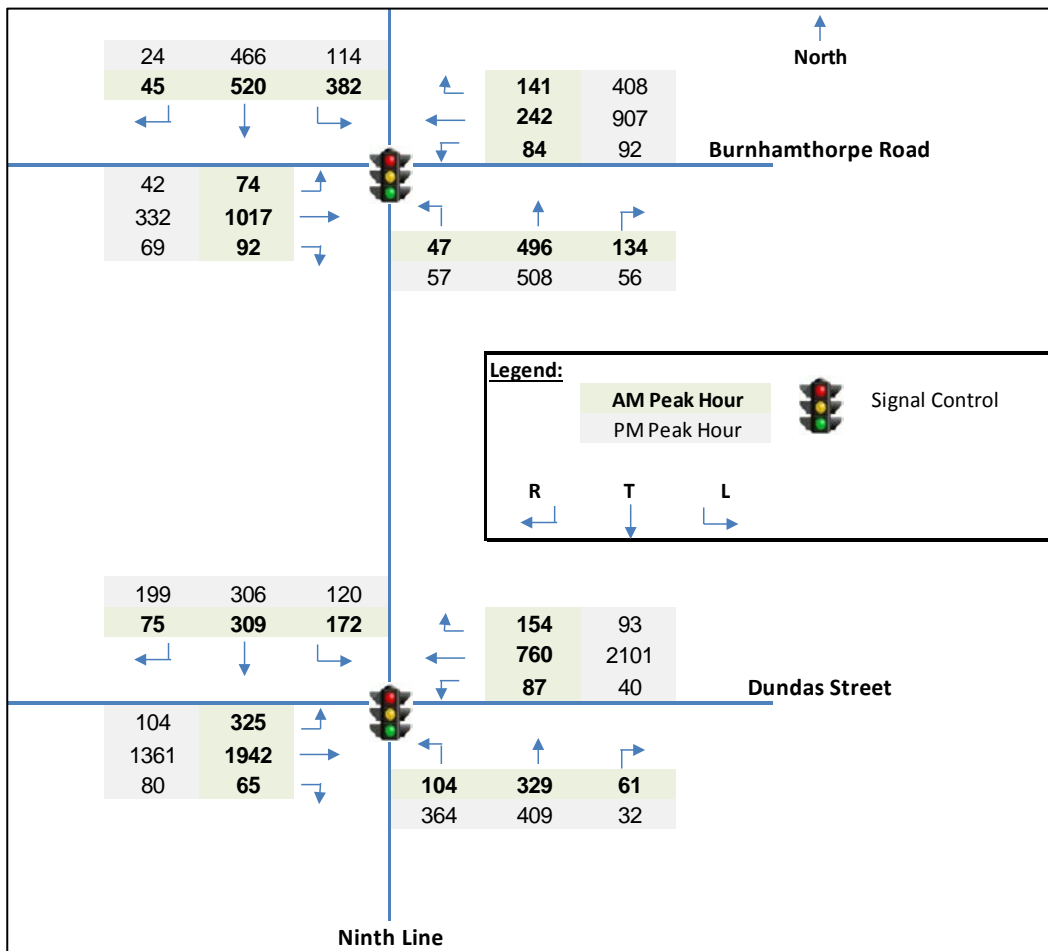
Figure 3: Existing Traffic Volumes

Turning movement counts were obtained from Halton Region (**Appendix A**). The counts (**Figure 3**), which were taken in June 2015, show the following:

- + Pedestrian activity is very low at the intersections;
- + The heaviest approach volumes are along the intersecting roadways (Burnhamthorpe Road and Dundas Street);
- + There are high truck volumes along Dundas Street; and
- + Overall intersection volumes are higher in the AM peak hour.

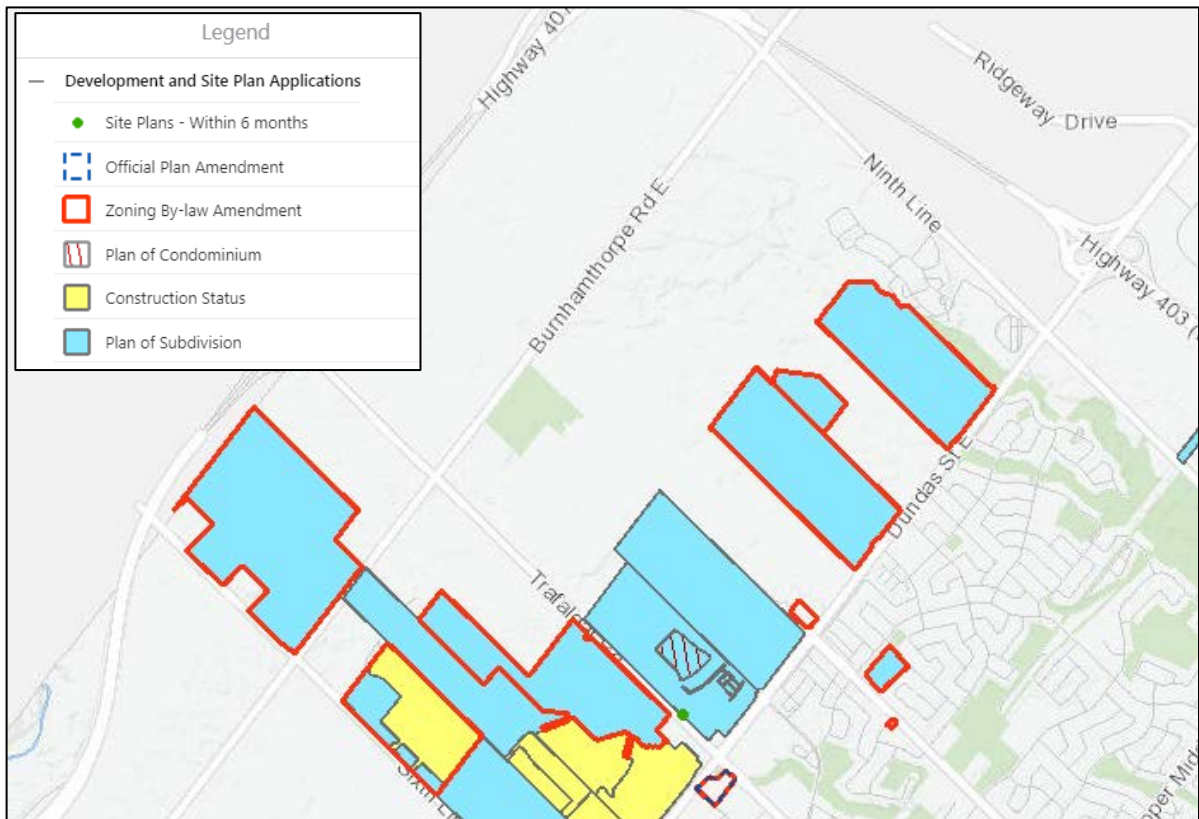
Figure 4: Current development applications (Source: Town of Oakville)

As noted in Section 1 the land use within the study area is primarily rural with localized institutional and residential areas. The Town of Oakville indicated that existing land uses on the west side of the corridor have significant redevelopment potential with several proposals. **Figure 4** identifies current development applications, and **Figure 5** shows the overall development strategy of the North Oakville Master Plan. It is important to note that no direct access between the proposed developments and Ninth Line is being considered.

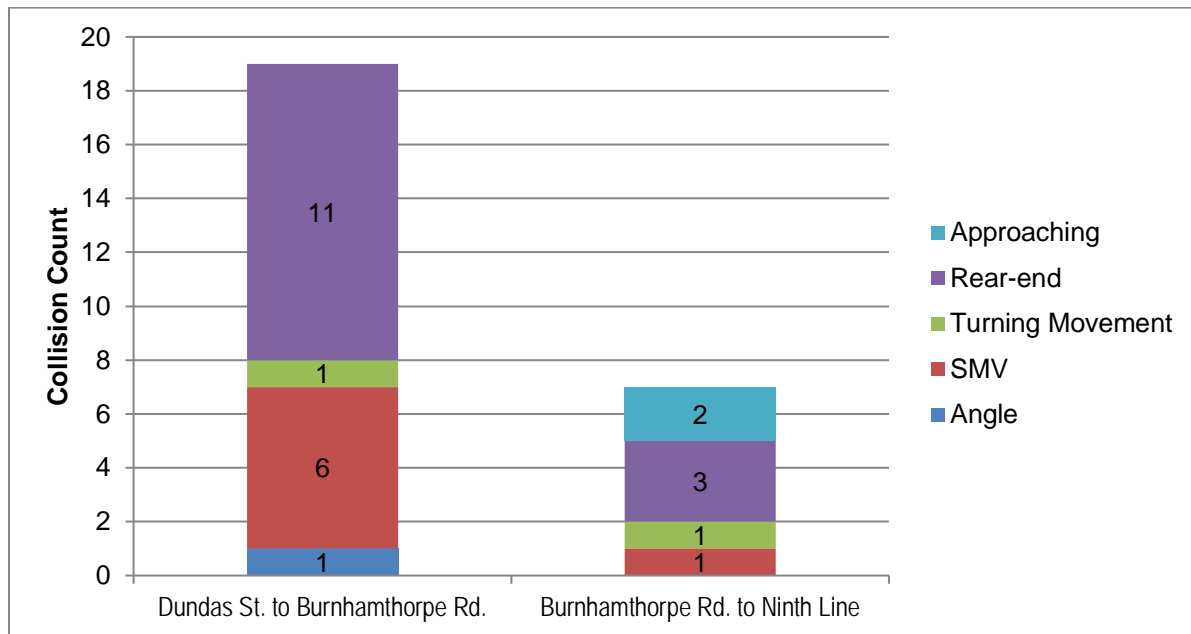
Figure 7: Summary of Midblock Collisions by Impact Type (January 2011 – December 2015)

Figure 7 summarize midblock collisions by impact type. Note that the following analysis excludes Ninth Line between a point 900 m north of Burnhamthorpe Road to Lower Base Line as the provided data did not note any collisions during the study period for this segment.

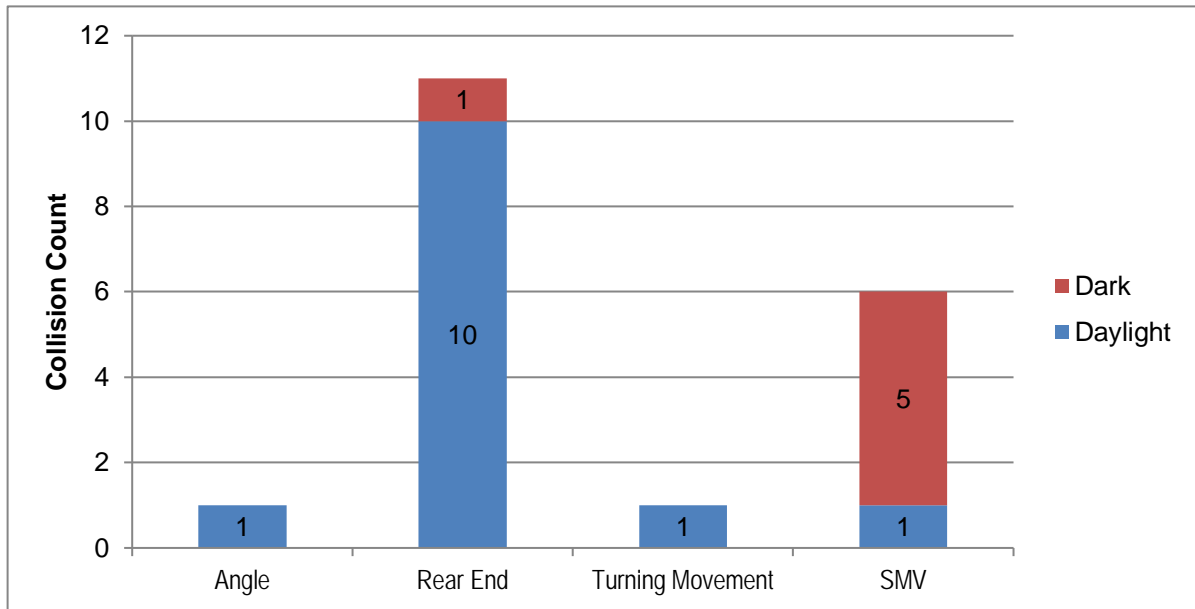
Figure 8 and Figure 9 show that rear-end collisions are the major collision type with 11 incidents of a total of 19 collisions, followed by SMV collisions with a total of 5 incident. The majority of collisions occurred during dry road surface conditions and during daylight lighting conditions. Northbound motorists were more often involved in collisions. Eight out of 11 rear-end collisions occurred in the northbound direction and 3 in the southbound direction. Three out of 5 SMV collisions occurred in the northbound direction with 2 in the southbound direction. The collision data did not reveal any other specific patterns.

Figure 8: Collisions by Road Surface Condition (January 2011 – December 2015)

Figure 9: Collisions by Lighting Condition (January 2011 – December 2015)

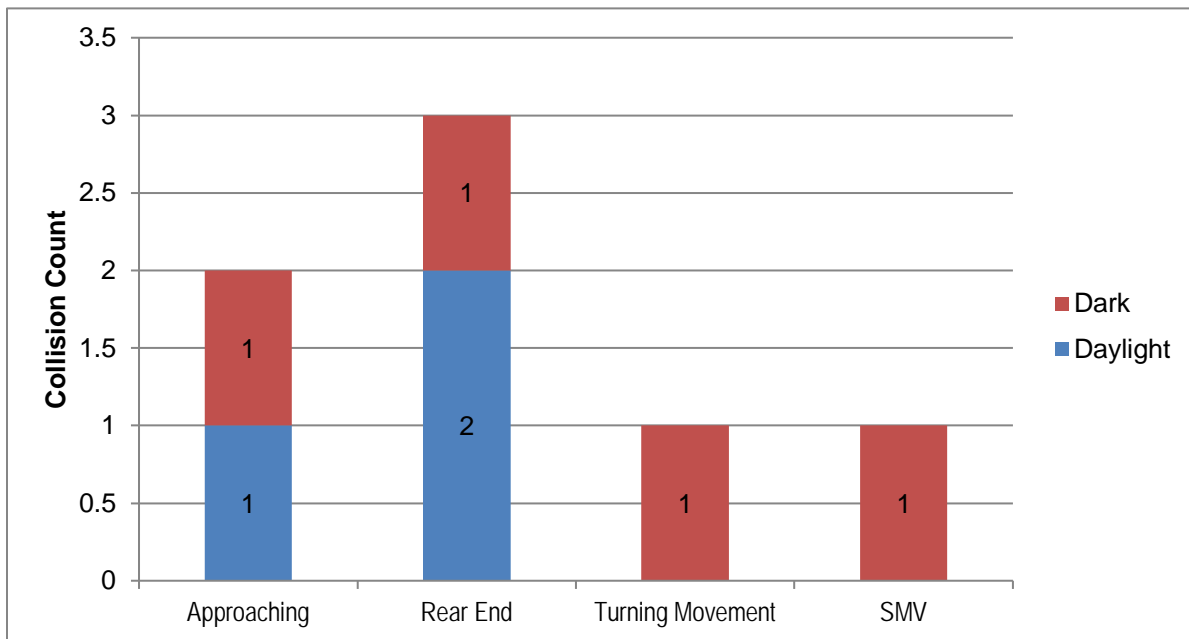
Figure 10 and Figure 11 show that rear-end collisions are the main collision type in this segment as well, with only 3 incidents of a total of 7 collisions. All rear-end collisions occurred in the southbound direction and were non-intersection related. Collisions involving approaching vehicles were the second-most important collision type with 2 incidents. Both approaching collisions involved a vehicle that was out of control. The majority of collisions occurred during dry road surface conditions and daylight lighting conditions. In general, the collision data did not reveal any specific collision patterns.

Figure 10: Collisions by Road Surface Condition (January 2011 – December 2015)

Figure 11: Collisions by Lighting Condition (January 2011 – December 2015)

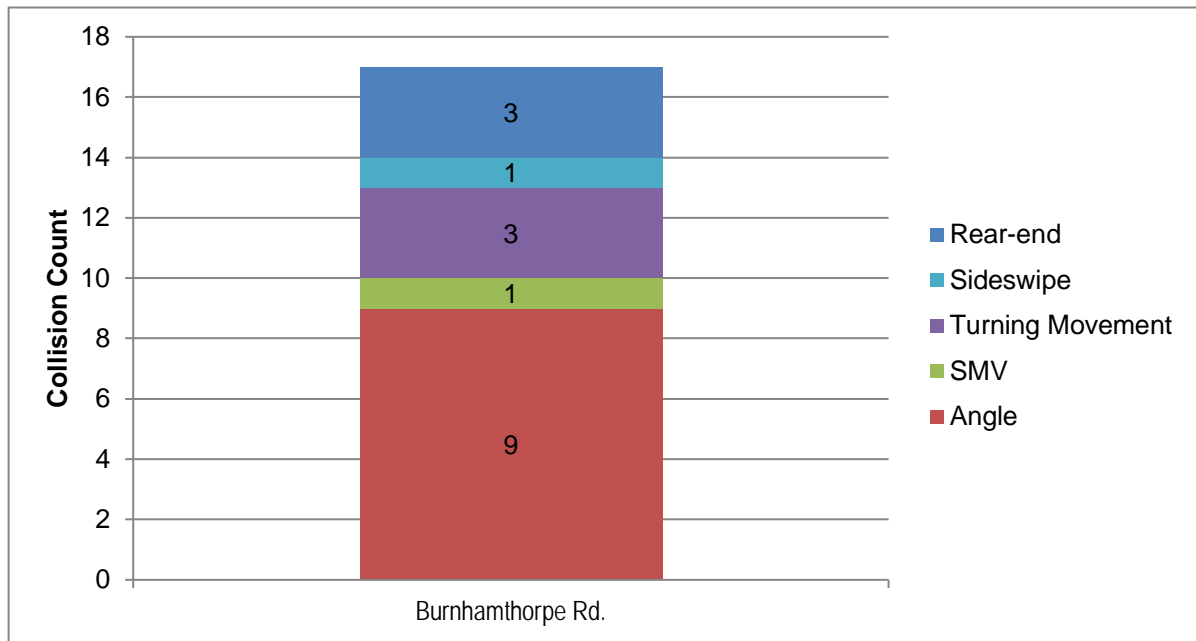
Figure 12: Summary of Collisions by Impact Type for the Intersection of Ninth Line and Burnhamthorpe Road (January 2011 – December 2015)

This section only evaluates the intersection of Ninth Line and Burnhamthorpe Road, as the intersection of Ninth Line and Dundas Street was recently upgraded. Based on **Figure 12**, angle collisions are the major collision type at this intersection with 9 incidents of a total of 17 collisions. No specific directional

movements were found to be involved more often than others in the angle collisions. Four angle collisions were reported to involve “Disobeyed Traffic Control” driver action.

Rear-end and turning movement collisions are ranked as the number-two collision type. Two of 3 rear-end collisions occurred in the eastbound direction with one in the northbound direction. Two of 3 turning movement collisions occurred involved southbound left-turn motorists and northbound through motorists. The majority of collisions occurred during dry road surface conditions as demonstrated in **Figure 13** and during daylight lighting conditions as demonstrated in **Figure 14**. In general, the collision data did not reveal any specific patterns that pinpoint to any particular deficiency.

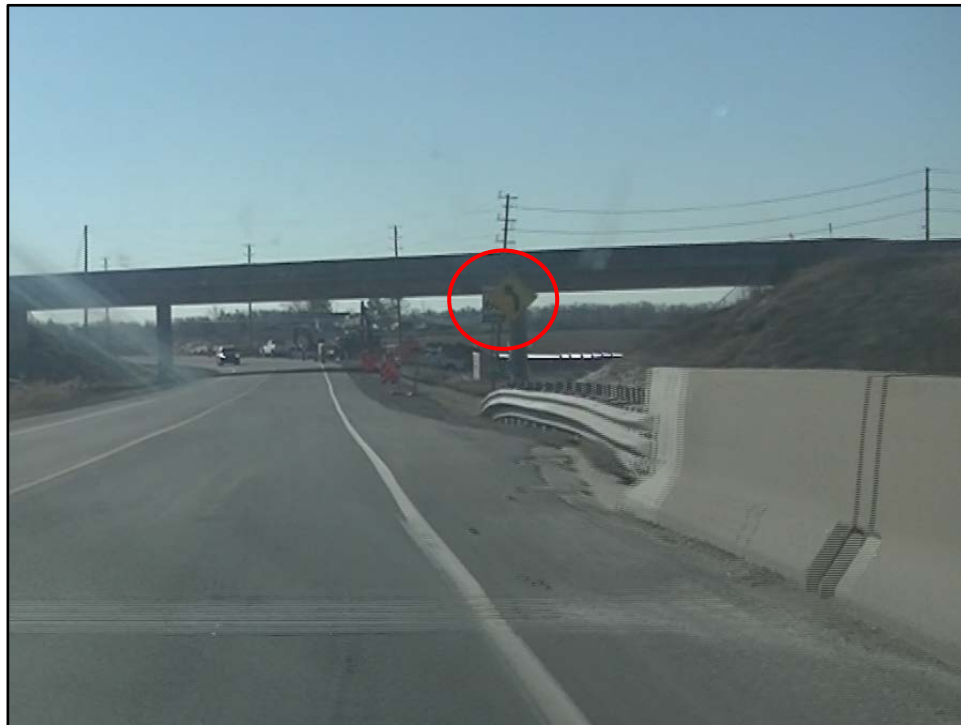
In the southbound direction on Ninth Line, a curve warning sign is placed immediately after the Highway 403 overpass bridge (just before 407 E to 403 N ramp). It was found that the placement of this sign obstructs the visibility of a speed-limit sign (**Figure 15**). No other signage deficiencies were observed. Signs appeared to be adequately designed according to the principles of positive guidance.

Figure 15: Curve Warning Sign Blocking Speed Limit Sign (Southbound)

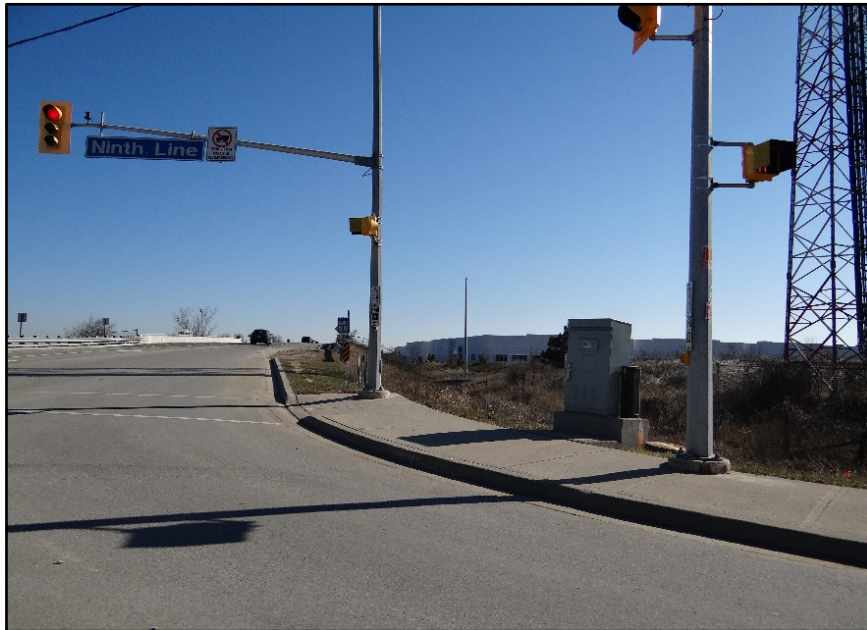
The vertical alignment of the intersection of Ninth Line and Burnhamthorpe Road is not level as a result of the bridge on the east leg of the intersection over Highway 403. As seen in **Figure 16**, the crest curve creates an approach downgrade in the westbound direction on Burnhamthorpe Road at Ninth Line which continues past the intersection. The downgrade may contribute to increased vehicle speeds as motorists approach the intersection which could contribute to rear-end collisions when motorists apply sudden brakes to avoid entering the intersection during the red signal indication or angle collisions in the event they are not able to make a timely stop. The review of collision history noted some angle collisions at this intersection. However, there is no evidence that suggests that the downgrade was a contributing factor.

Figure 16: Downgrade at East Approach at Intersection of Ninth Line and Burnhamthorpe Road (Looking East)

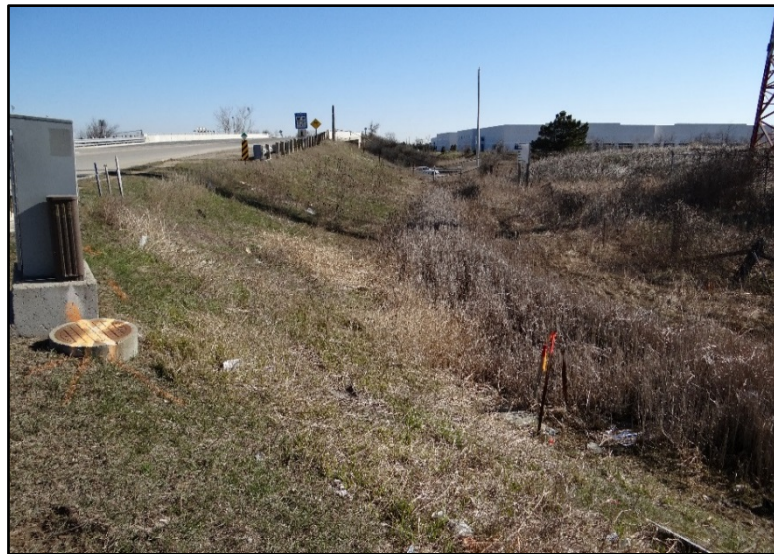
Significant embankment depths were also observed in three of the four corners of the intersection. The southeast corner is shown in **Figure 17**.

Figure 17: Southeast corner at Intersection of Ninth Line and Burnhamthorpe Road (Looking East)

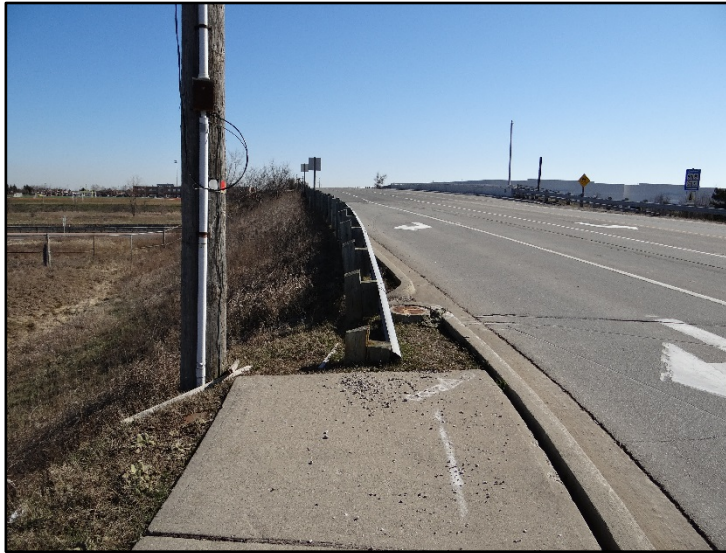
Pedestrian pushbuttons and signal heads were present in all corners of the intersection. The pushbuttons were fully functional. Marked crosswalks and landing pads were also present for pedestrians waiting to cross the roadways, despite Ninth Line and Burnhamthorpe Road not providing any pedestrian facilities (e.g., sidewalks, multi-use trails). Along the north side of the east leg of the intersection (Burnhamthorpe Road), there is insufficient space for pedestrians to safely walk between the curb and guide rail as can be seen in **Figure 18**.

Figure 18: Pedestrian Facility along East Leg of Intersection (Burnhamthorpe Road West)

Pedestrian signage should be provided to inform pedestrians that there is no sidewalk along the north side of the bridge structure.

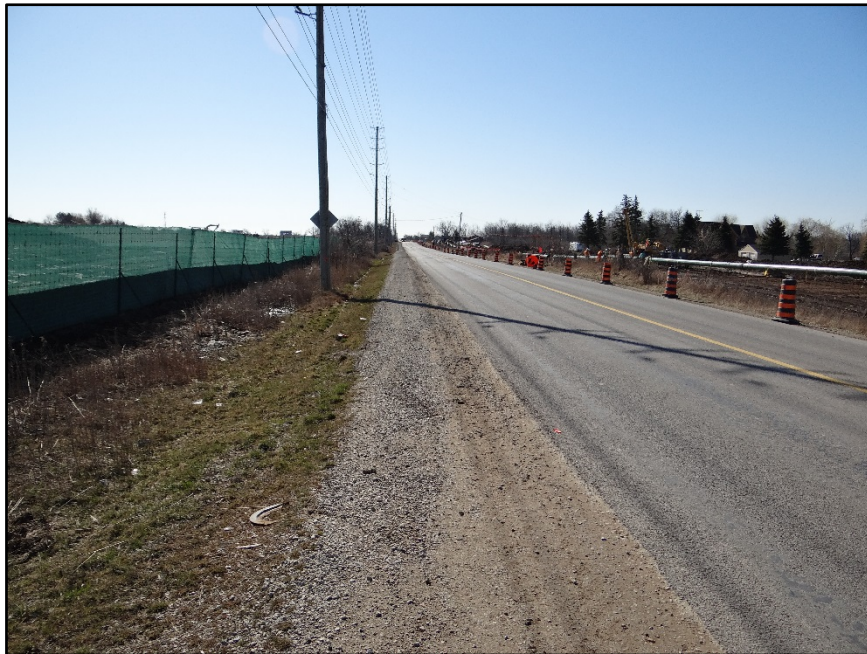
The shoulders on Ninth Line were found to be of variable condition in both surface and width. The gravel shoulders on Ninth Line between Dundas Street and Burnhamthorpe Road (**Figure 19**), were generally narrow and in some areas, measured to be as narrow as 1.75 meters. At certain locations, the shoulders appeared to be soft as a result of erosion/aging.

Figure 19: Narrow Gravel Shoulders on Ninth Line south of Burnhamthorpe Road

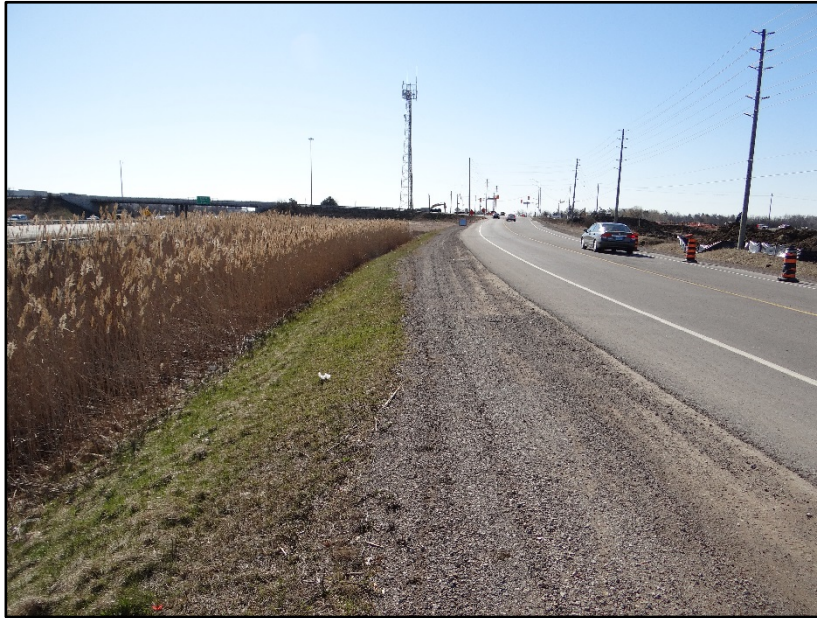
North of the intersection of Ninth Line and Burnhamthorpe Road, the roadway appears to have been resurfaced recently with wide partially paved shoulders (**Figure 20**). The paved portion of the shoulder on this section of Ninth Line was found to be in good condition.

Figure 20: Paved and Gravel Shoulder on Ninth Line North of Burnhamthorpe Road

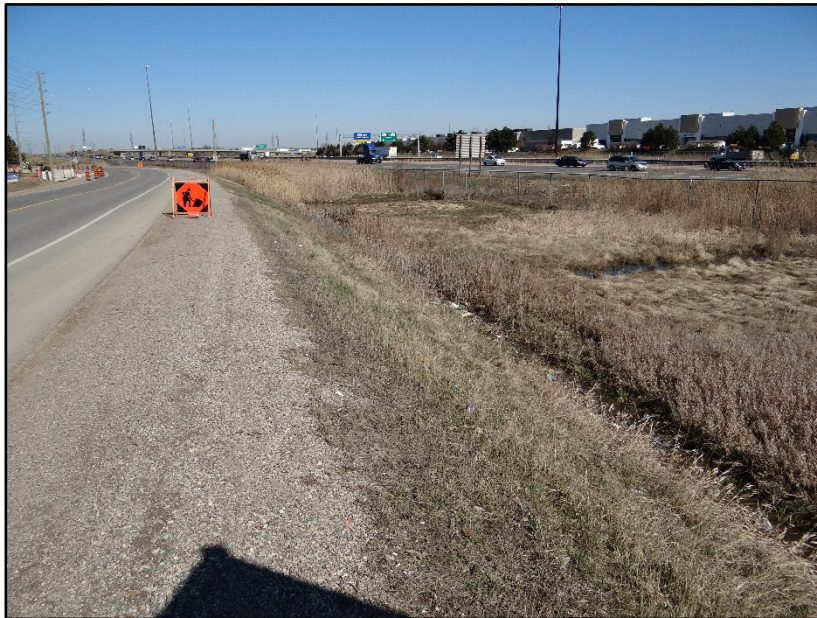
The side slopes of the roadway were generally found to be irregular. In certain locations of Ninth Line, the slopes appeared to be steeper than 3:1 with a depth of approximately 3 metres or more. **Figure 21** illustrates a typical roadside slope within the clear zone north of Burnhamthorpe Road.

Figure 21: Typical Side Slope on Ninth Line north of Burnhamthorpe Road

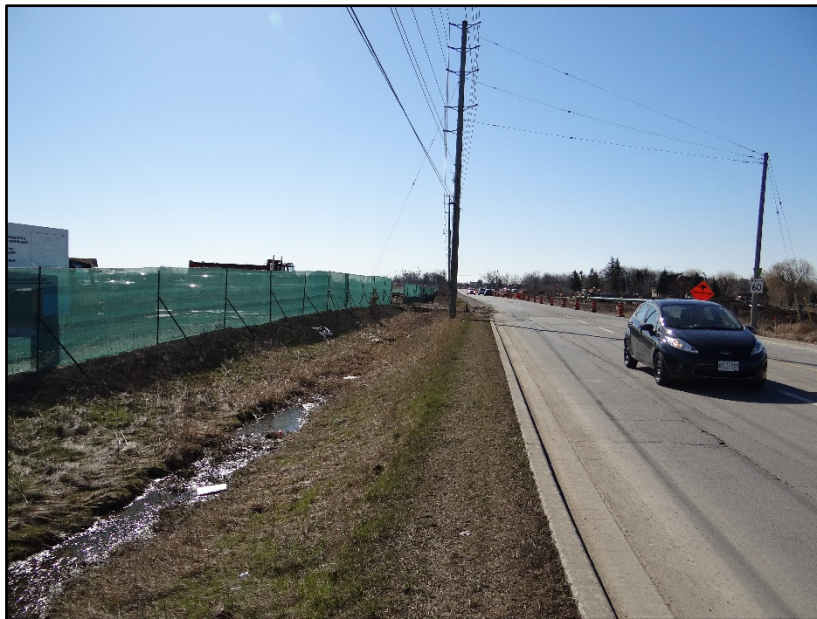
Examination of fixed objects along the roadside found that a significant number of non-breakaway utility poles that do not meet the clear zone requirement. Hydro poles on Ninth Line between Dundas Street and Burnhamthorpe Road (**Figure 22**) are located on the east side of the roadway, some of which are only 2.1 metres from the edge of pavement and therefore are within the clear zone. While placement of hydro poles within the clear zone is not uncommon, it would be desirable to relocate hydro poles outside the clear zone when the roadway is widened.

Figure 22: Utility Pole on East Side of Ninth Line south of Burnhamthorpe Road

- + Consider relocating utility poles and other fixed objects, such as culvert head walls outside of the clear zone. As an interim proactive measure, the Region could consider to delineate the fixed object hazards. The utility poles located on the shoulder as well as poles within 2.0 m of the traveled lane (if not on the shoulder) should be marked with object marker signs. Likewise, culvert head walls within 2.0 m of the travelled lane should be marked with object marker signs;

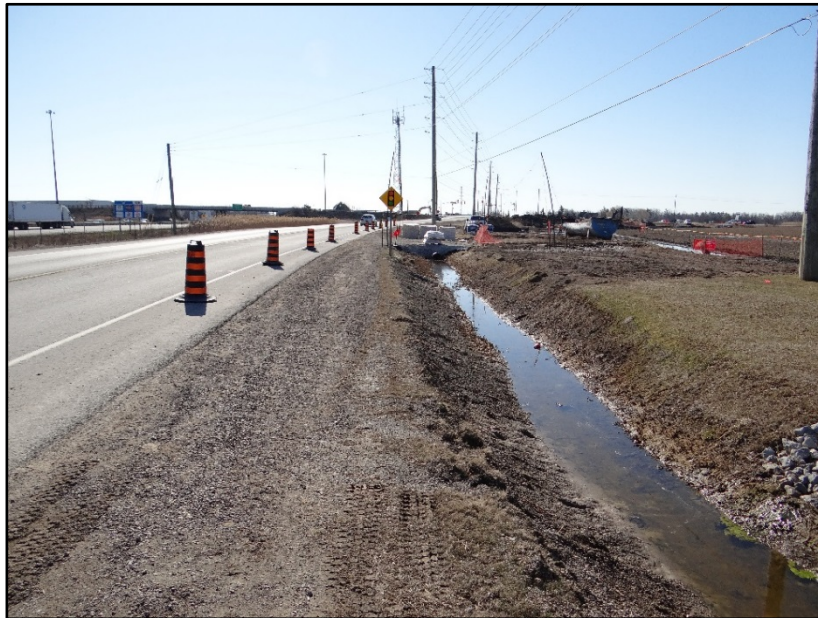
Additionally, a few culvert embankments located at the driveways are located within the clear zone (**Figure 23**). When ditches parallel to the through roadway cross intersecting roadways or driveways, culverts are placed at the base of the ditch to allow water to flow through under the driveway. Many run off the road vehicles follow the ditch line and if a culvert embankment is present, it can potentially be struck head on by an errant vehicle.

Figure 23: Culvert on West Side of Ninth Line north of Burnhamthorpe Road

The Road Safety Manual recommends side slopes of 4:1 or flatter for embankments of intersecting roadways or entrances. The manual also recommends that the inlet and outlet slope of the culvert should be matched to the embankment slopes, which will result in a smaller target area for an errant vehicle.

A review of collision history did not reveal any collisions involving these fixed objects. As a proactive interim measure, the Region may consider to mark these hazards using object marker signs as per guidelines provided in OTM Book 11 as follows:

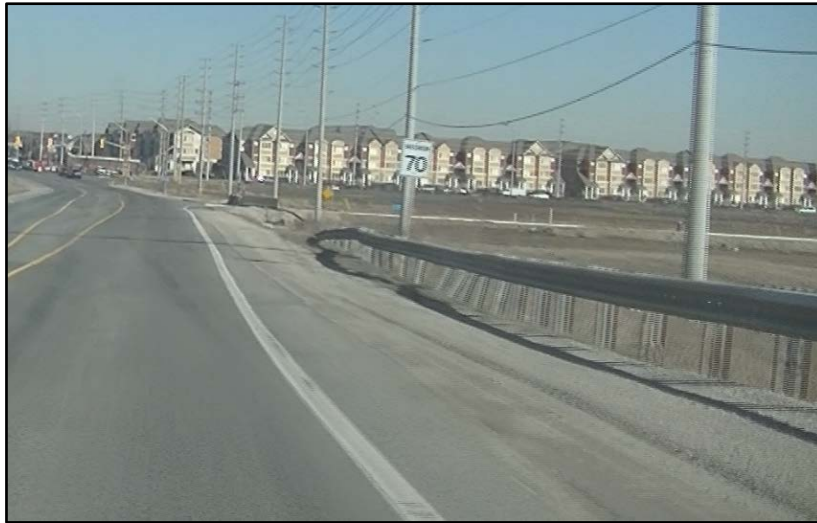
The application and condition of guide rails within the study area were also reviewed. Some steel beam guide rails are present along Ninth Line mainly in the vicinity of 407 ETR structures. The steel posts of the steel beam guide rail installed immediately north of the 407 ETR northbound on-ramp on the east side were observed to be deformed as shown in **Figure 24**. The leaving end of this guide rail was also found out to be turned down. The south ends of the guide rails connected to the overpass structure of 407 ETR main line were also found to be turned down as demonstrated in **Figure 25**.

Figure 24: Poor Condition of Guide Rail located north of 407 ETR Northbound On-ramp

approved end treatment or energy attenuation device². It should be noted that since Ninth Line was constructed, the guide rail standards might have been updated. It is expected that as part of this project, the guide rails and the roadside design will be upgraded to current practices and standards.

- + Protect the ends of guide rails by using approved end treatments; and
- + Provide appropriate storage lengths for left turn lanes at the intersection of Ninth Line and Burnhamthorpe Road.

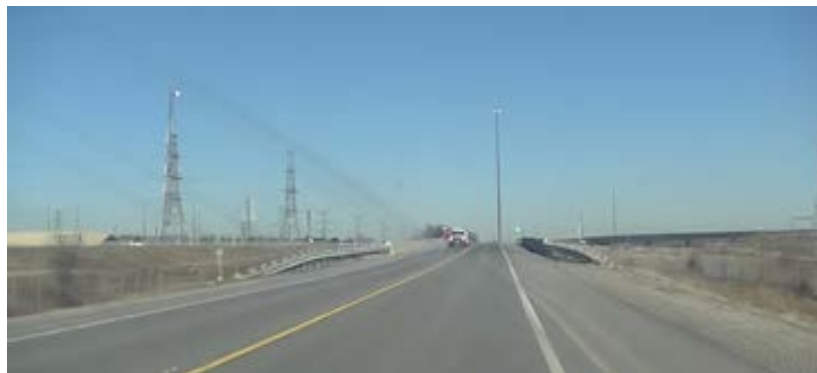
Figure 25: Downturned End Treatments

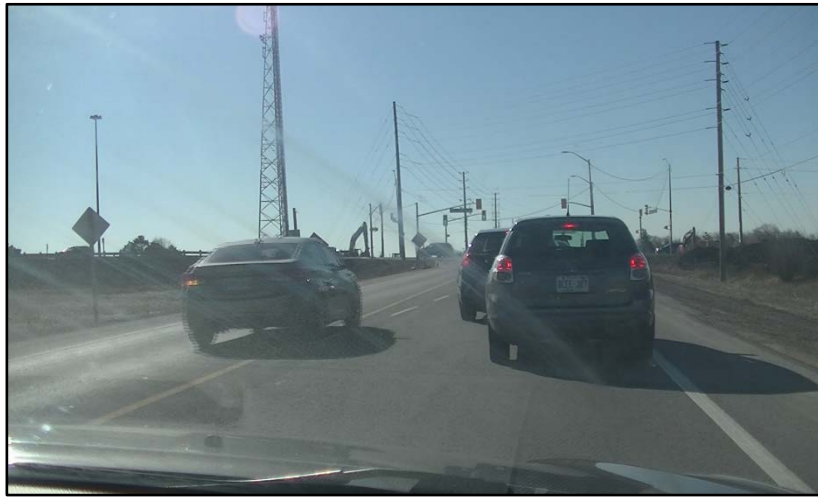
During the AM peak hour, significant southbound vehicle queues of approximately 260 metres were observed at the north approach of the intersection of Ninth Line and Burnhamthorpe Road, which is consistent with the results of our operational analysis and supports the widening. Several motorists were observed performing aggressive manoeuvres around queued vehicles by crossing into the opposing lane as shown in **Figure 26**.

Figure 26: Southbound Vehicle Queue at Intersection of Ninth Line and Burnhamthorpe Road
