**Regional Road 25 Class
Environmental Assessment –
Natural Environment Report**

FINAL REPORT

Prepared for:
Region of Halton

Prepared by:
Stantec Consulting Ltd.
200-835 Paramount Drive
Stoney Creek, ON L8J 0B4

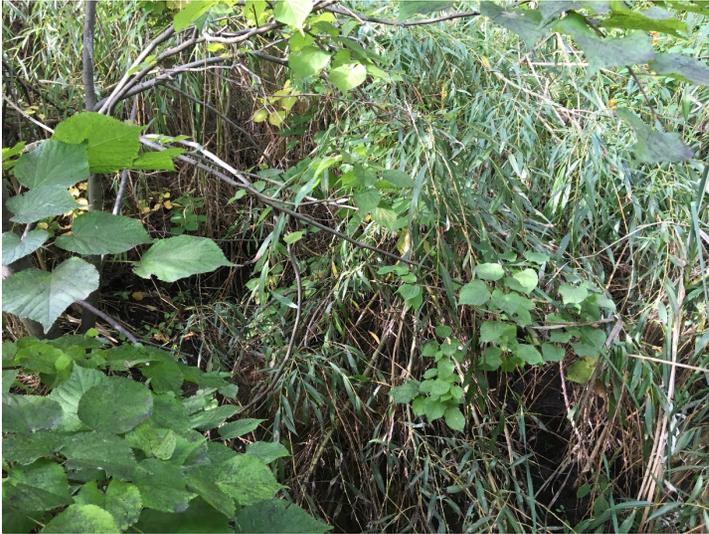
Photo 1: Facing upstream from the inlet of culvert C1 (09/08/2017).

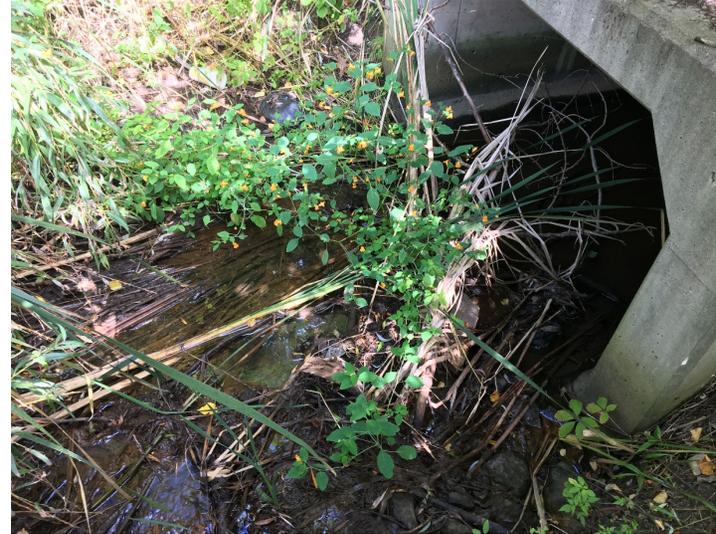
Although it does not qualify as SWH, a dry ledge is present in culvert C1 and it was noted that racoons and possibly other small mammals are using the culvert as a travel corridor.

Photo 2: Inlet of culvert C1 (09/08/2017).

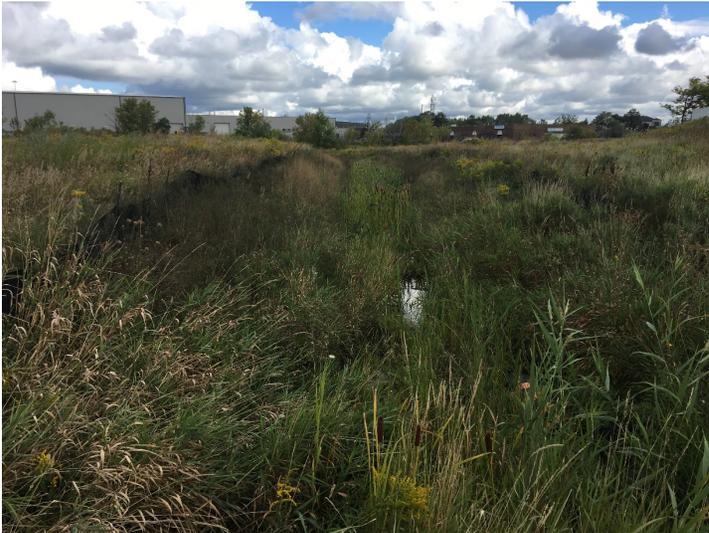
Photo 3: Facing downstream from the outlet of culvert C1 (09/08/2017).

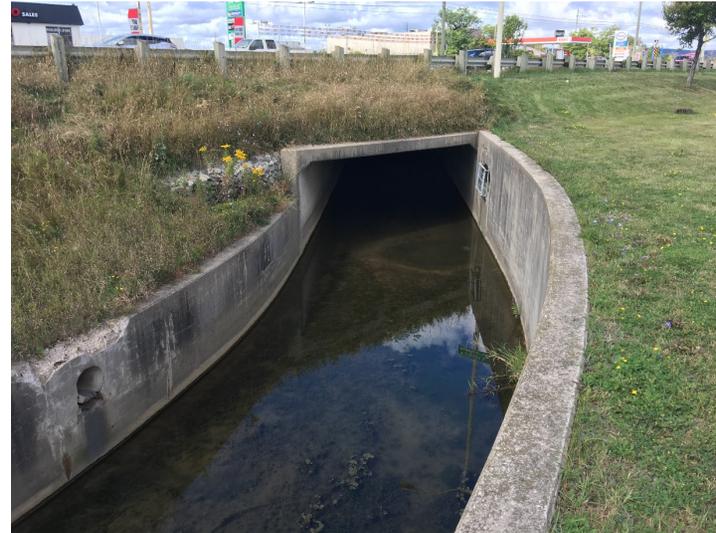
Photo 4: Facing upstream at the Culvert c2 outlet (09/08/2017).

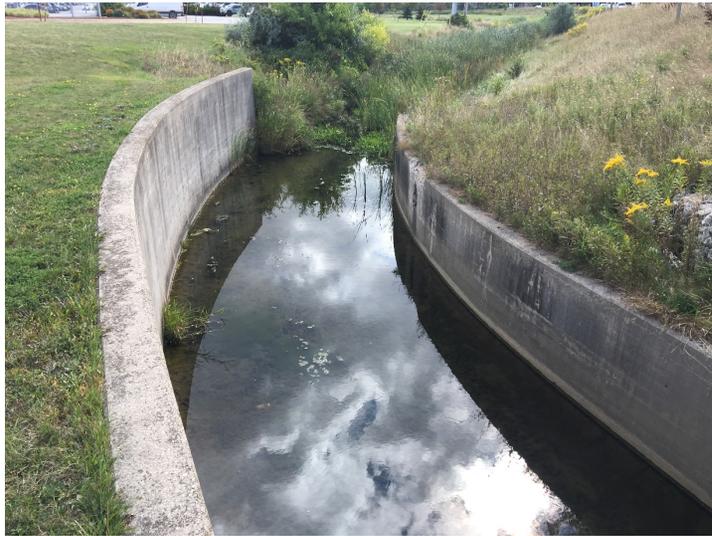
Photo 5: Facing downstream from the outlet of culvert 2 culvert (08/09/2017).

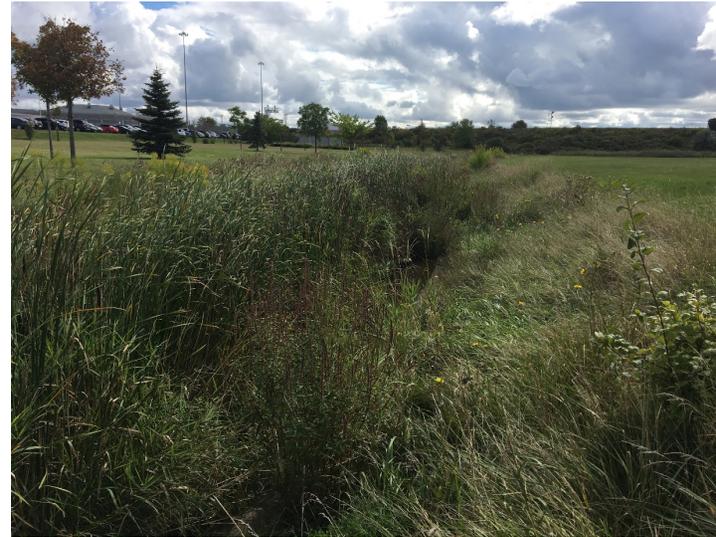
Photo 6: Facing downstream from culvert C2 (08/09/2017).

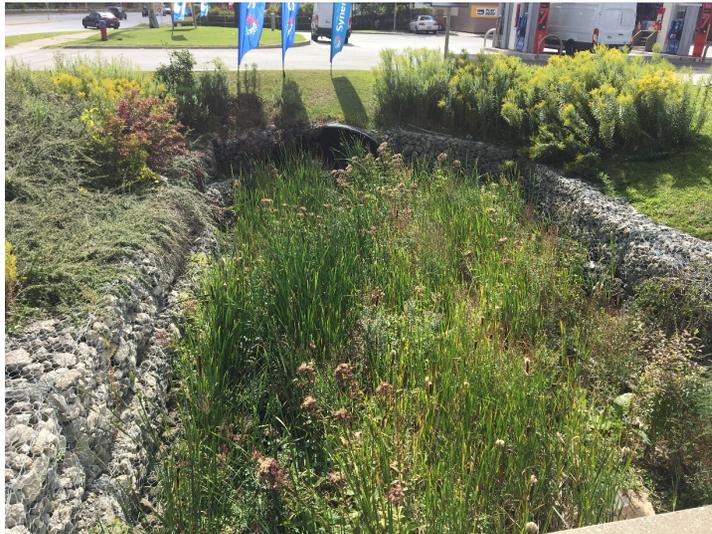
Photo 7: Facing the inlet of culvert C2 from the culvert C3 outlet (08/09/2017).

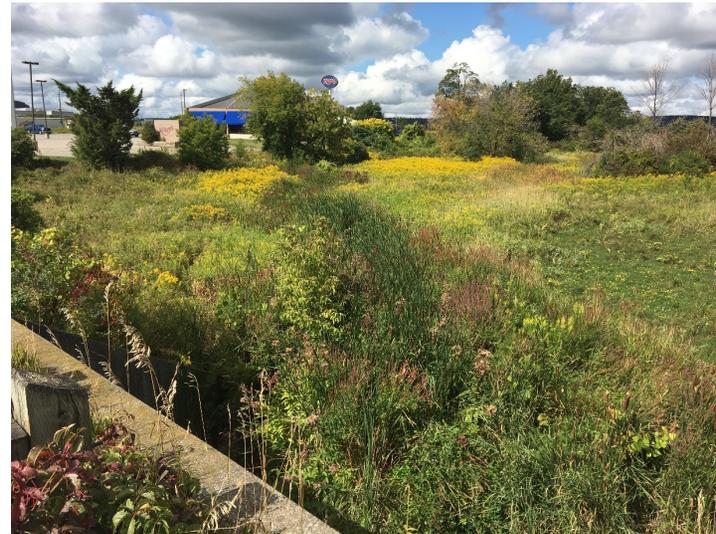
Photo 8: Facing upstream from the culvert C3 inlet (08/09/2017).

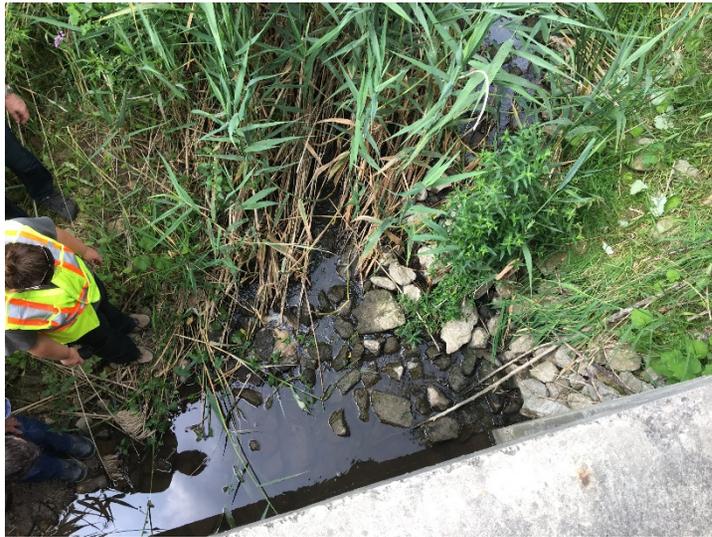
One Barn Swallow nest was present in culvert C4. While no other bird nests were observed, the natural vegetation in the study area likely supports nesting migratory birds.

Photo 9: Inlet of culvert C4 (12/07/2017).

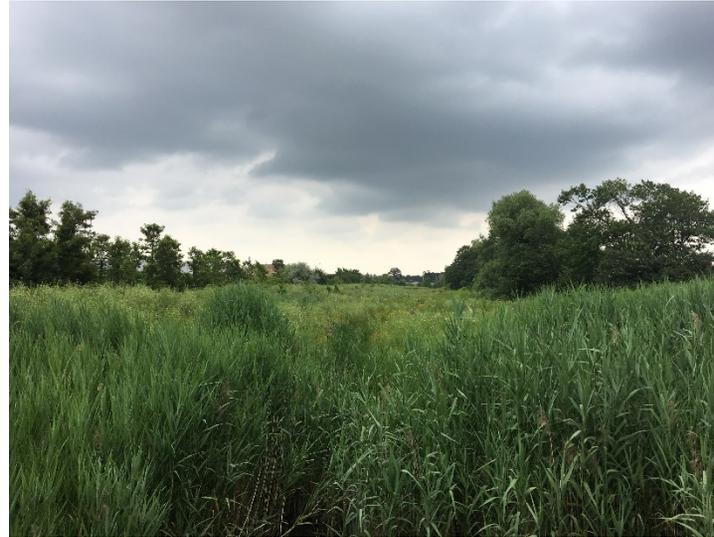
Photo 10: Facing downstream from culvert C4 (12/07/2017).
