Proposed Burlington Quarry Expansion
JART COMMENT SUMMARY TABLE – Natural Heritage

JART Comments (February 2021)	Reference	Source of Comment	Applicant Response (July 2021)	JART Response
Report/Date: Level 1 and Level 2 Natural Environment Technical Report, April 2020		Author: Savanta

Watercourse Characterization Summaries Proposed Burlington Quarry Extension, Nelson Aggregates Co.

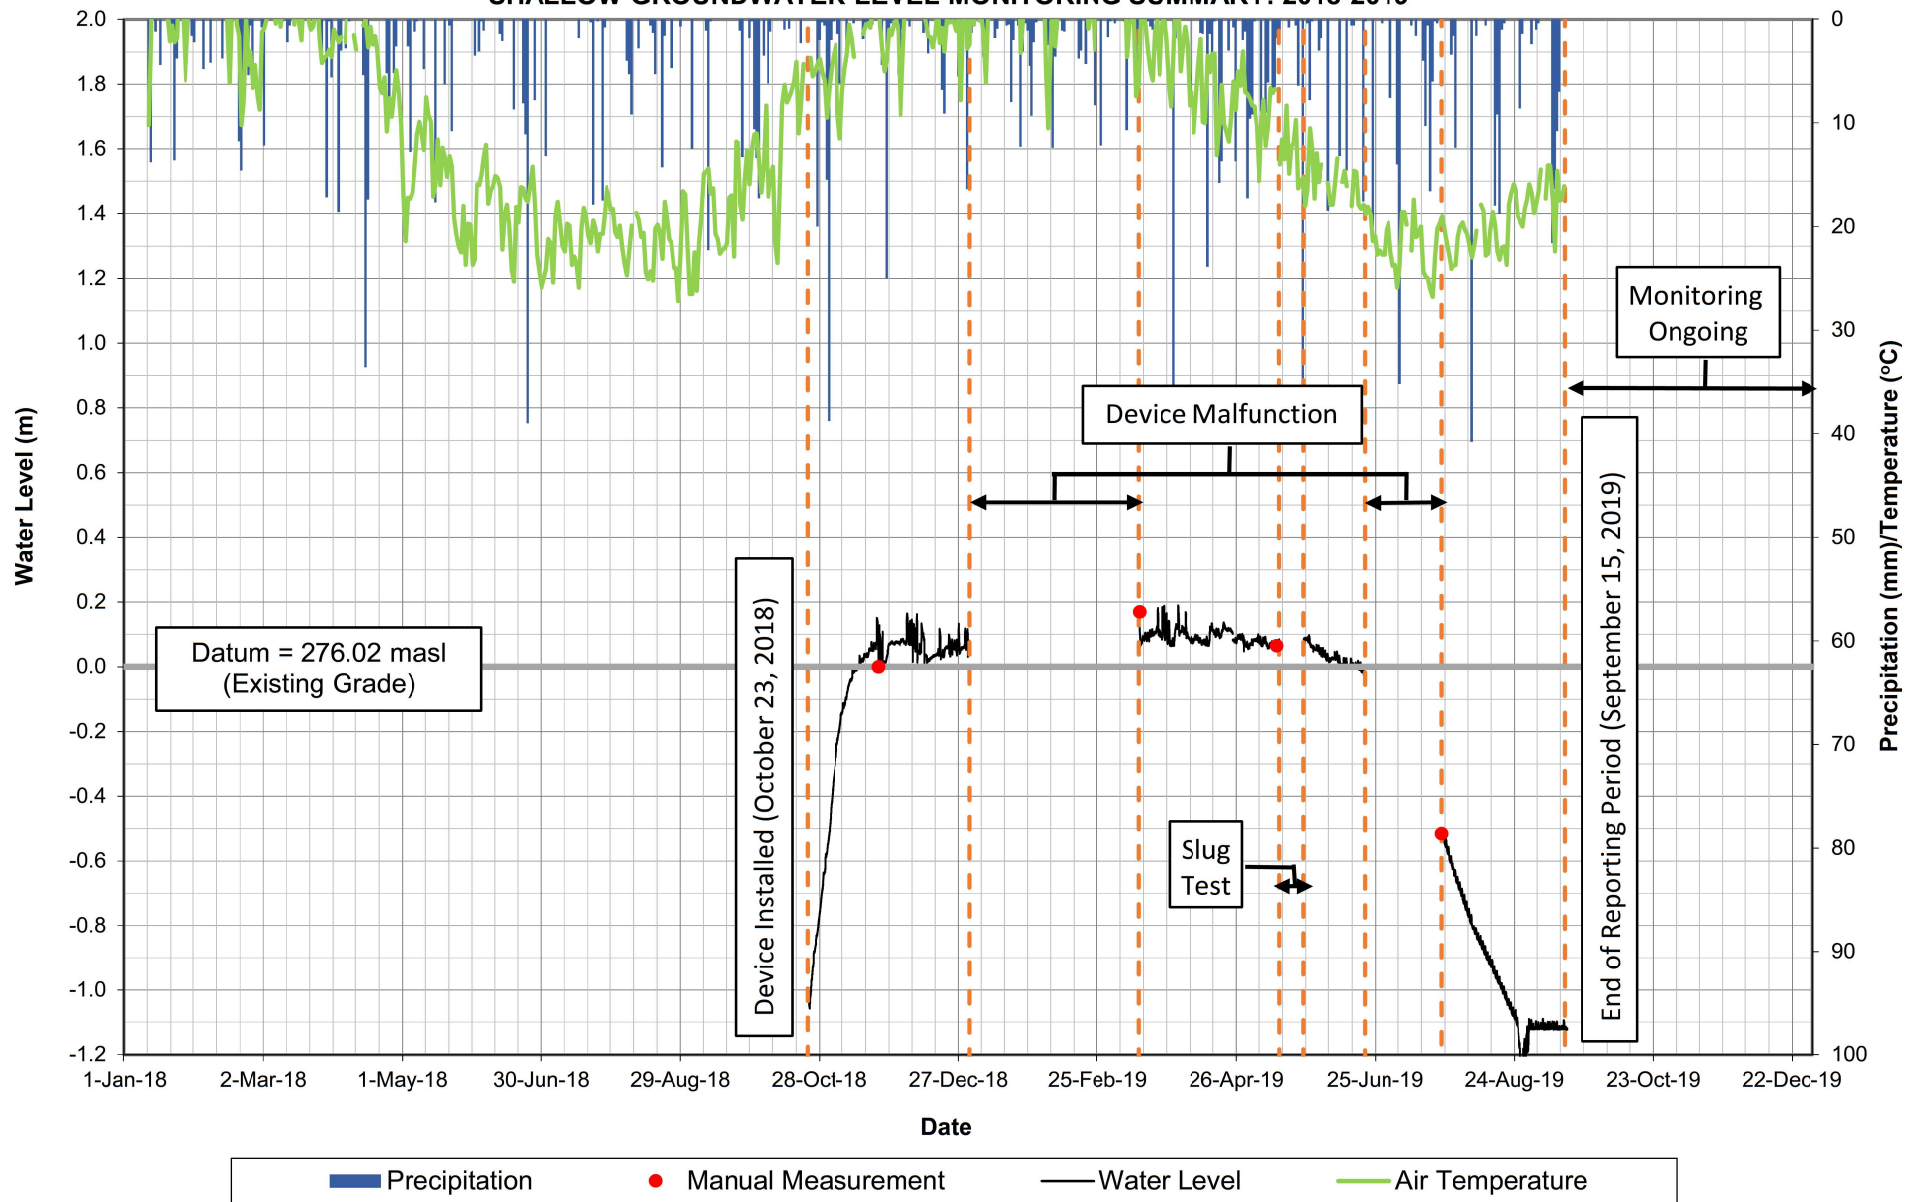
**BURLINGTON QUARRY
MONITORING LOCATION SW12B
SHALLOW GROUNDWATER LEVEL MONITORING SUMMARY: 2018-2019**

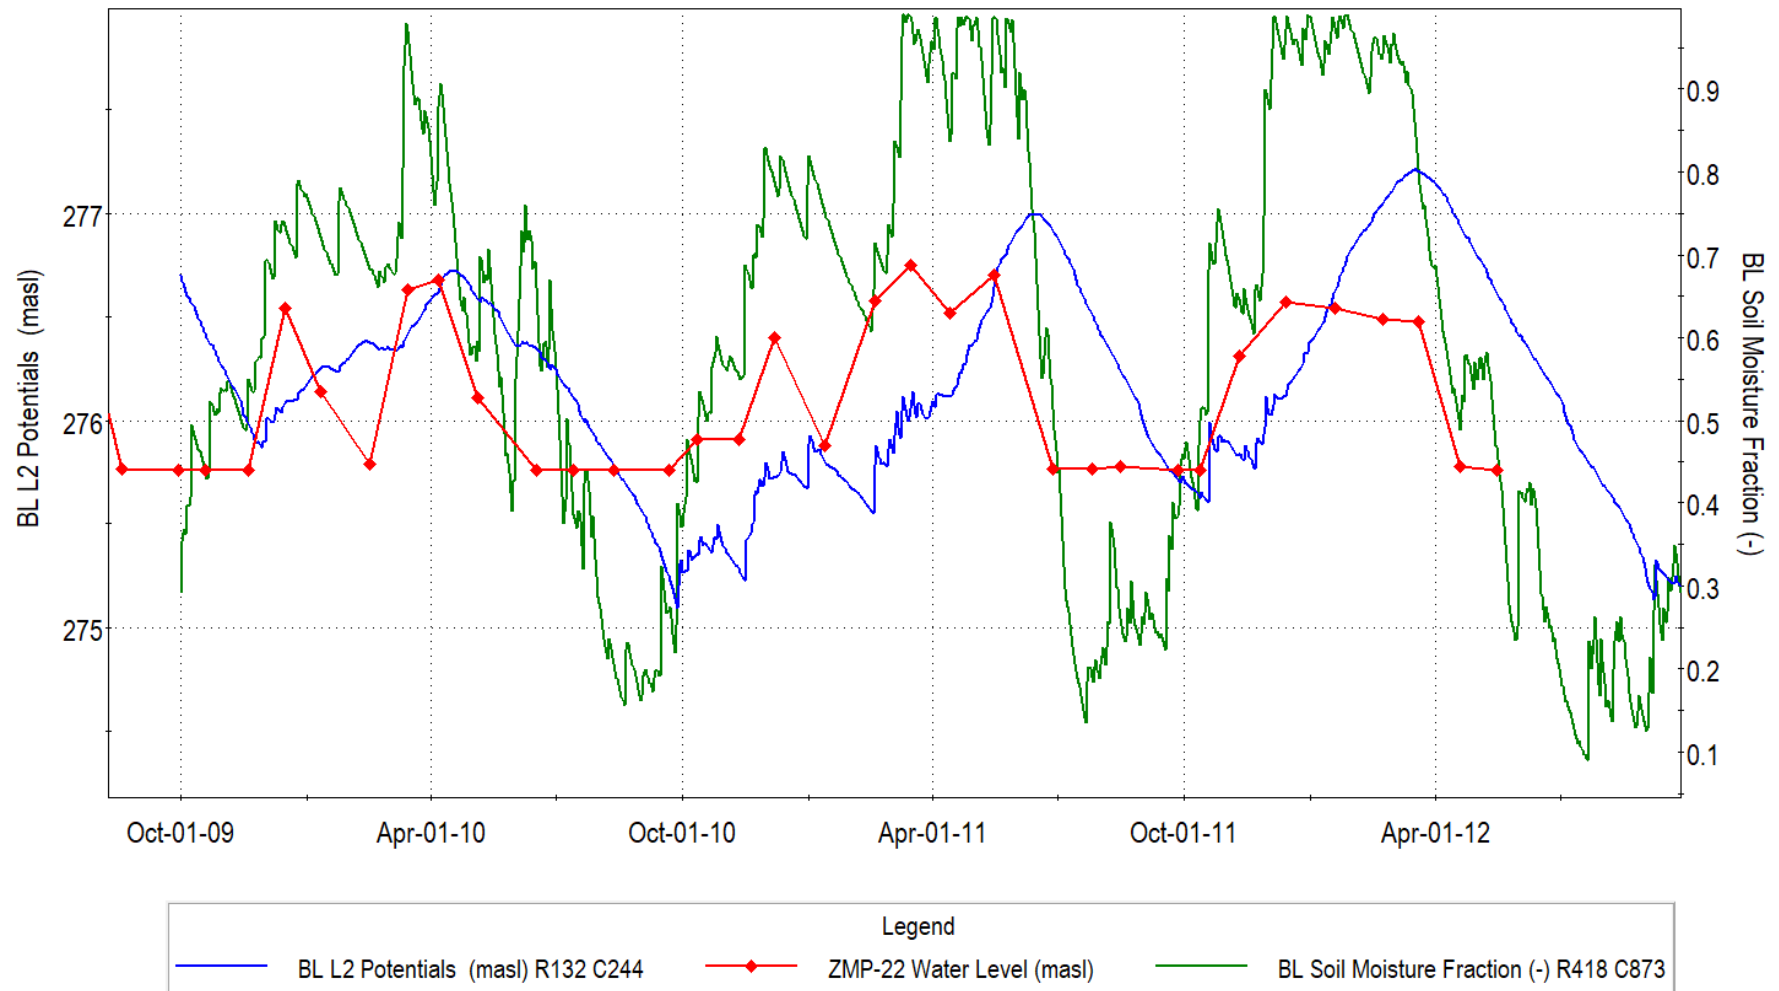
Integrated Model Calibration Wetland 13022

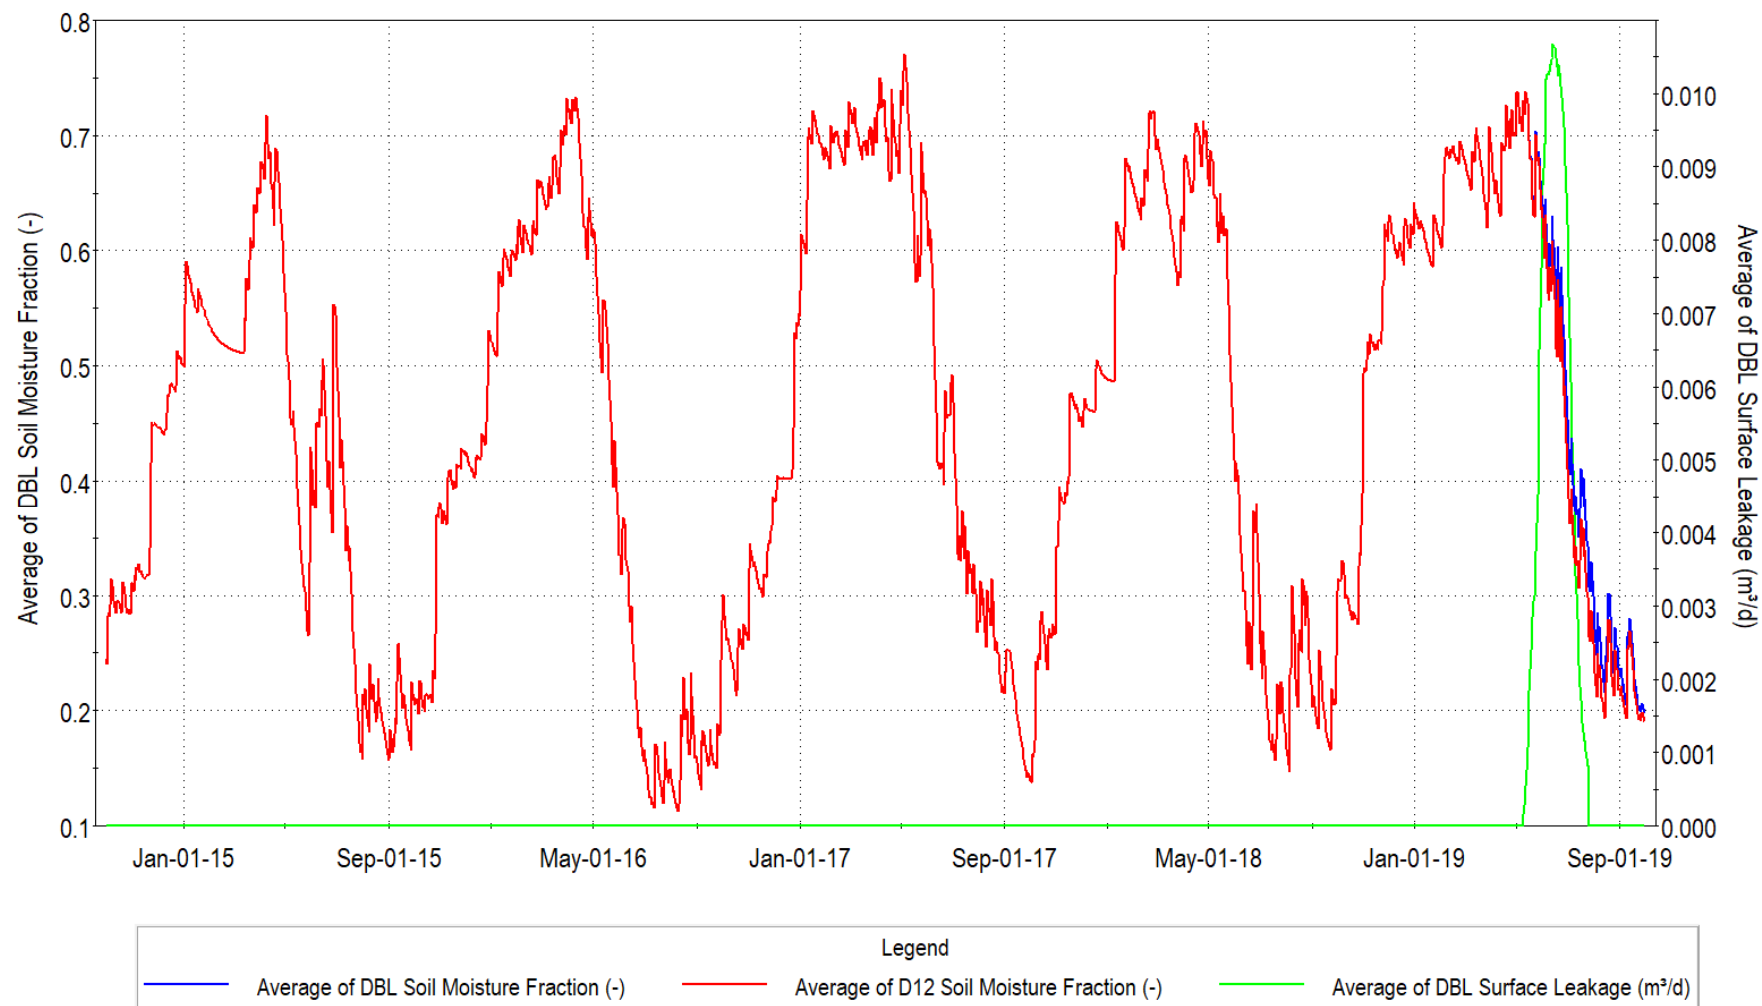
Change in Soil Moisture Conditions Wetland 13022

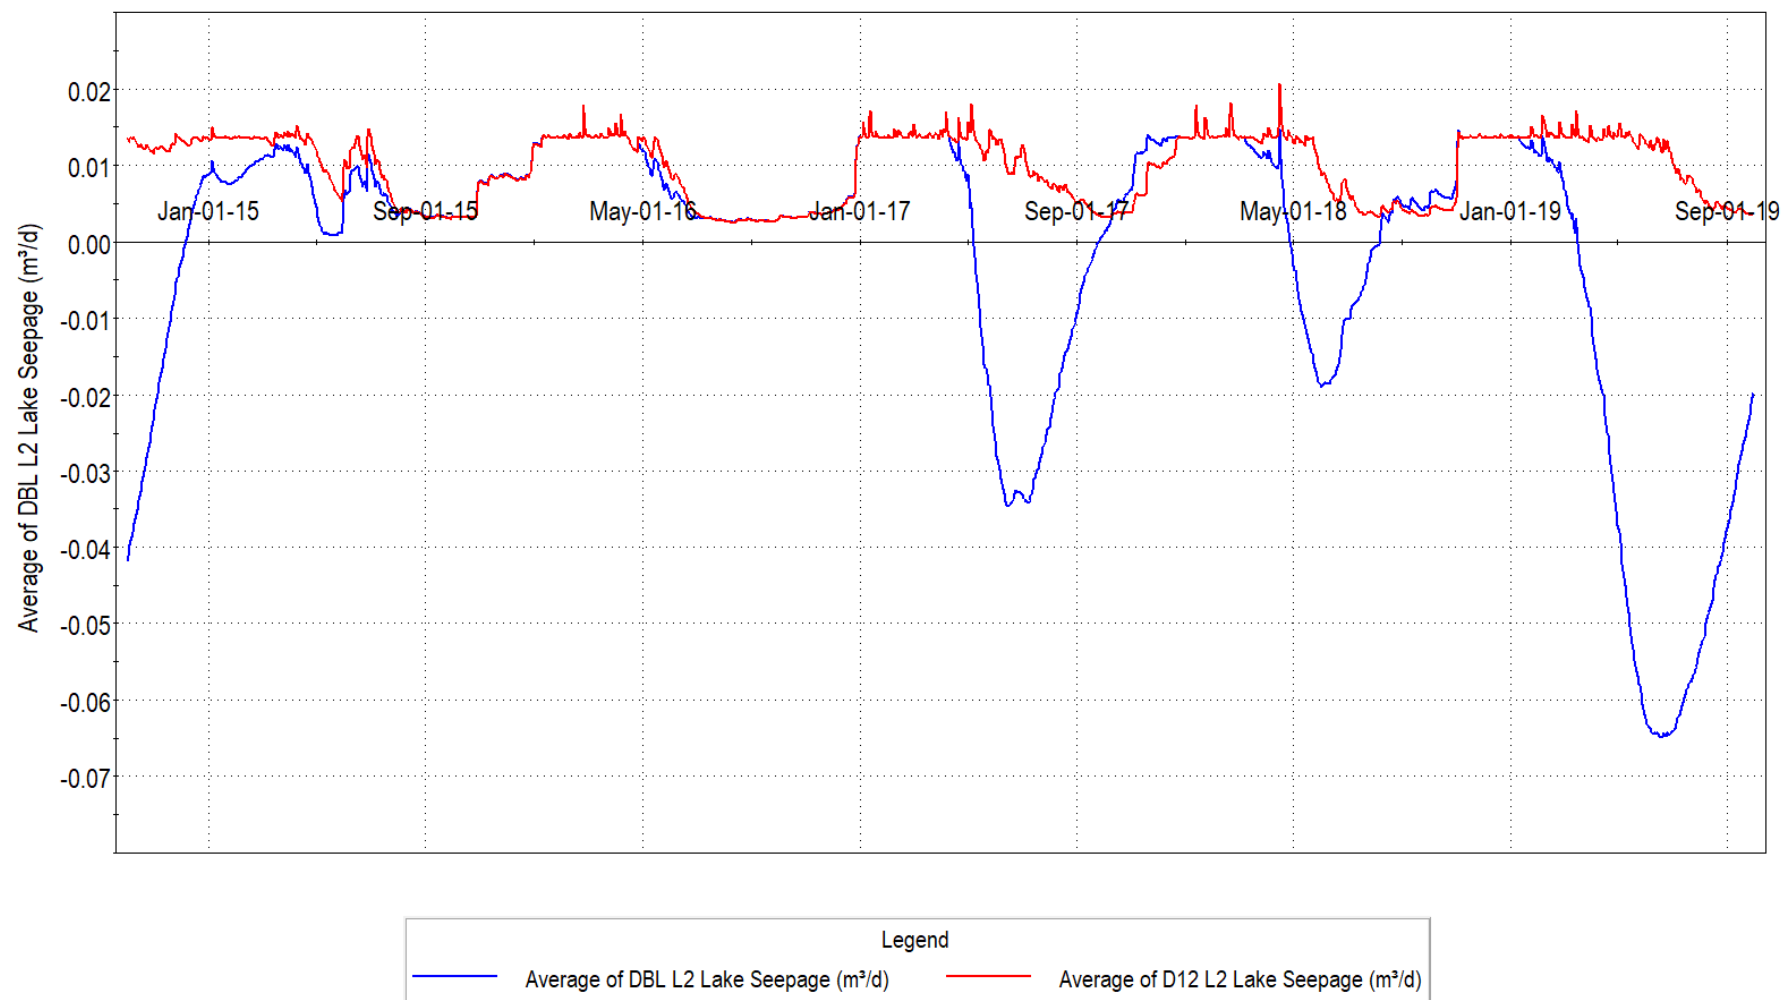
Change in Soil Moisture Conditions Wetland 13022

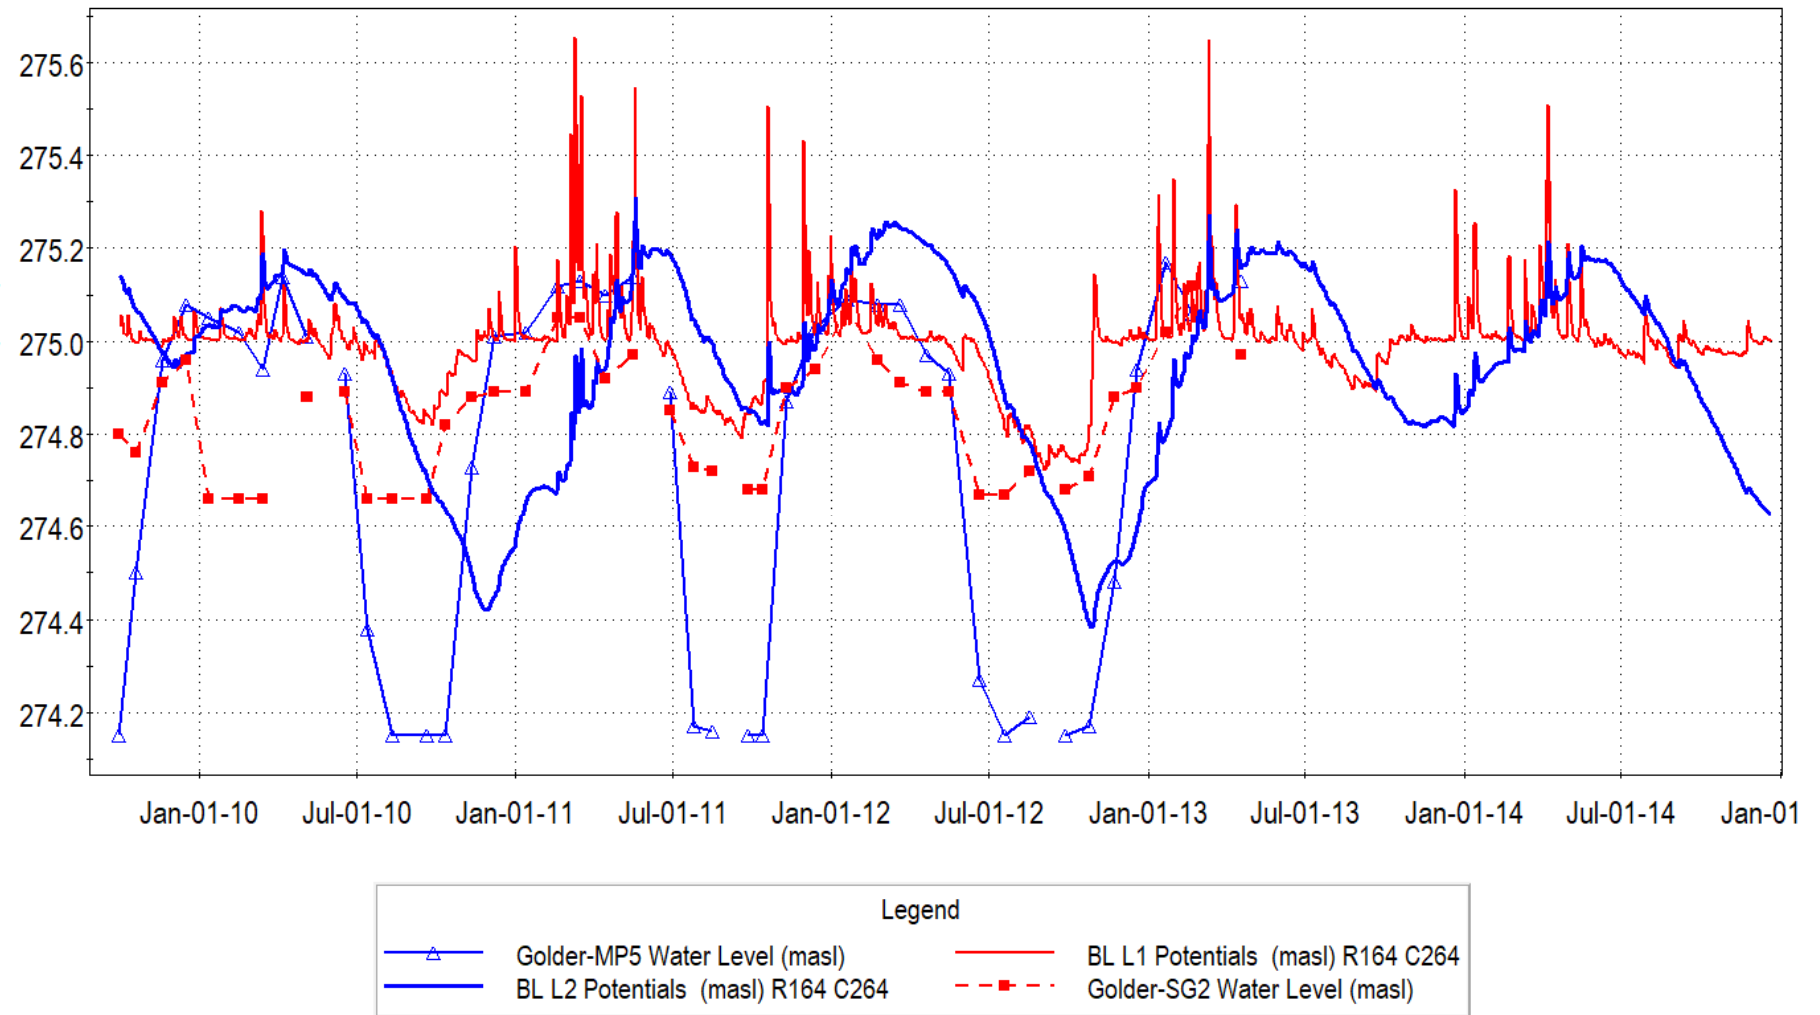
Integrated Model Calibration Wetland 13027

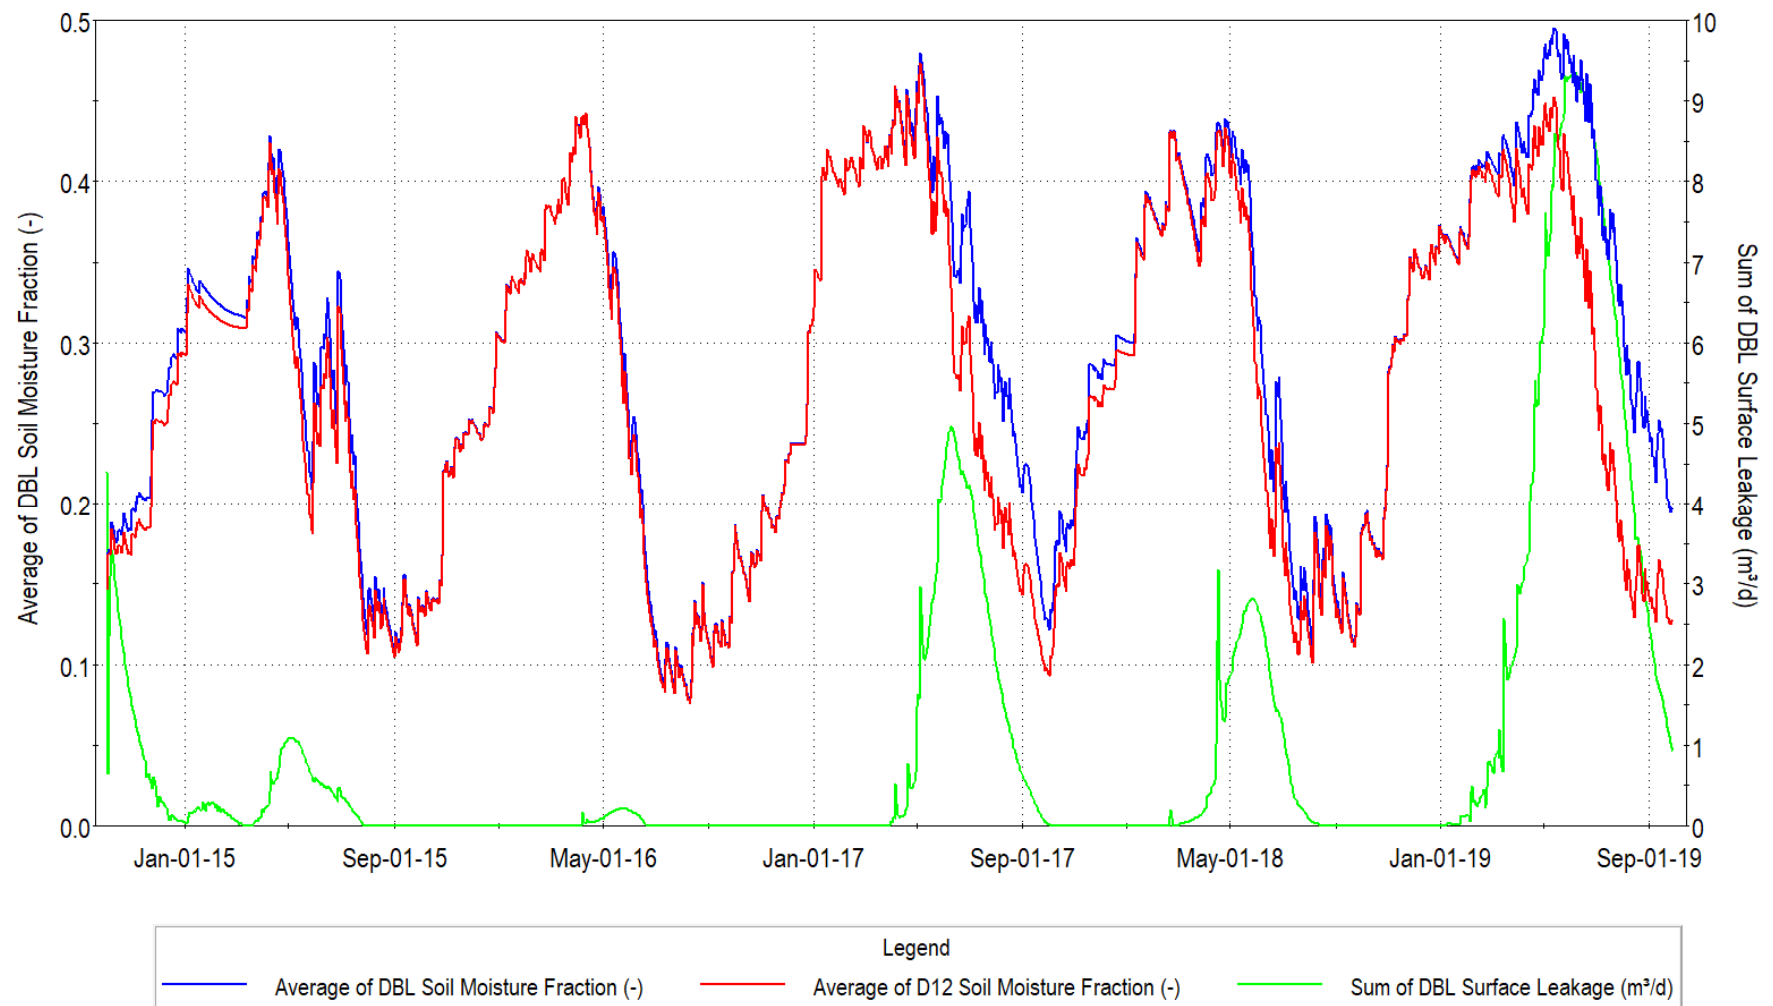
Change in Soil Moisture Conditions Wetland 13027

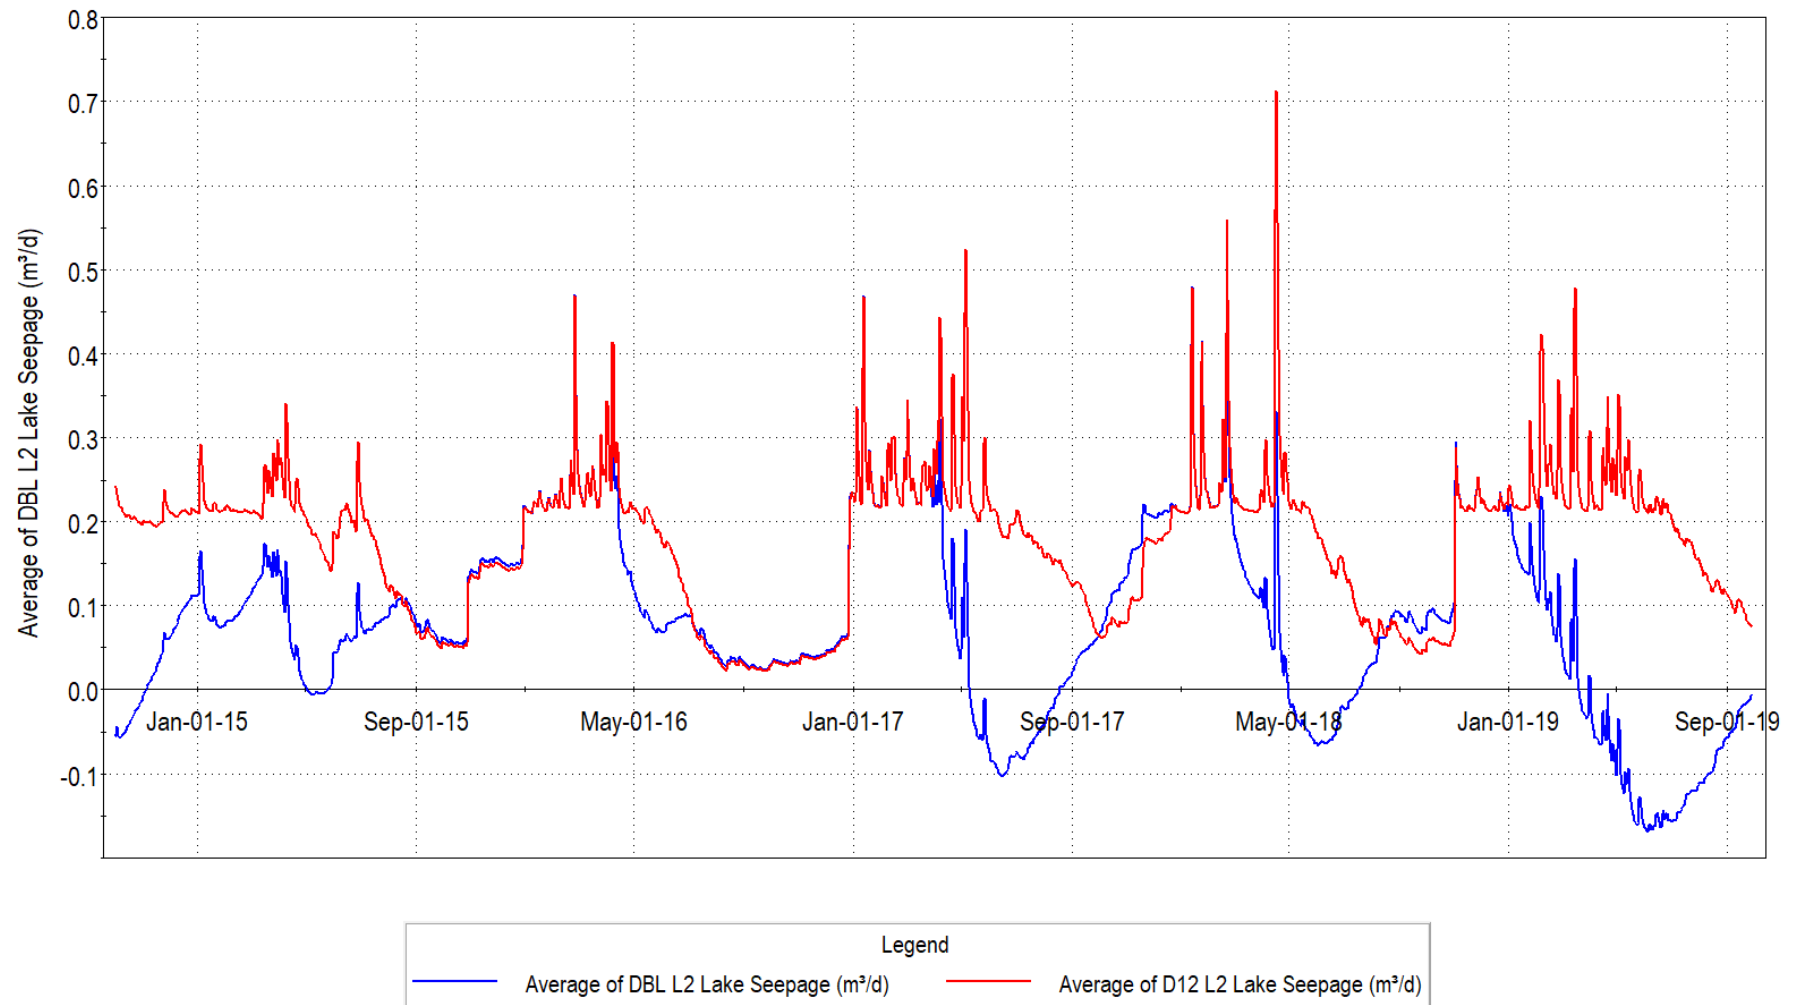
Change in Soil Moisture Conditions Wetland 13027

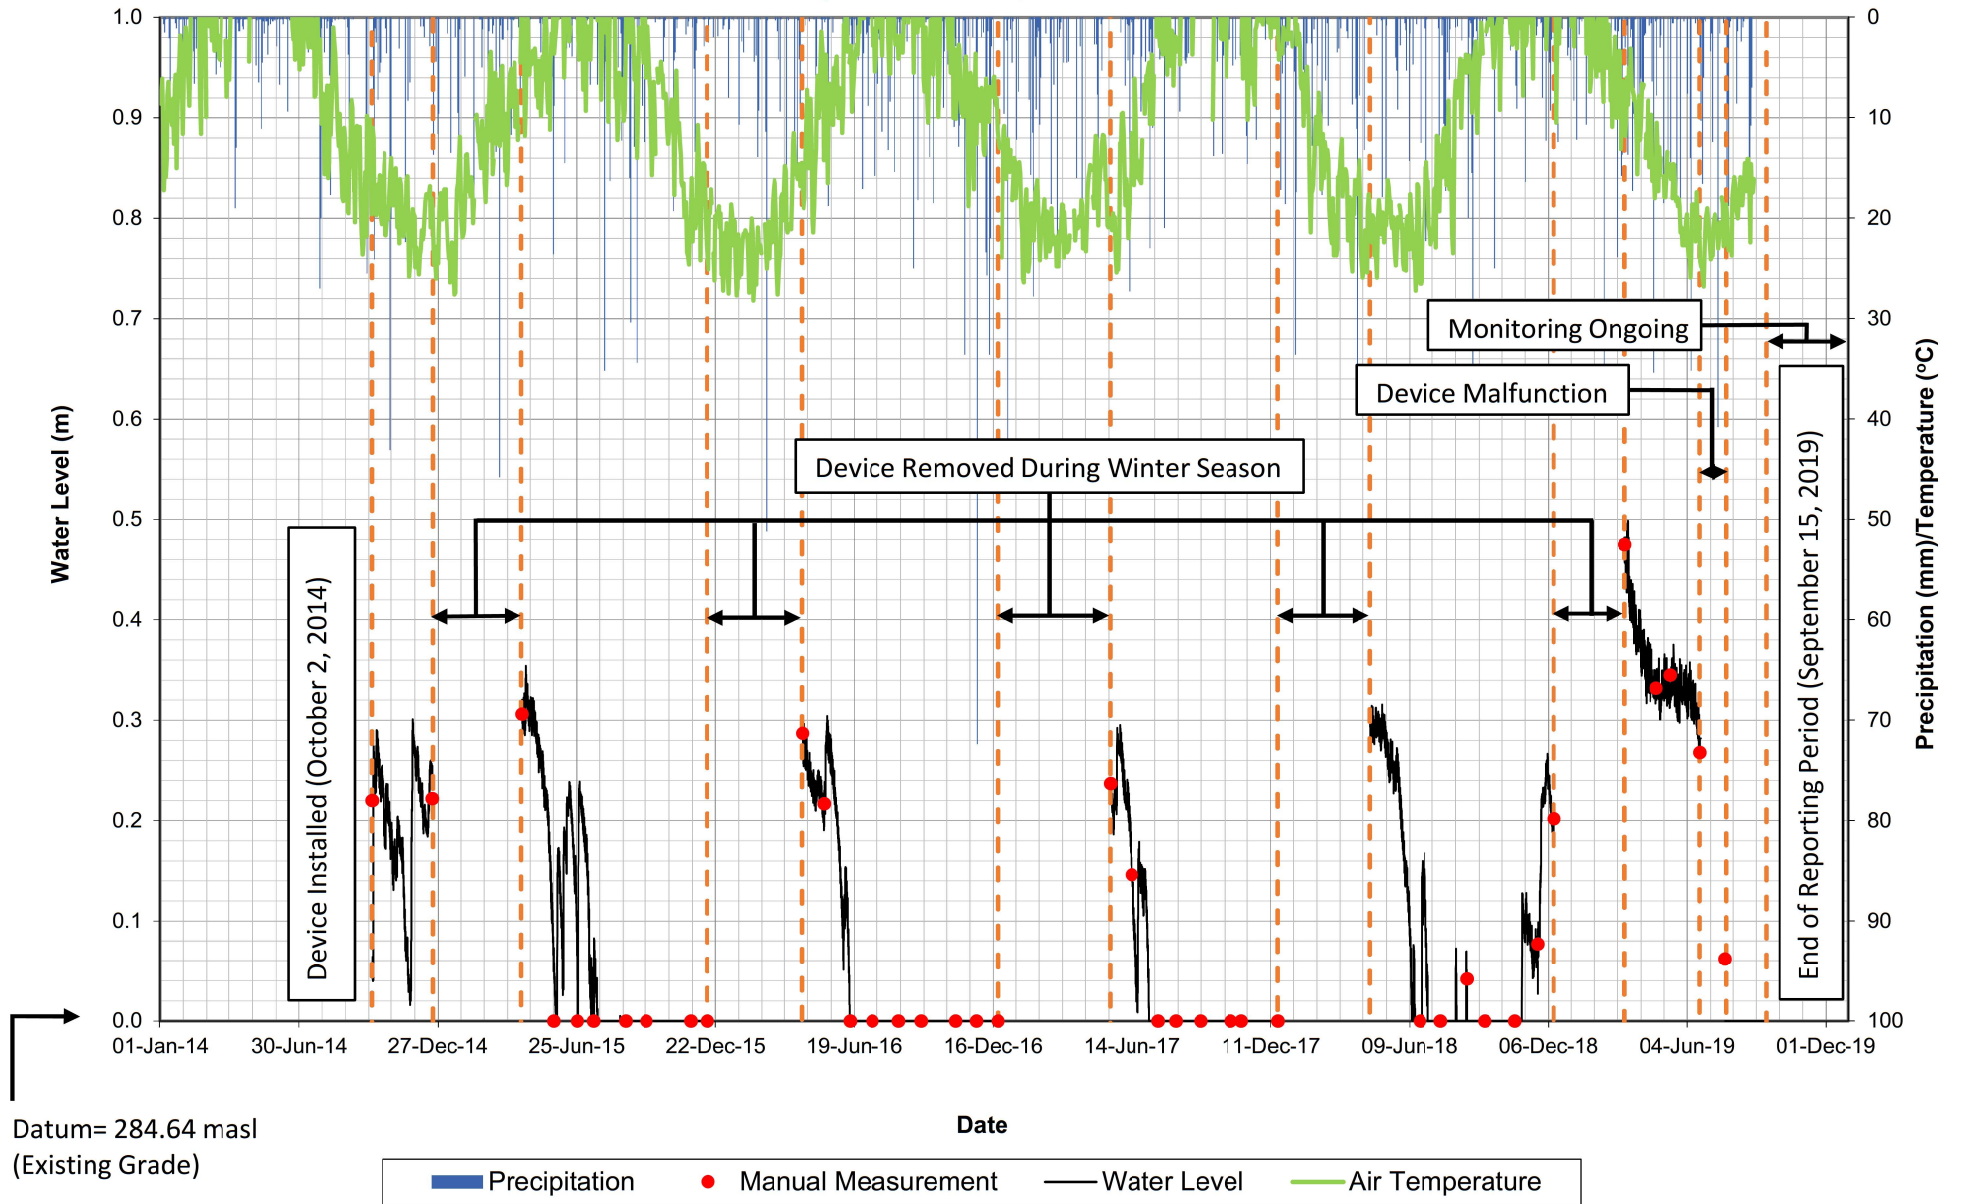
WETLAND 13031 - GRAPH 1

BURLINGTON QUARRY MONITORING LOCATION SW5A WETLAND HYDROPERIOD (WATER LEVEL) MONITORING SUMMARY: 2014-2019

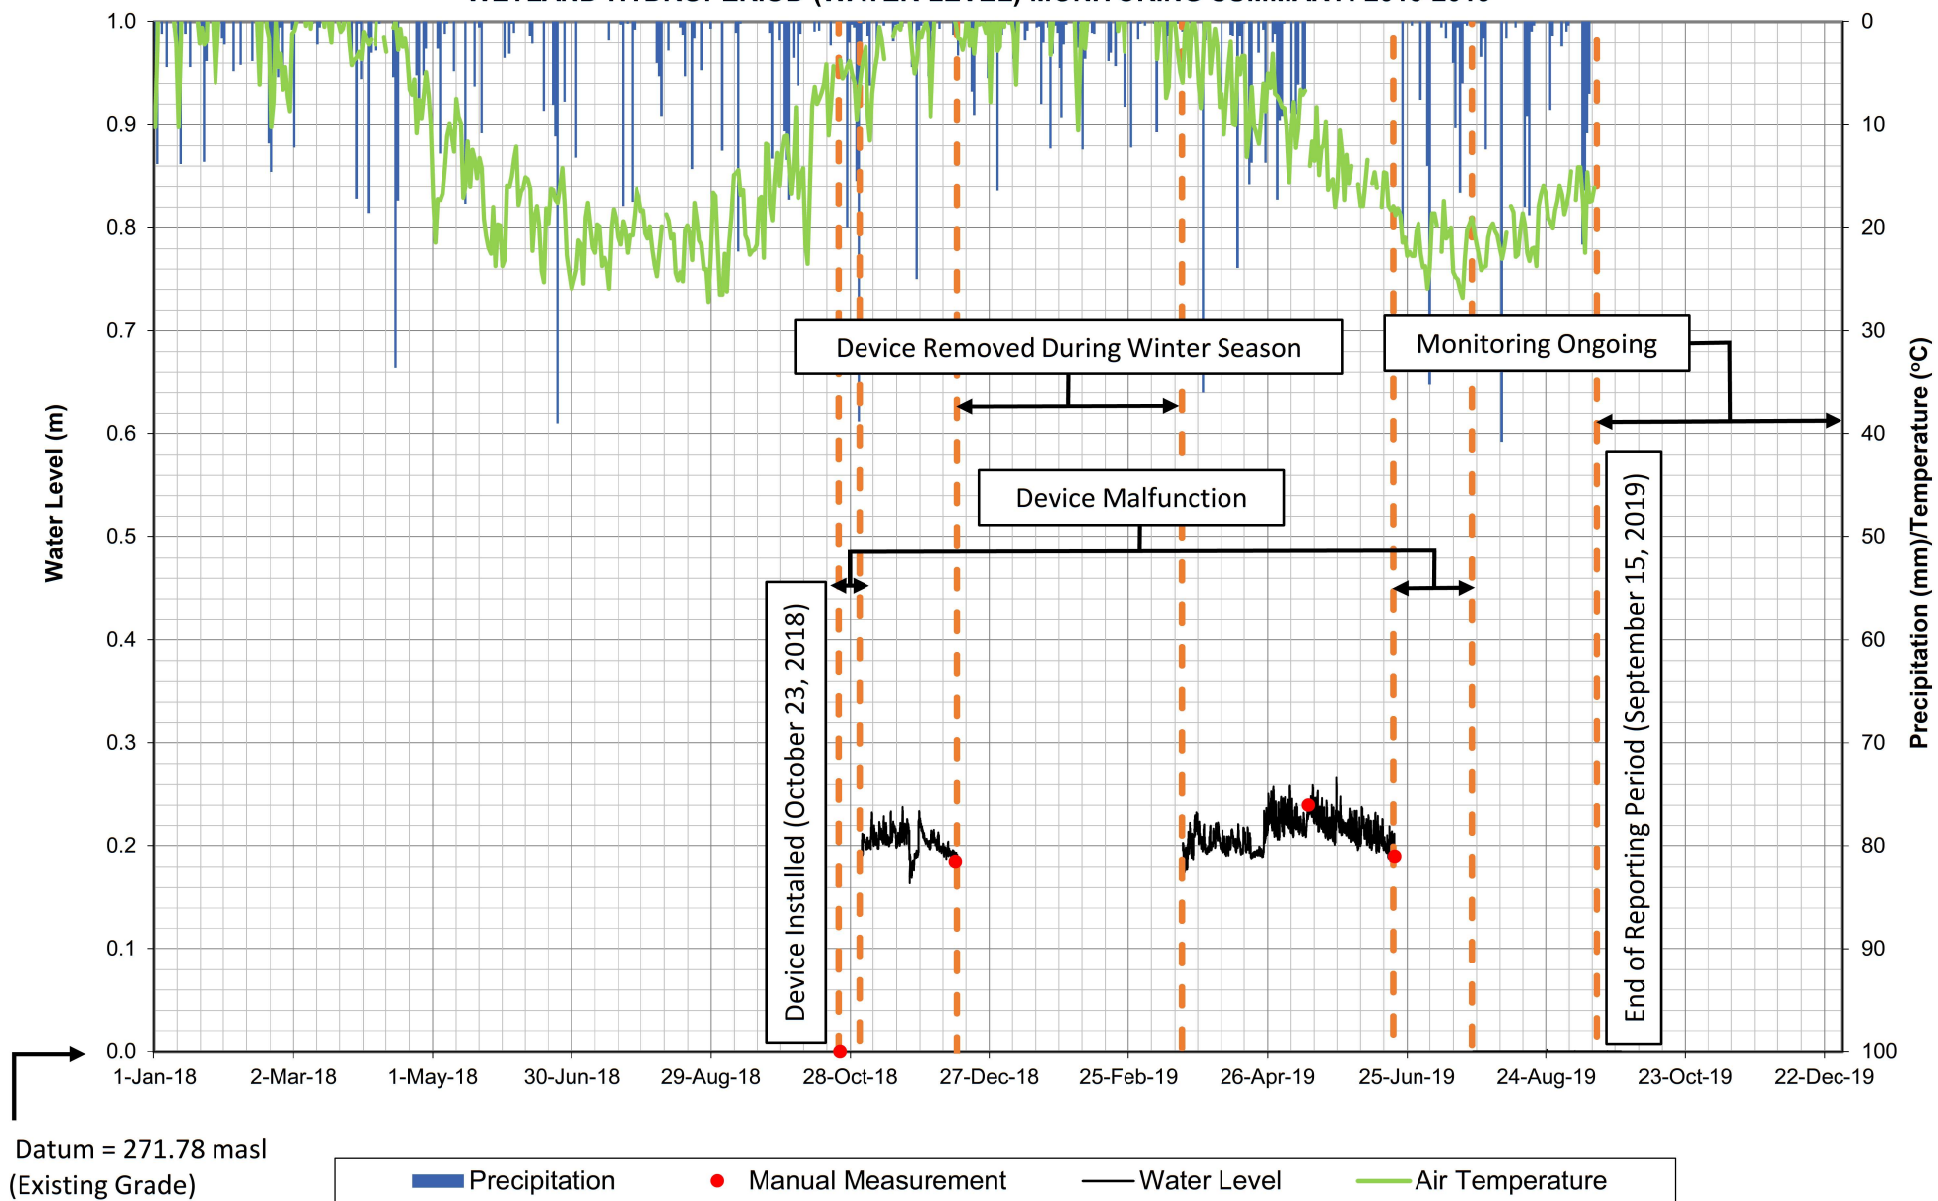
BURLINGTON QUARRY
MONITORING LOCATION SW16B
SHALLOW GROUNDWATER LEVEL MONITORING SUMMARY: 2018-2019

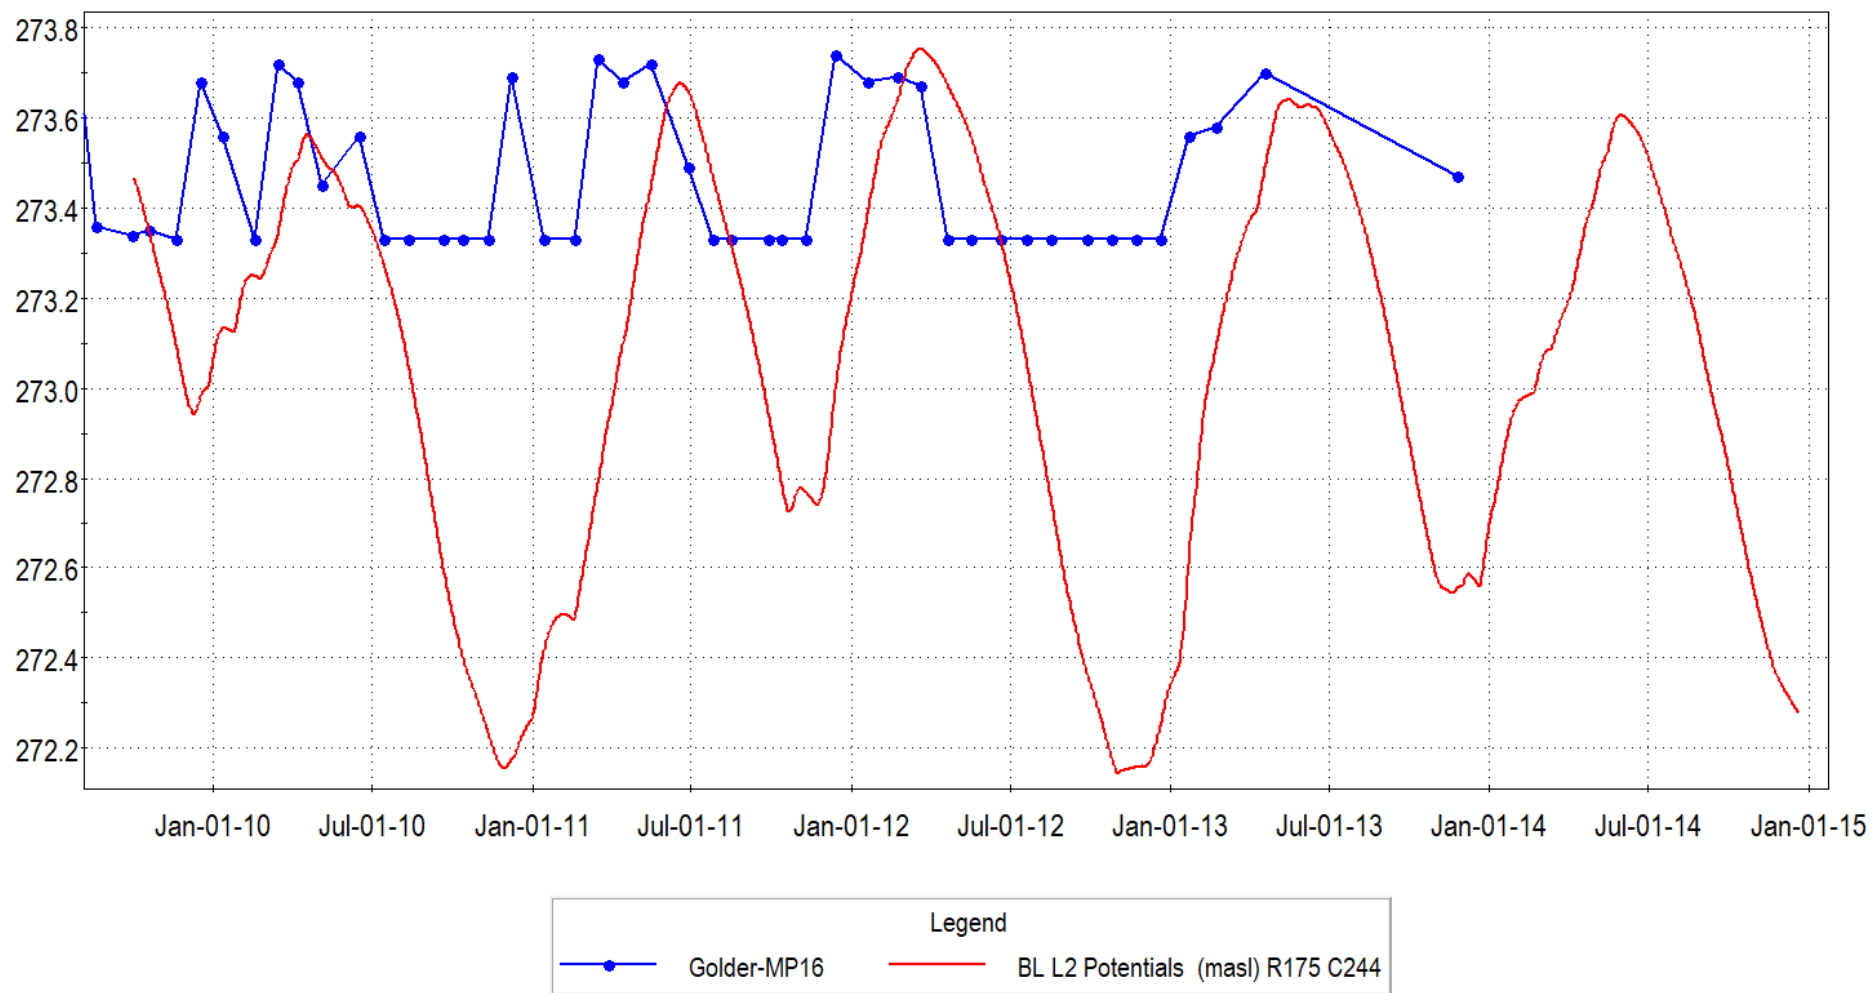
Integrated Model Calibration Wetland 13037

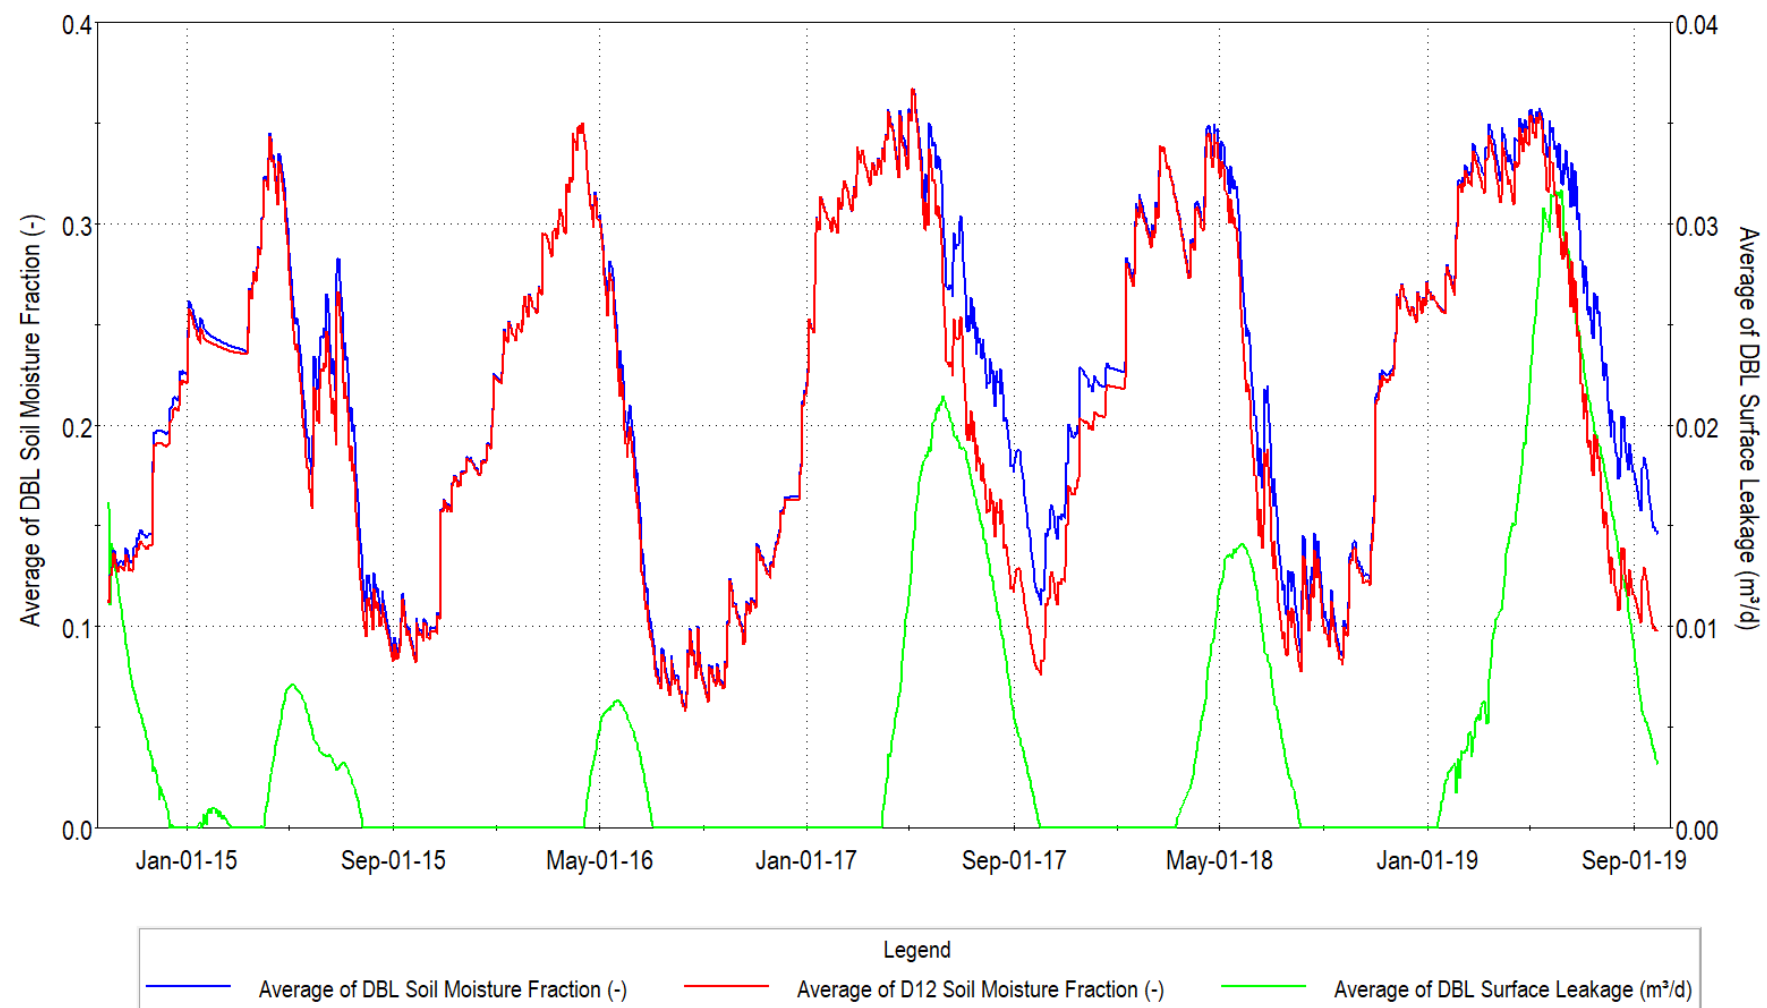
Change in Soil Moisture Conditions Wetland 13037
