Proposed Burlington Quarry Expansion
JART COMMENT SUMMARY TABLE – Natural Heritage

JART Comments (February 2021)	Reference	Source of Comment	Applicant Response (July 2021)	JART Response
Report/Date: Level 1 and Level 2 Natural Environment Technical Report, April 2020		Author: Savanta

Watercourse Characterization Summaries Proposed Burlington Quarry Extension, Nelson Aggregates Co.

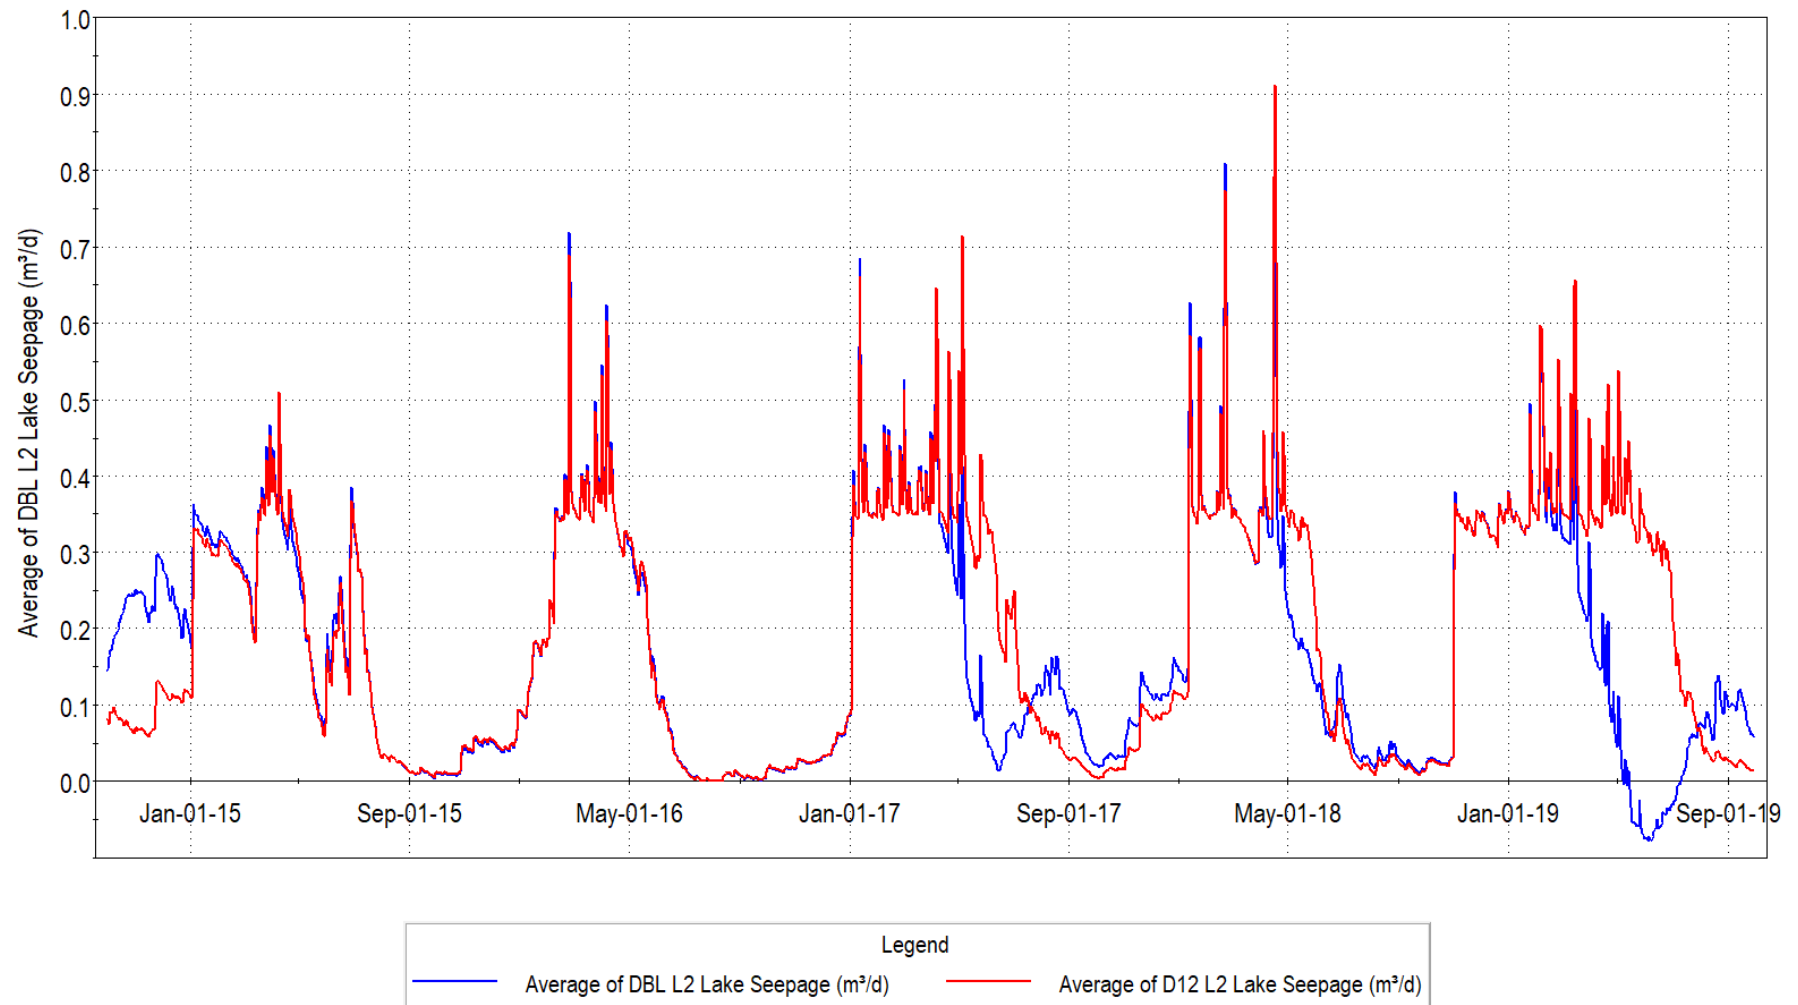
Change in Soil Moisture Conditions Wetland 13037

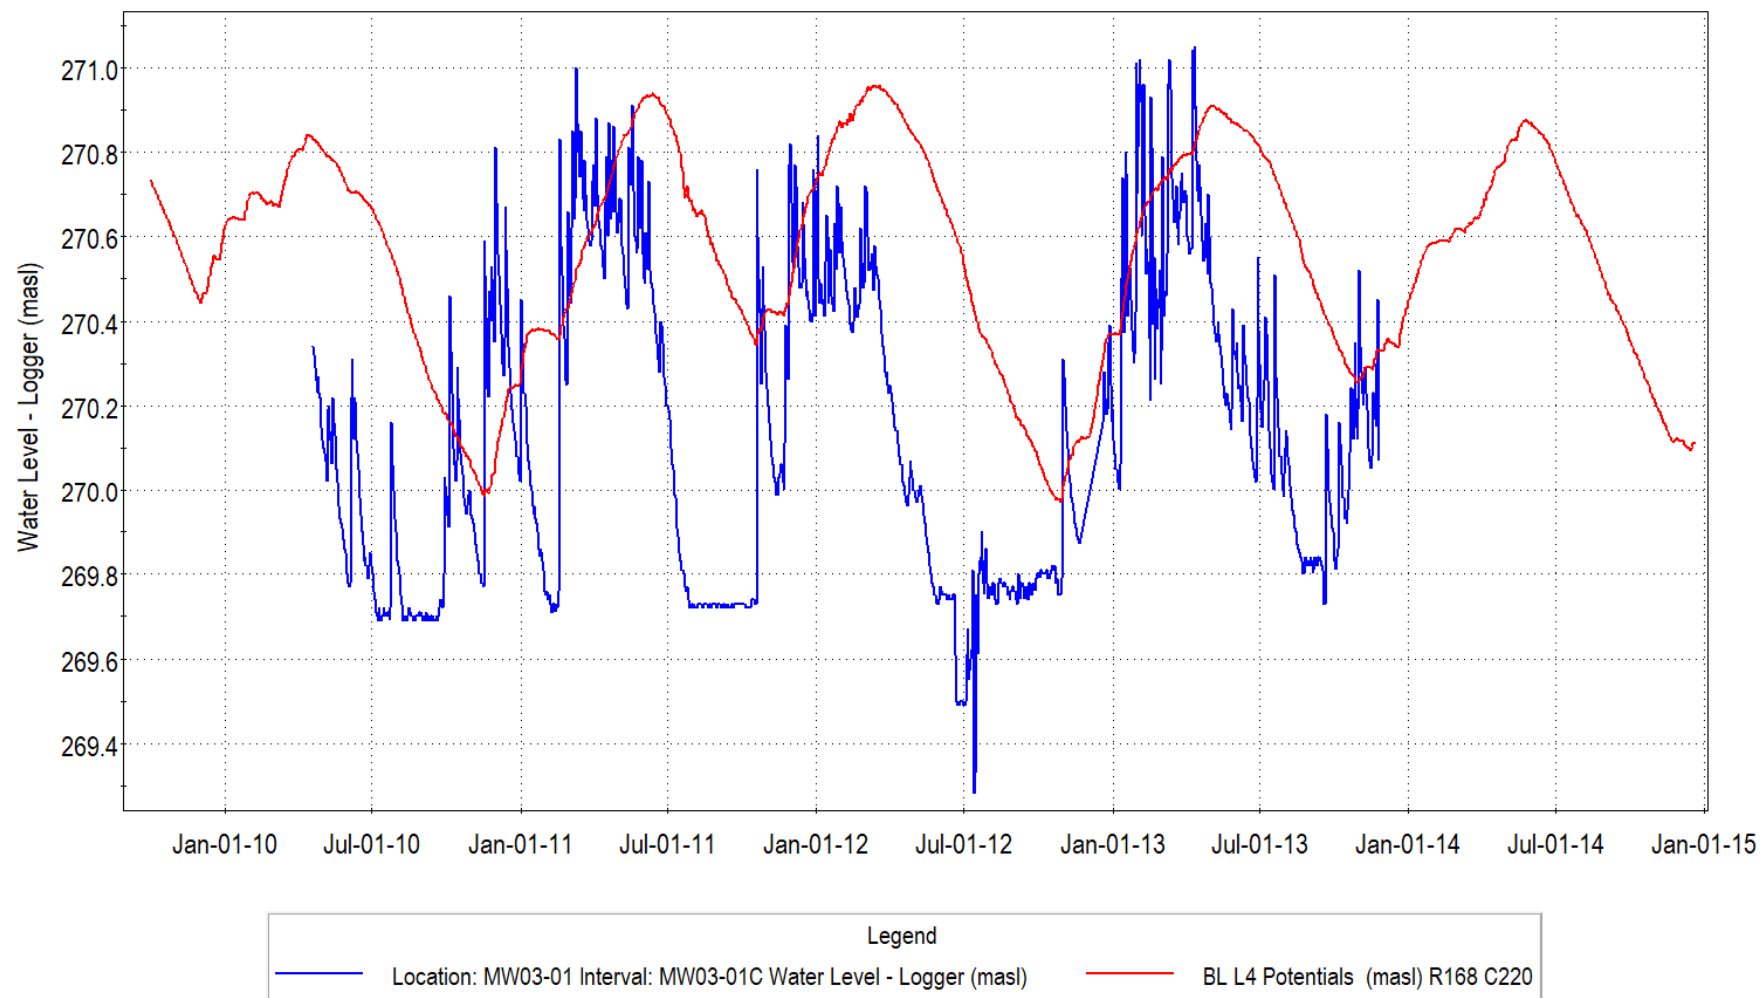
Integrated Model Calibration Wetland 13203

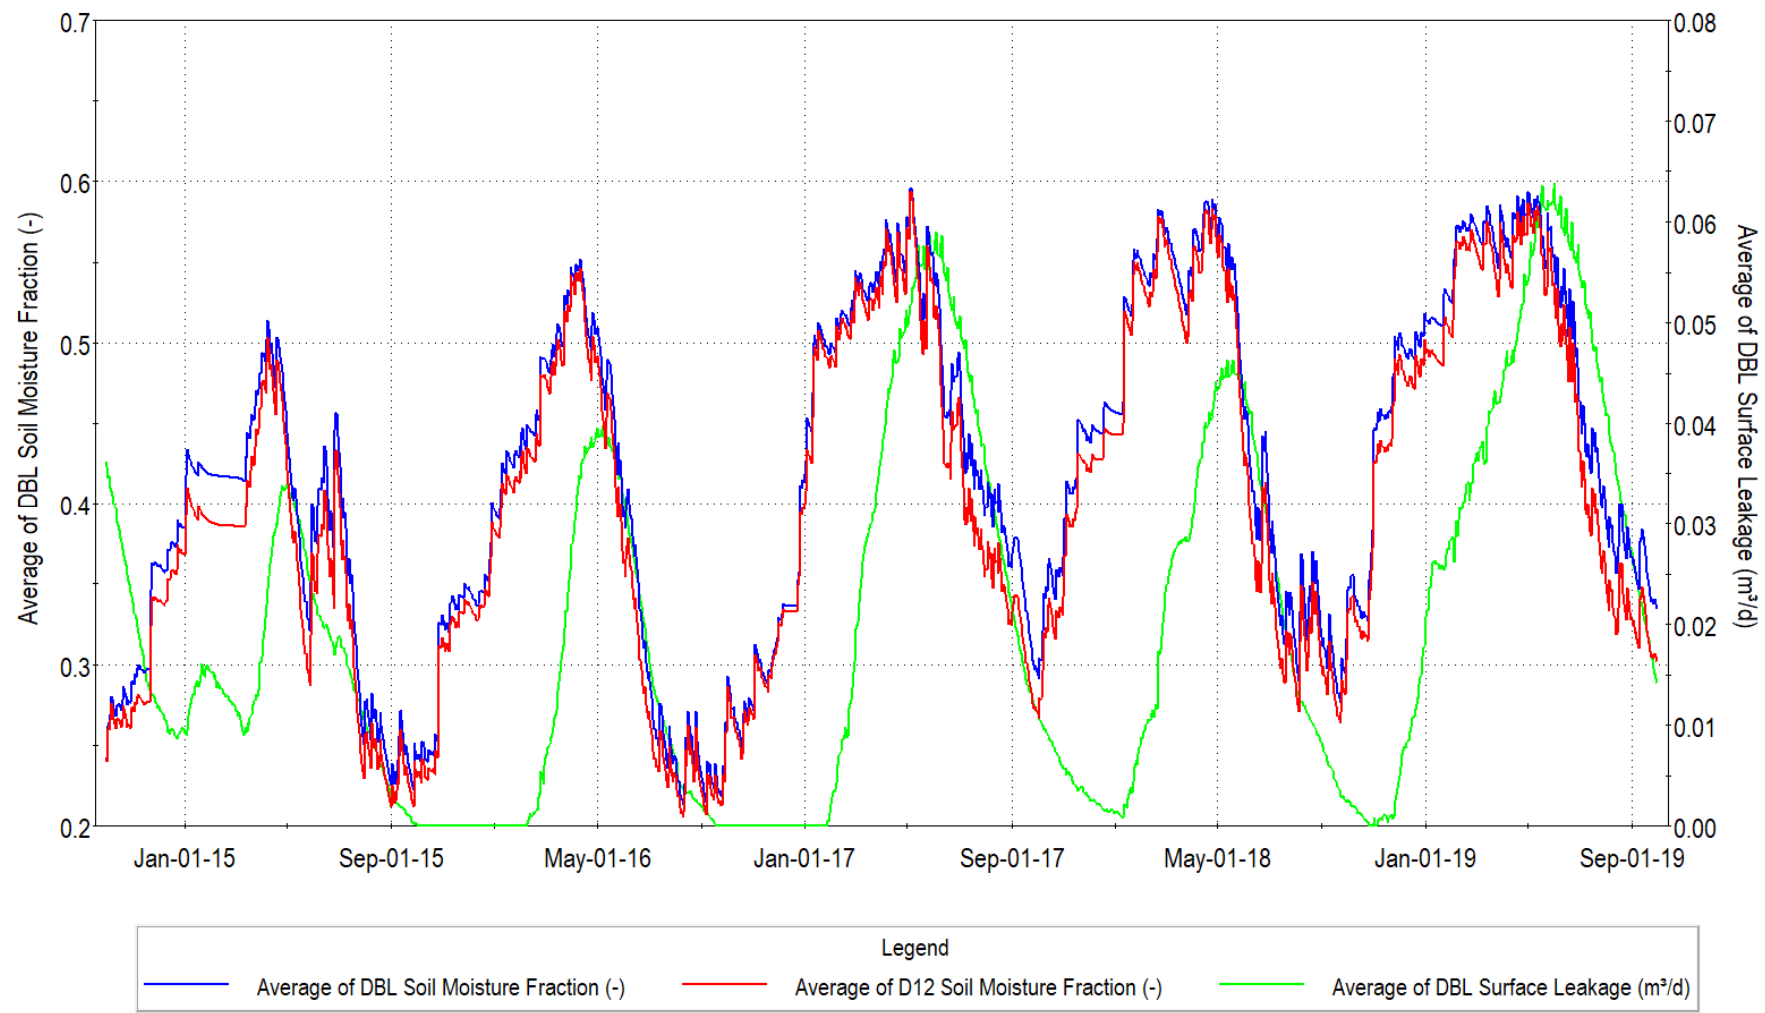
Change in Soil Moisture Conditions
Wetland 13203

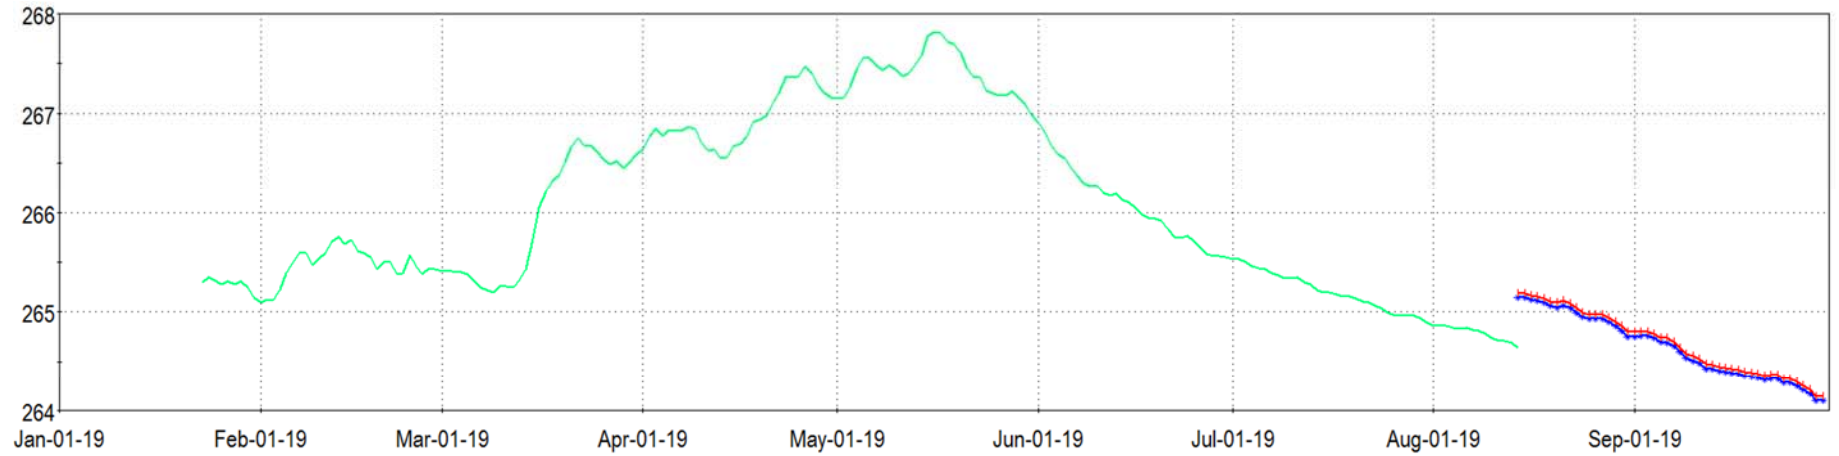
Groundwater Hydrographs Wetland 13200

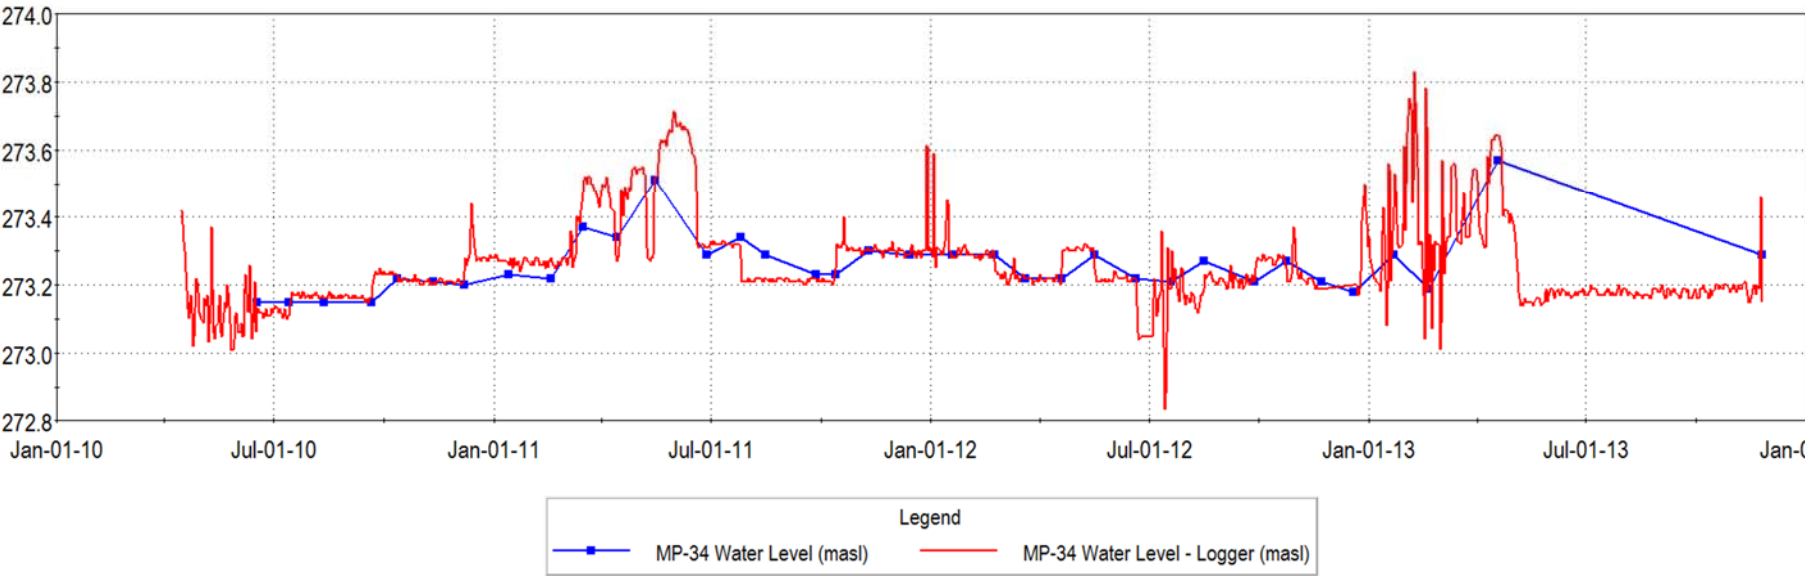
Groundwater Hydrographs
Wetland 13201

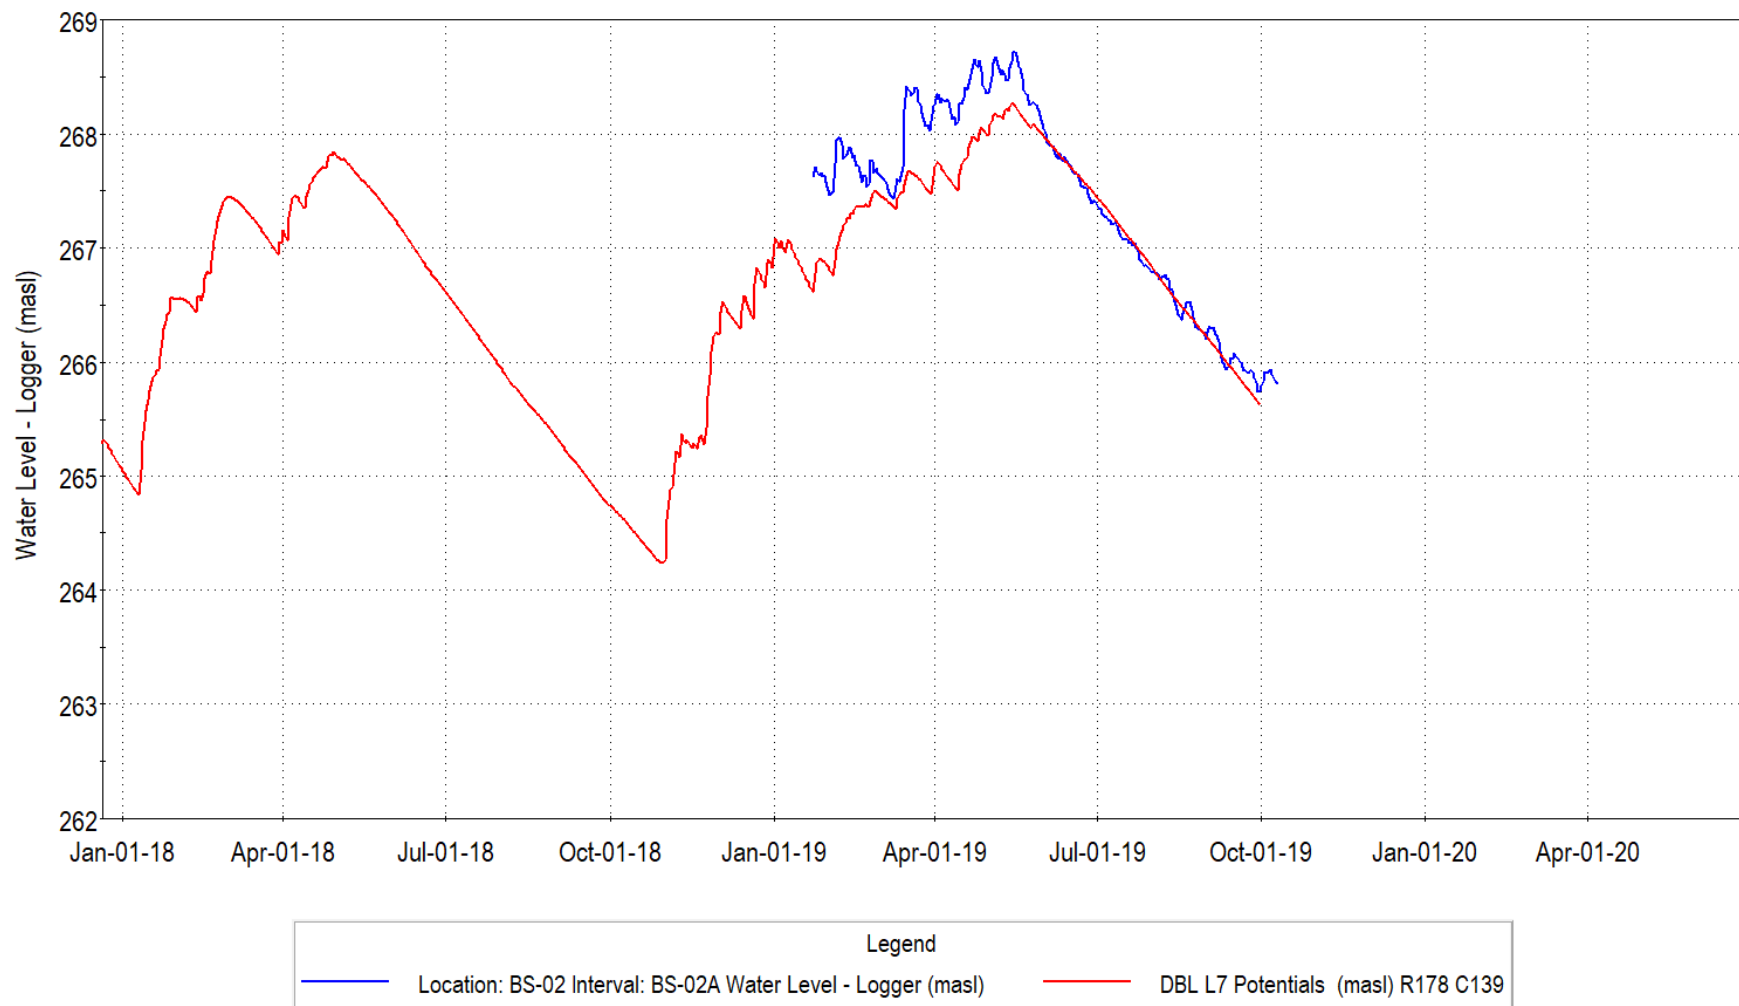
Integrated Model Calibration Wetland 13201

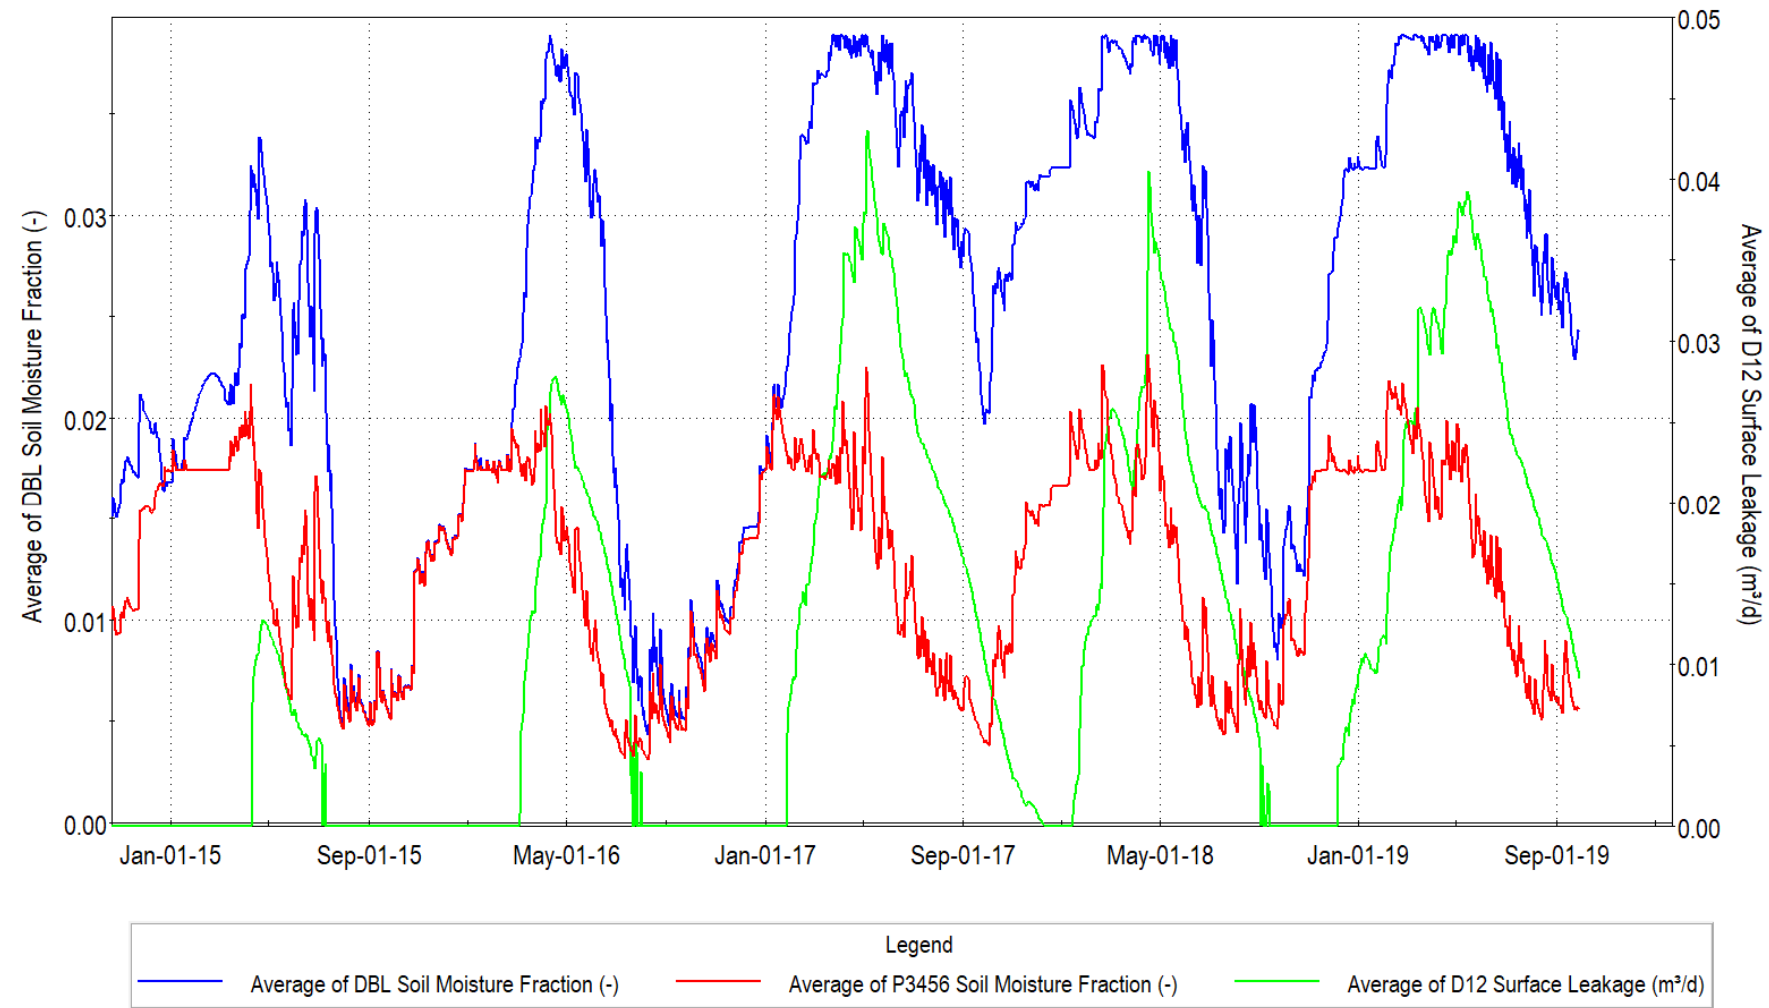
Change in Soil Moisture Conditions
Wetland 13201

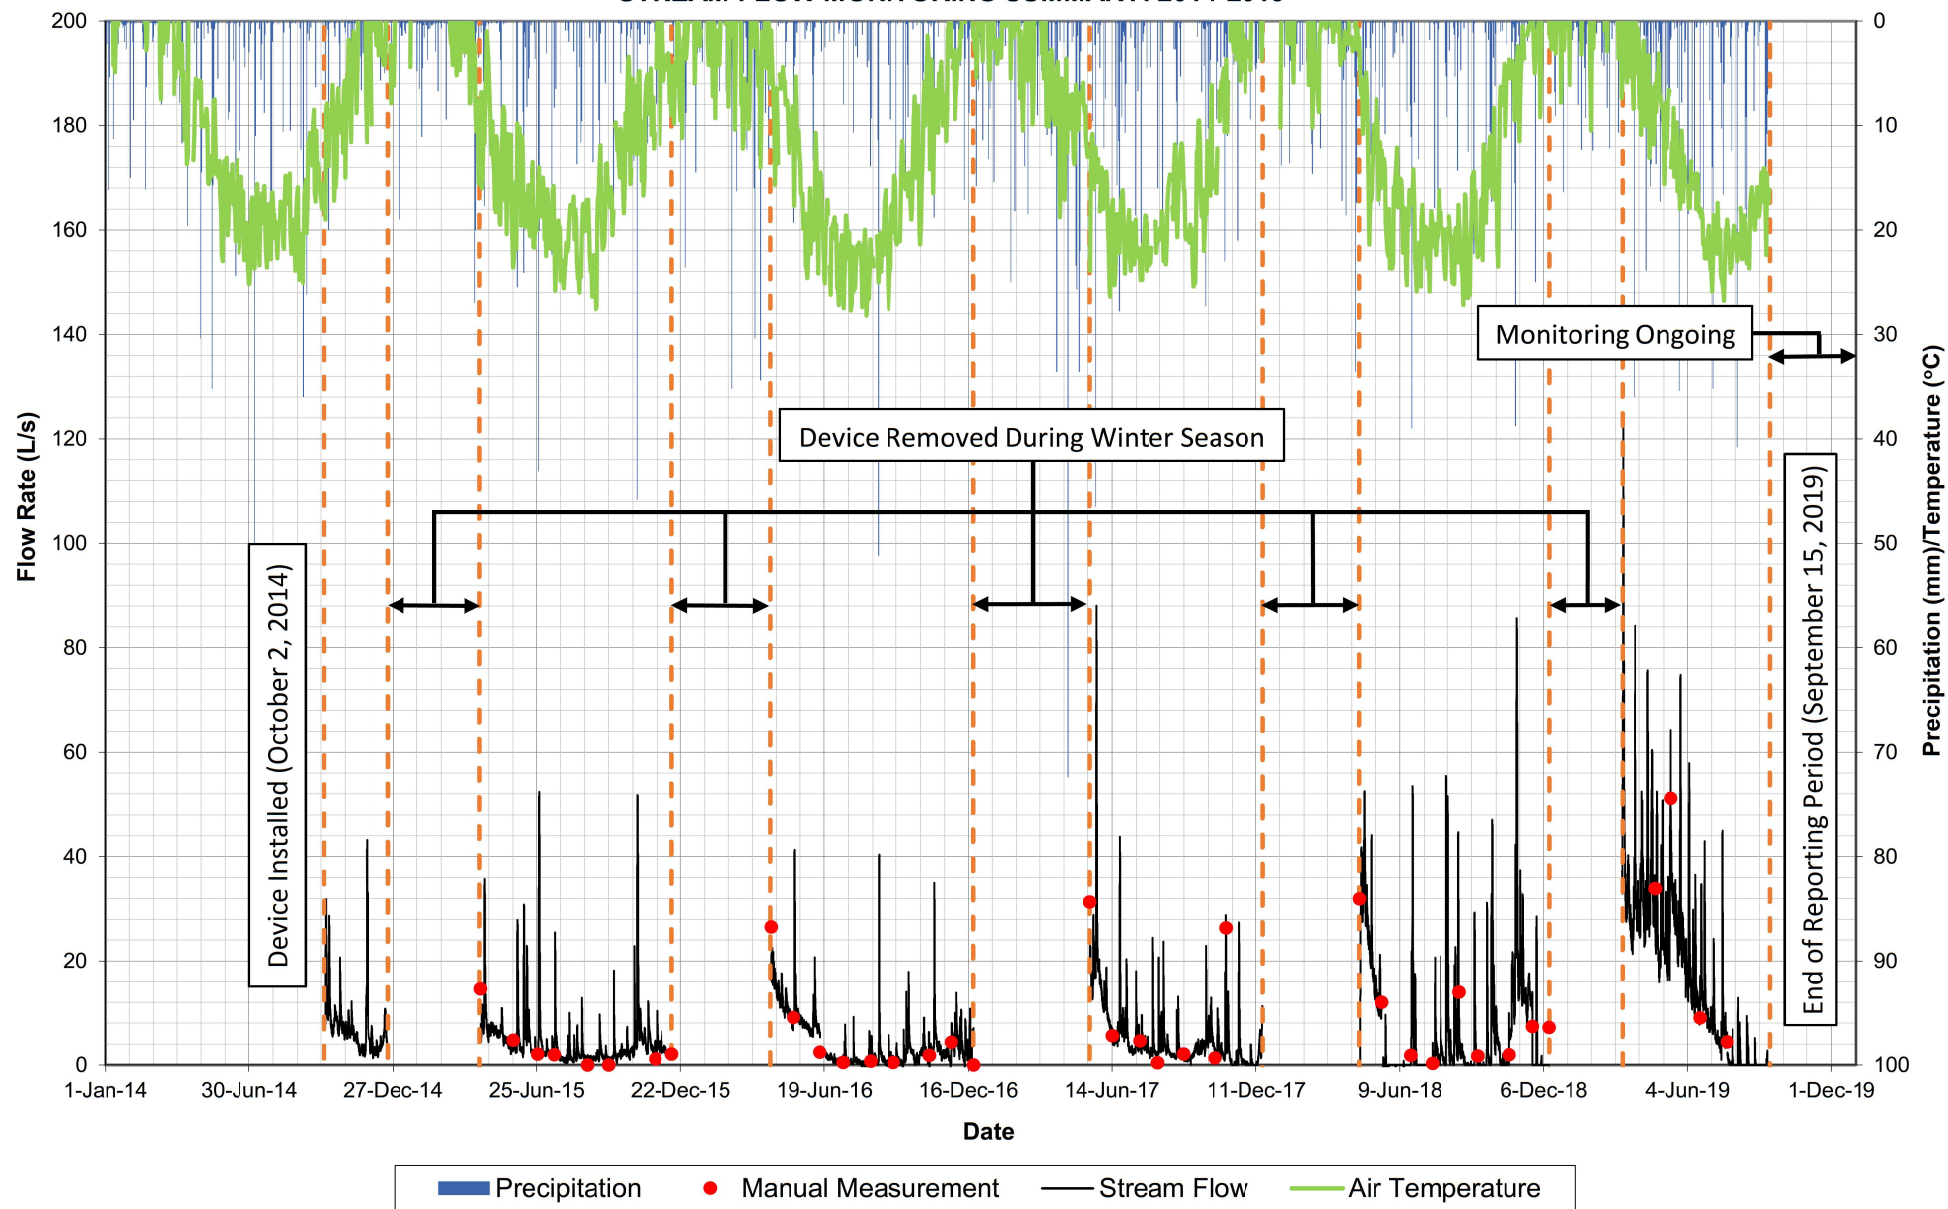
**BURLINGTON QUARRY
MONITORING LOCATION SW14
STREAM FLOW MONITORING SUMMARY: 2014-2019**

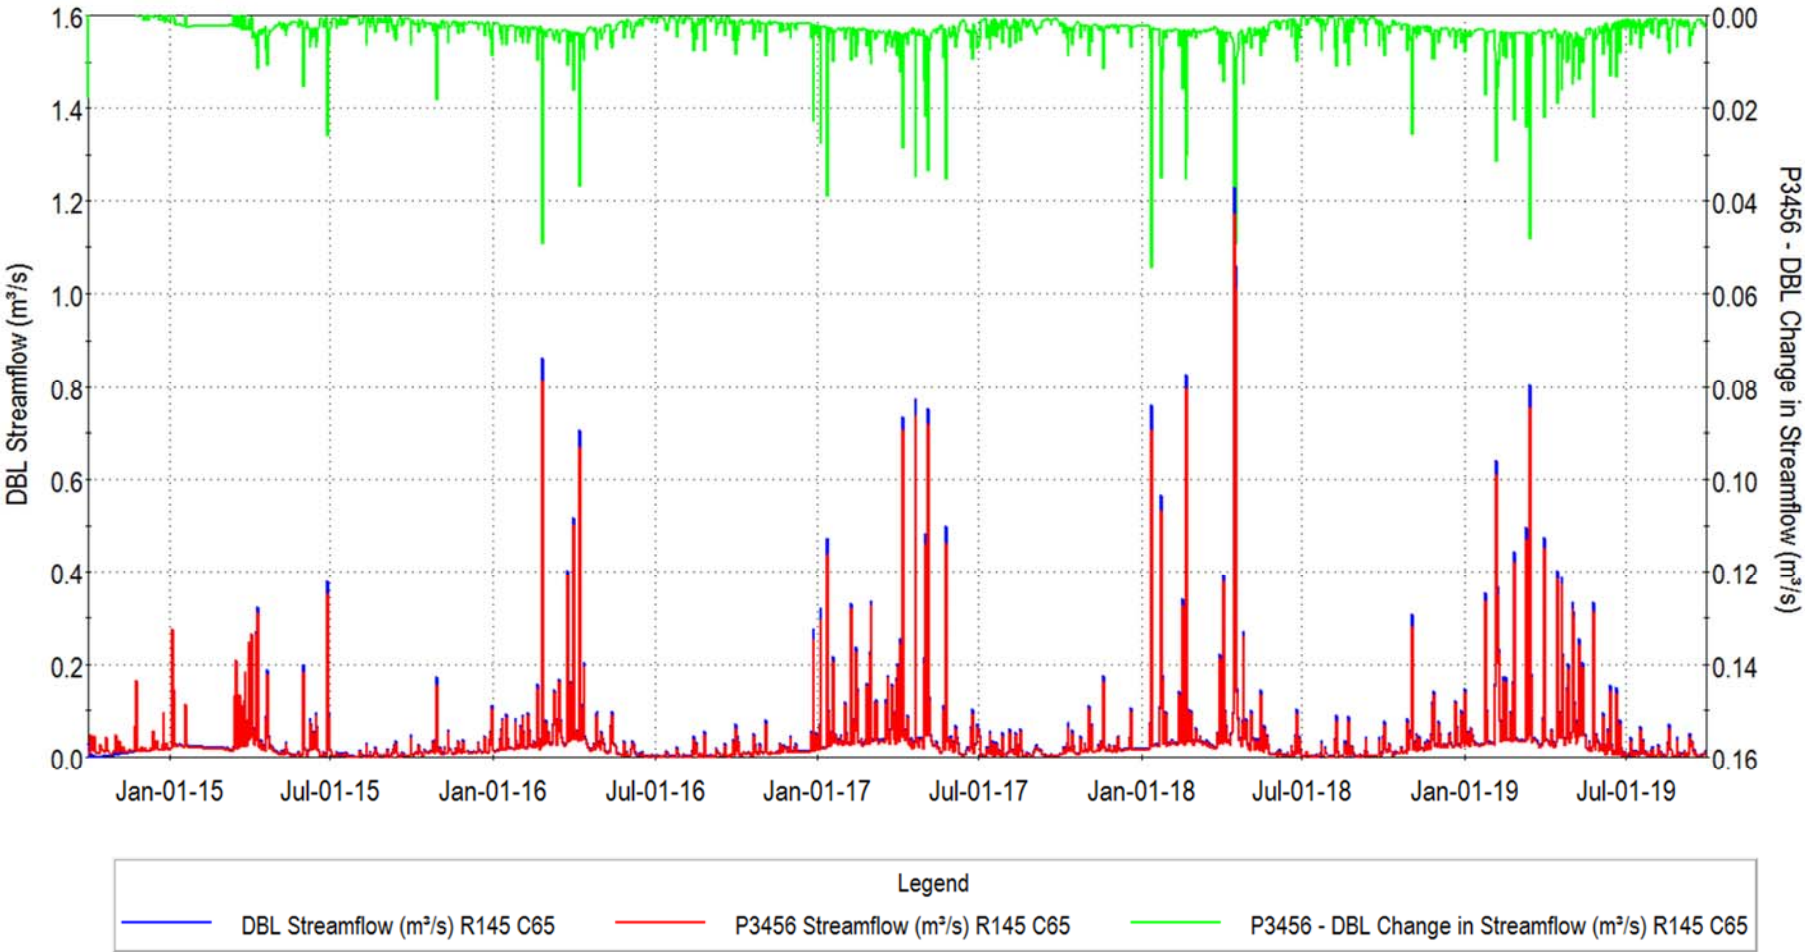
Change in Water Budget
Wetland 13204

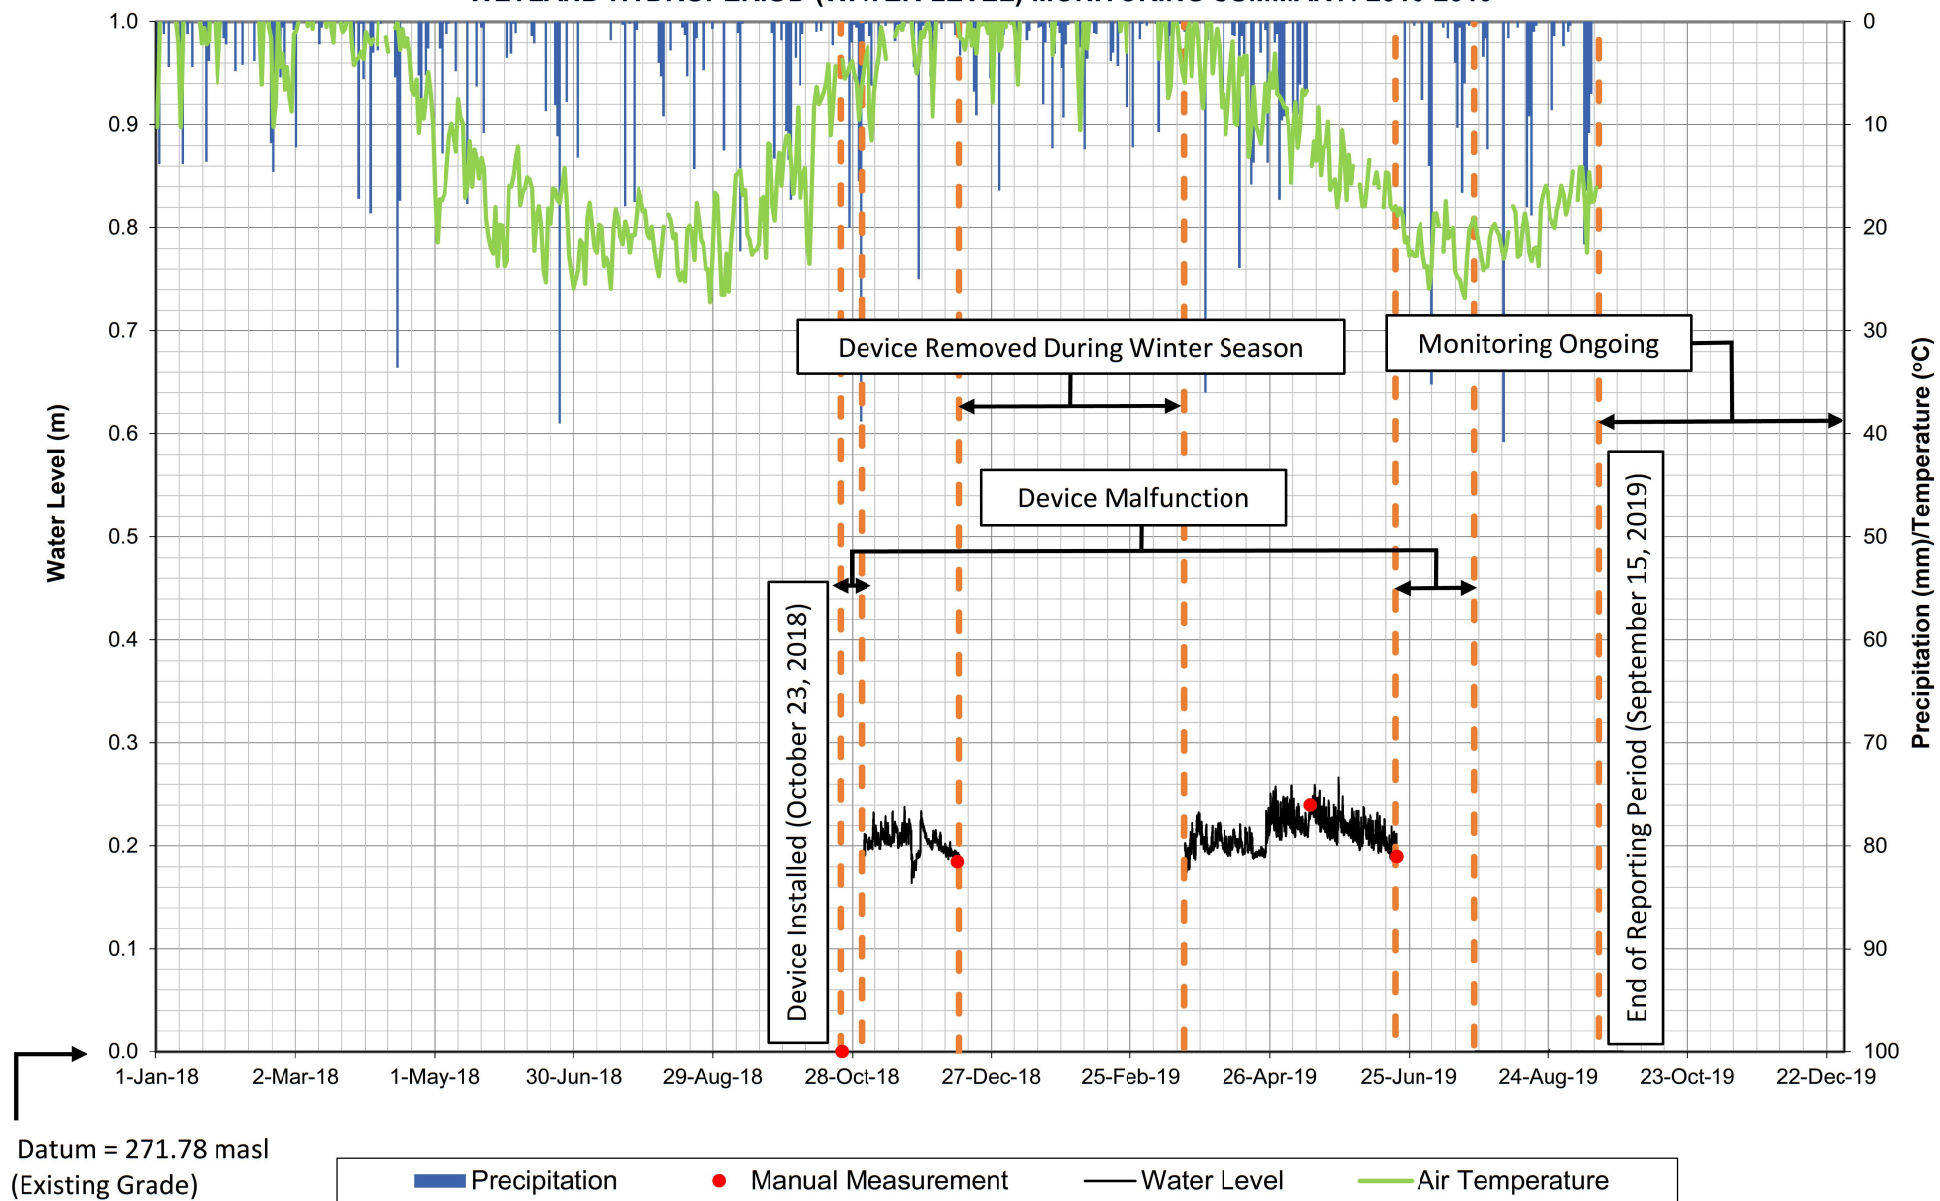
BURLINGTON QUARRY MONITORING LOCATION SW16A WETLAND HYDROPERIOD (WATER LEVEL) MONITORING SUMMARY: 2018-2019

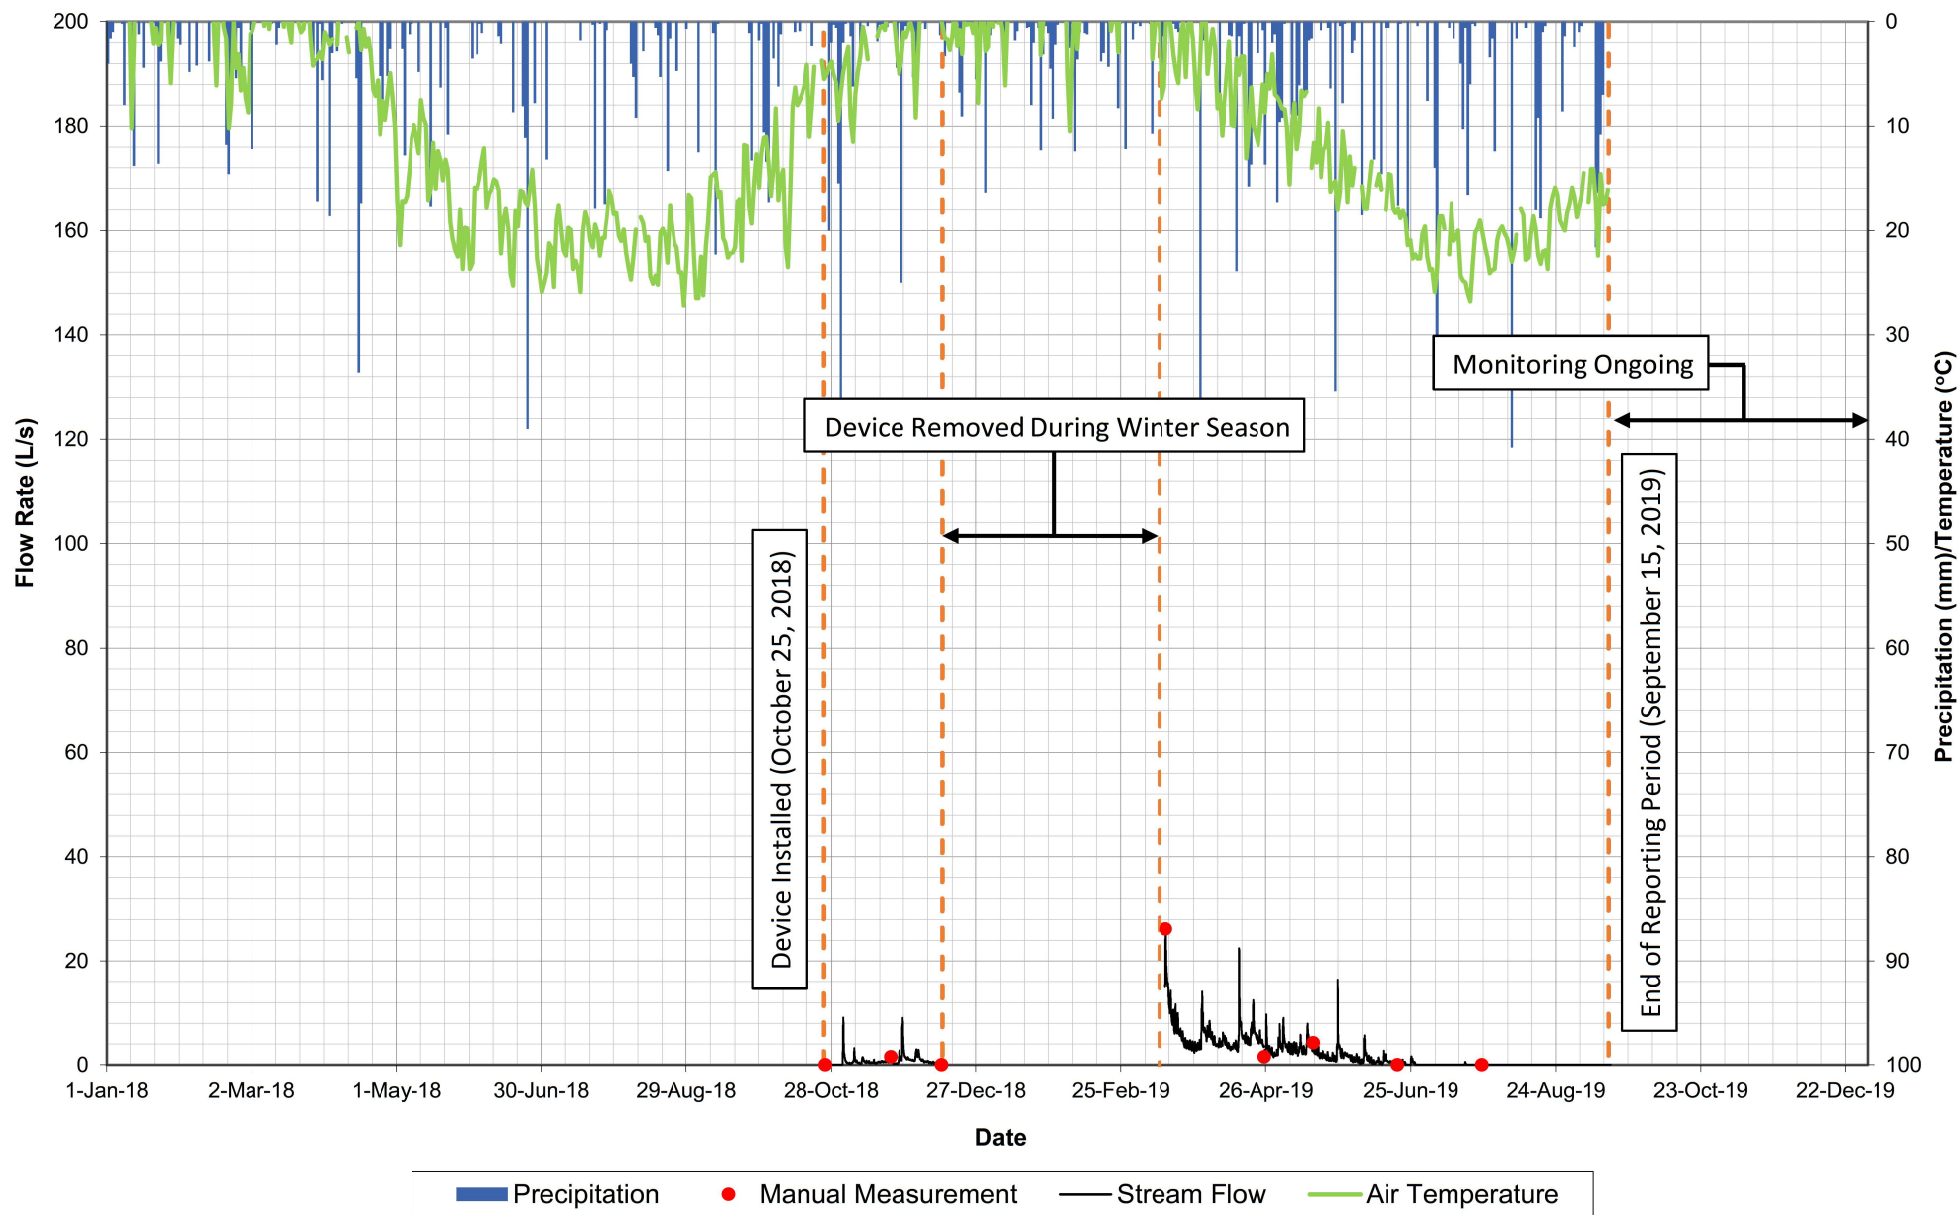
**BURLINGTON QUARRY
MONITORING LOCATION SW29
STREAM FLOW MONITORING SUMMARY: 2018-2019**

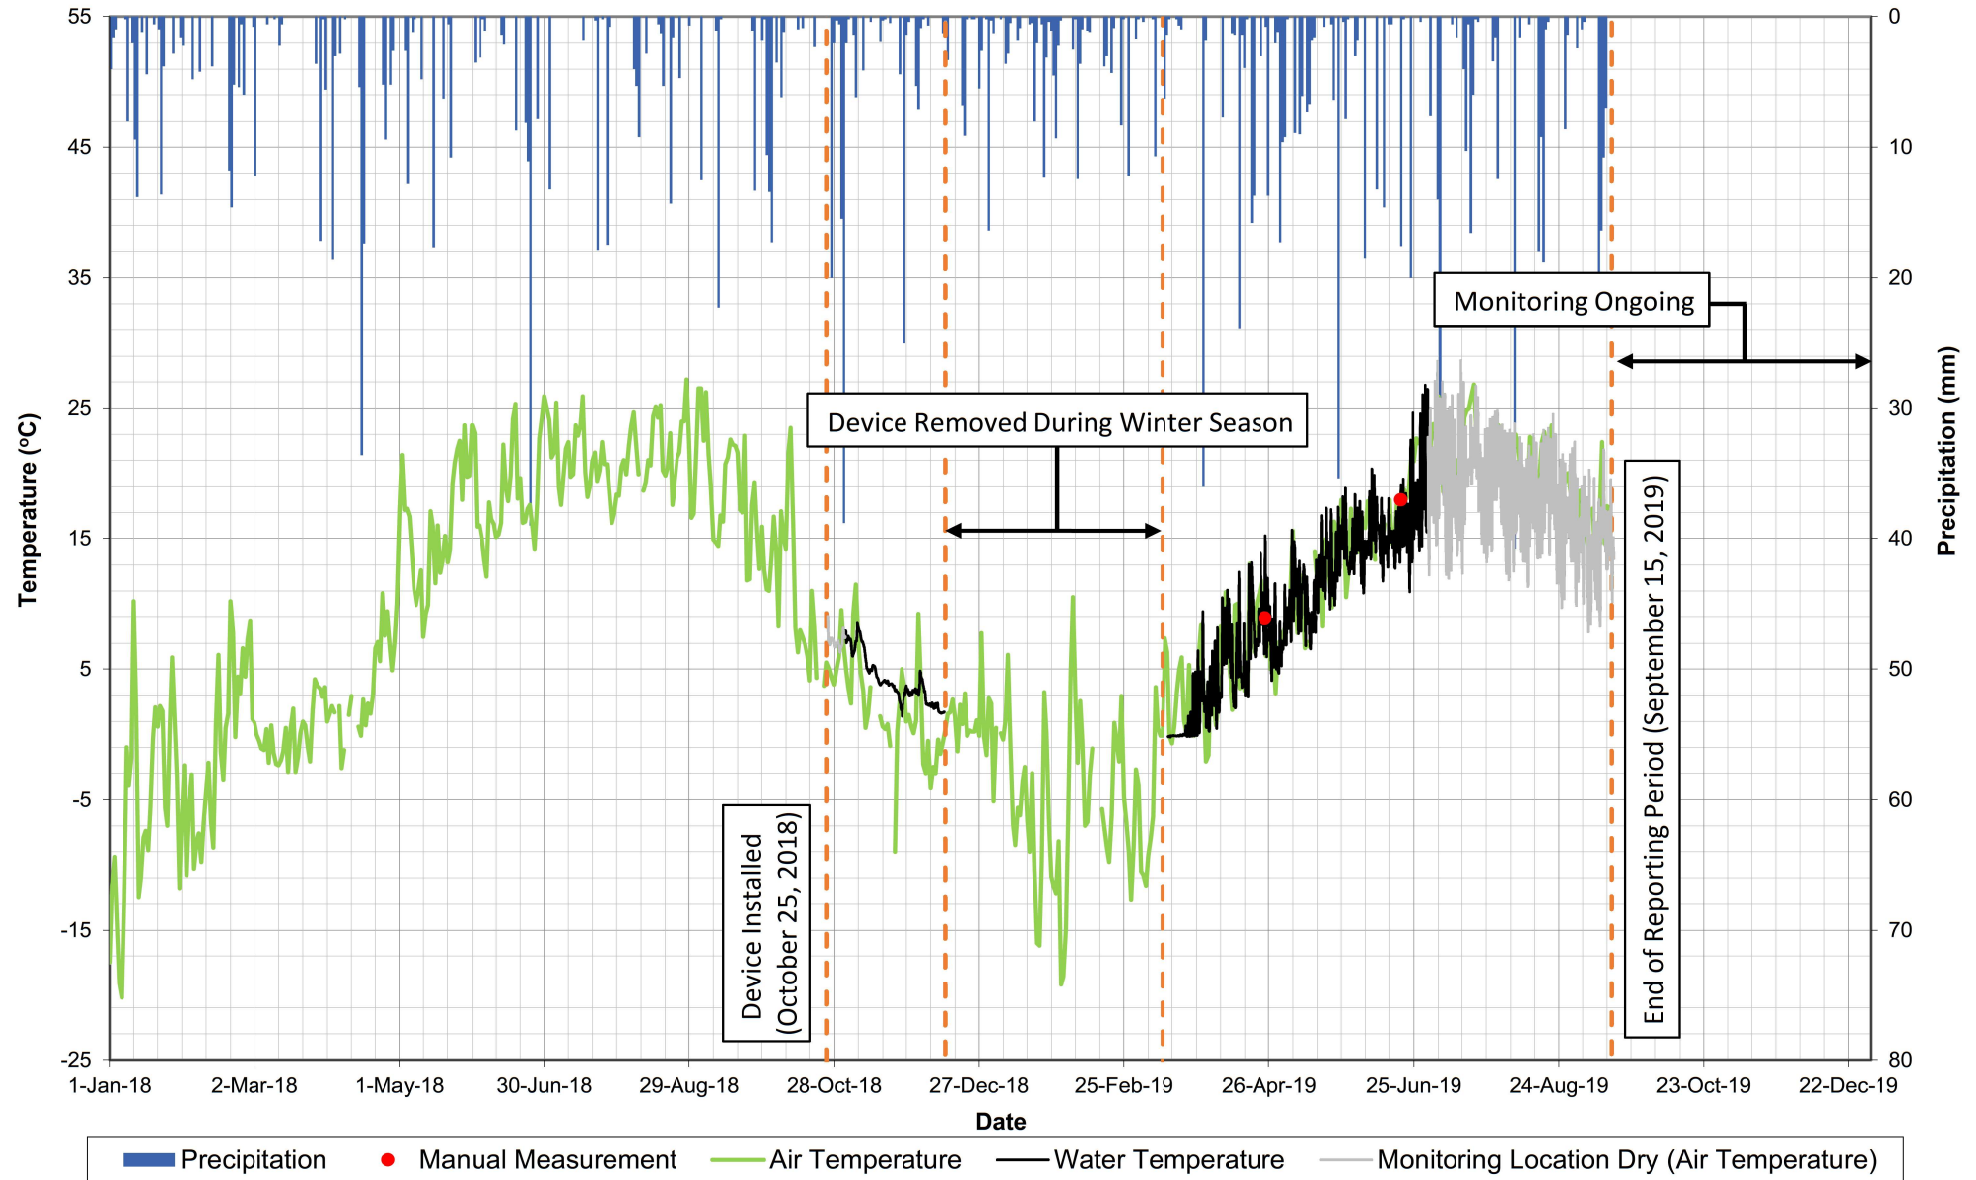
BURLINGTON QUARRY
MONITORING LOCATION SW29
STREAM TEMPERATURE MONITORING SUMMARY: 2018-2019

* Grey data indicates the monitoring location was dry and therefore the recorded values are representative of the air temperature.
