Proposed Burlington Quarry Expansion
JART COMMENT SUMMARY TABLE – Natural Heritage

JART Comments (February 2021)	Reference	Source of Comment	Applicant Response (July 2021)	JART Response
Report/Date: Level 1 and Level 2 Natural Environment Technical Report, April 2020		Author: Savanta

Watercourse Characterization Summaries Proposed Burlington Quarry Extension, Nelson Aggregates Co.

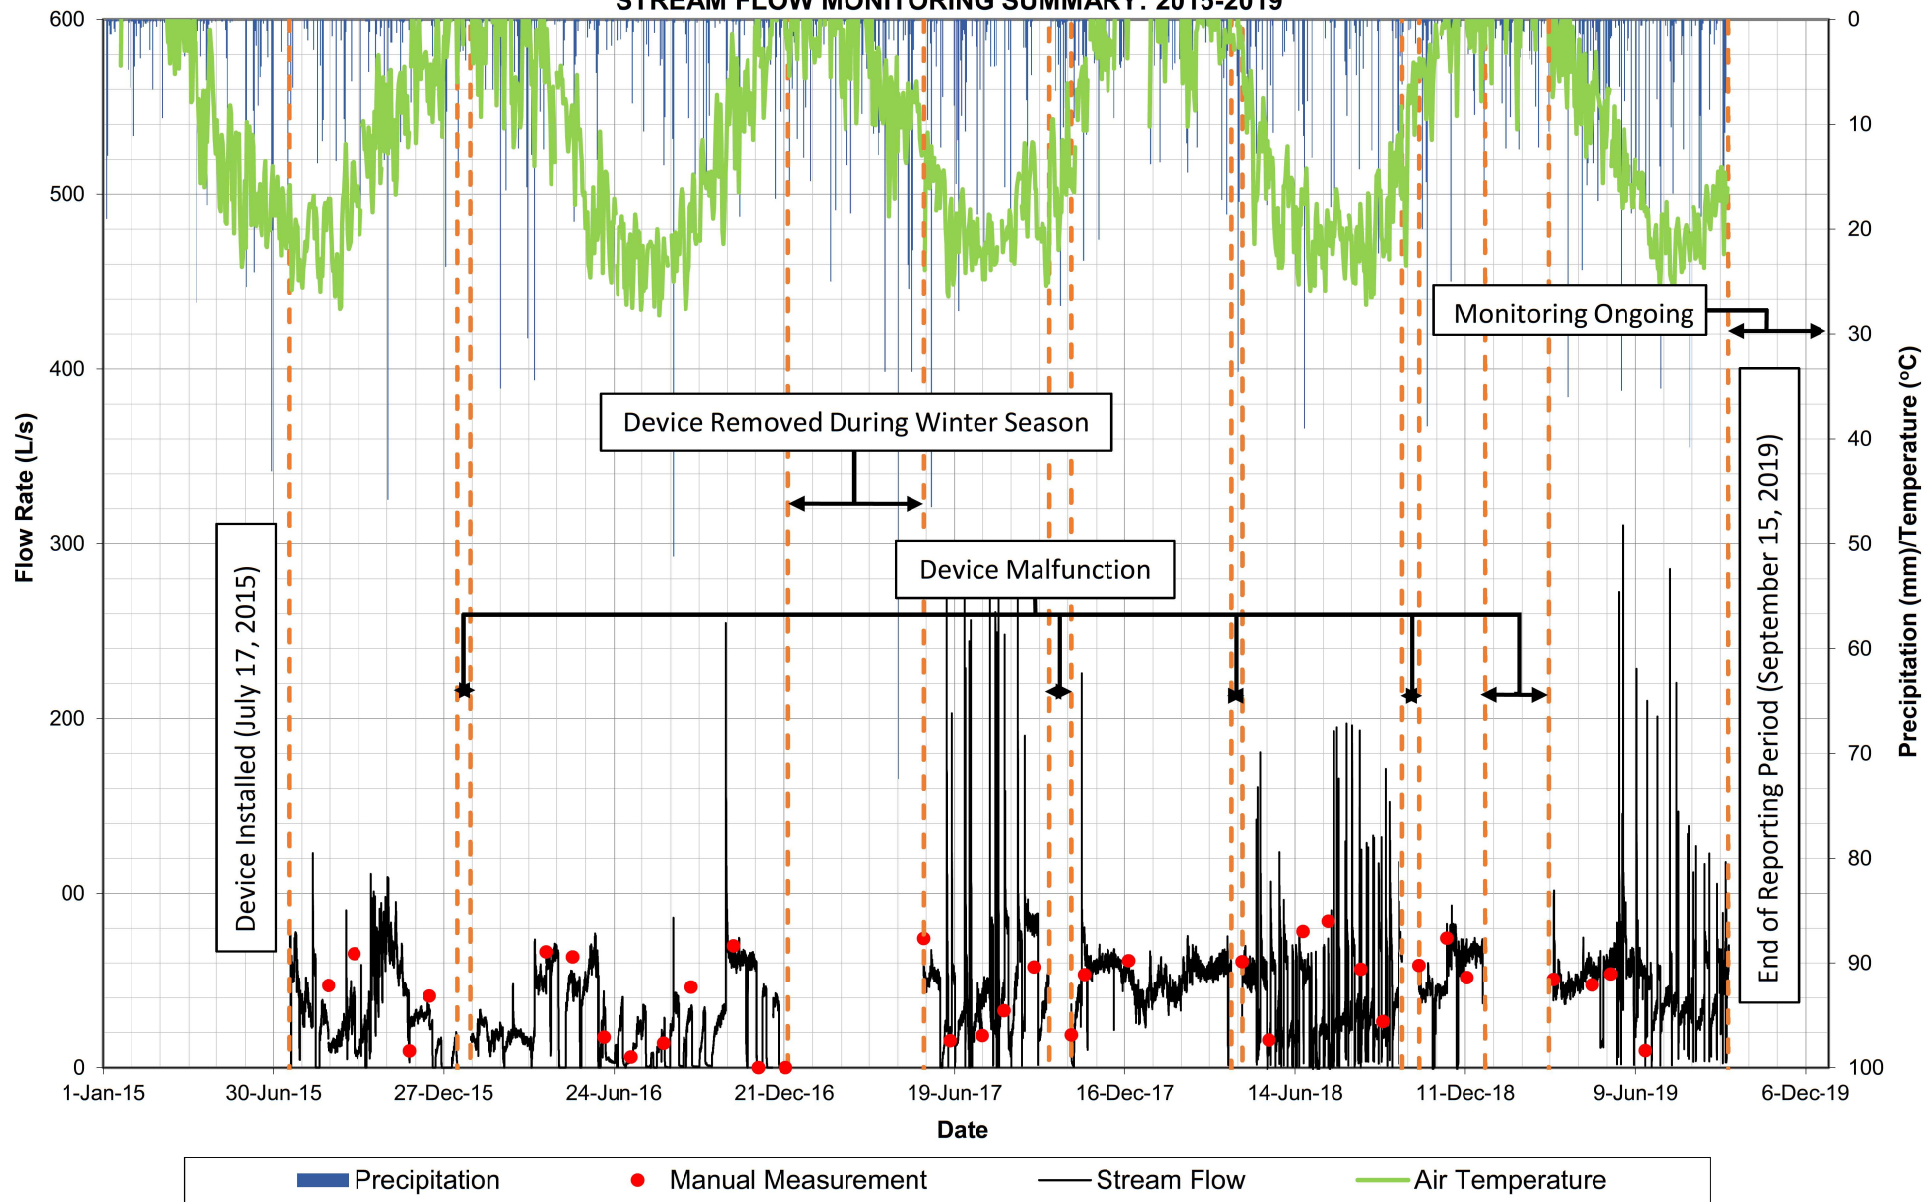
BURLINGTON QUARRY MONITORING LOCATION SW1 STREAM FLOW MONITORING SUMMARY: 2015-2019

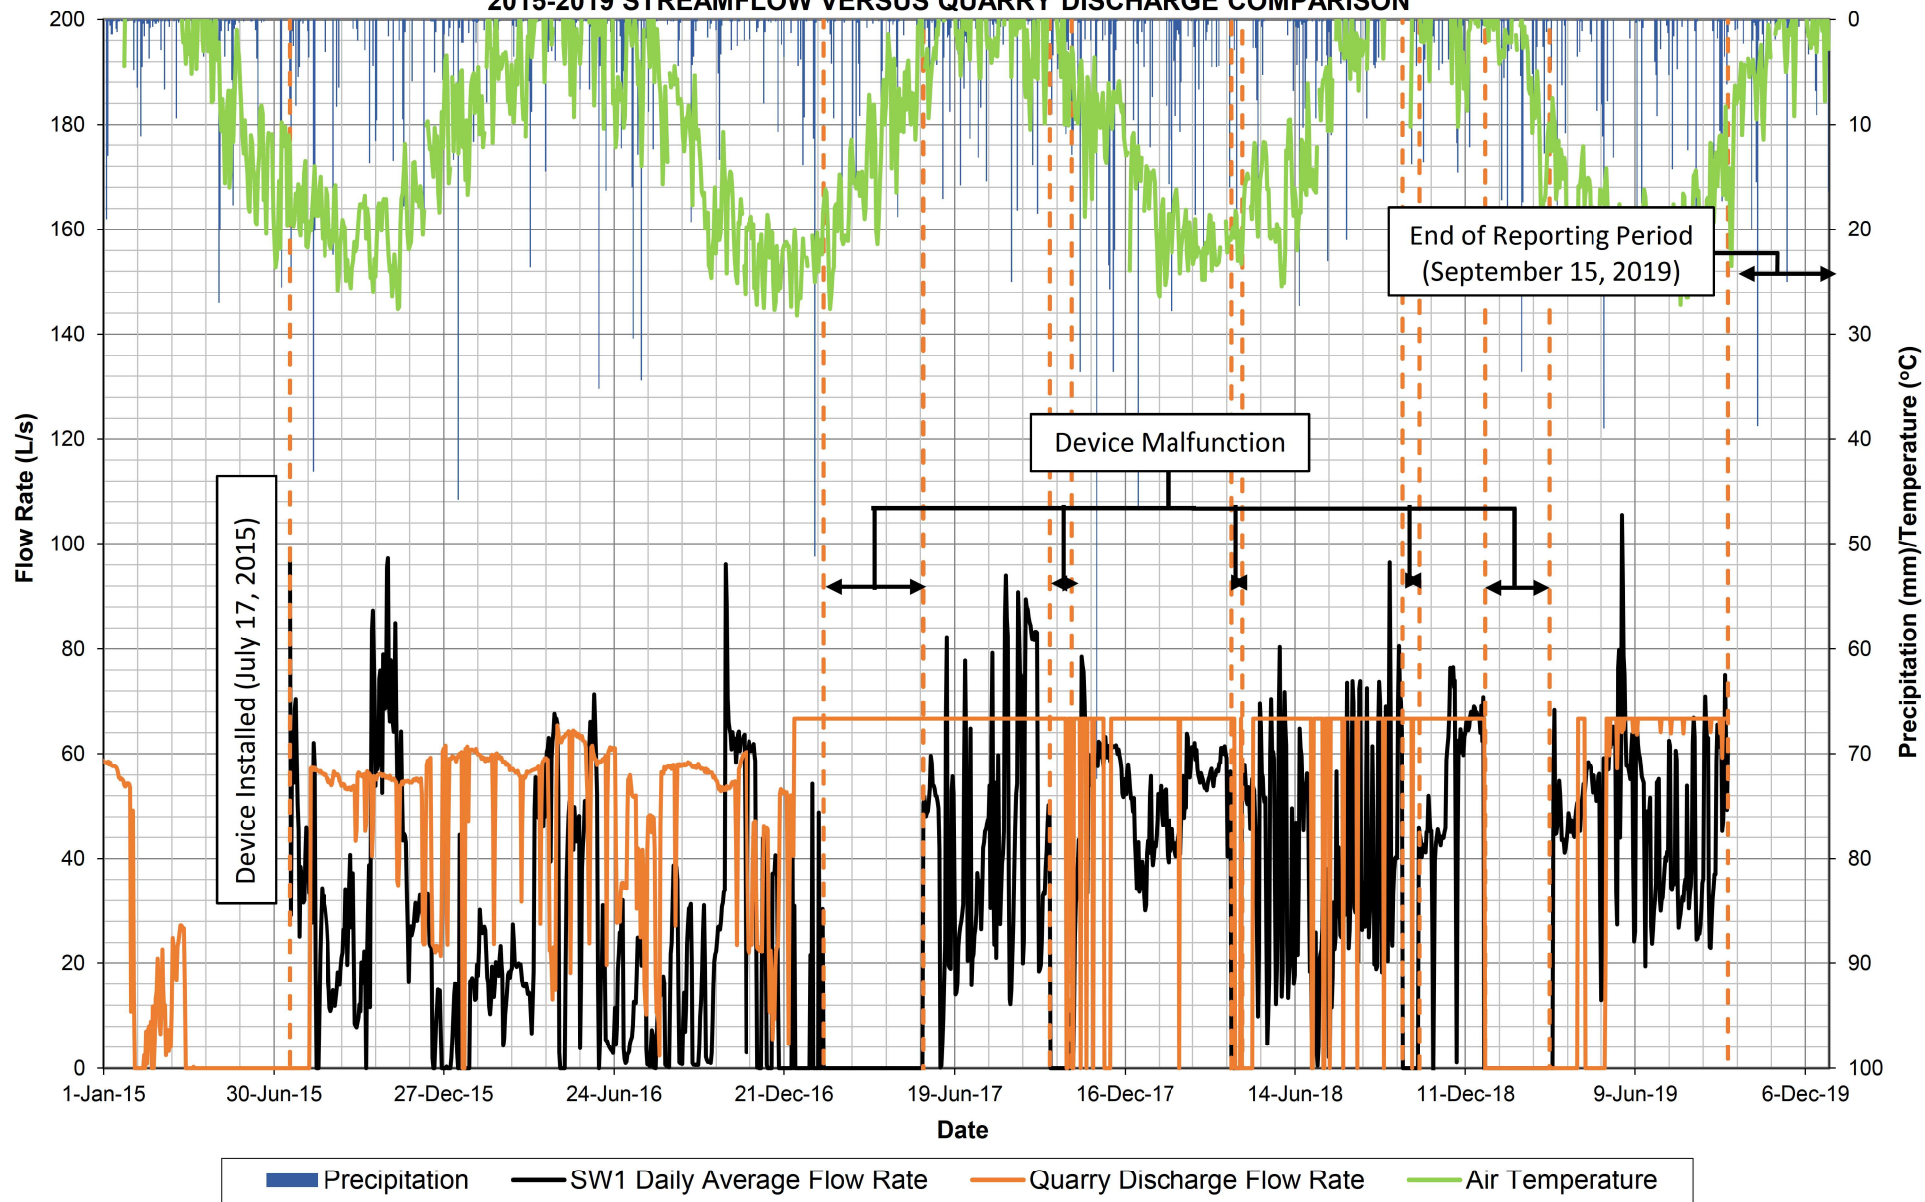
TRIBUTARY OF WILLOUGHBY CREEK - GRAPH 2

BURLINGTON QUARRY MONITORING LOCATION SW1 2015-2019 STREAMFLOW VERSUS QUARRY DISCHARGE COMPARISON

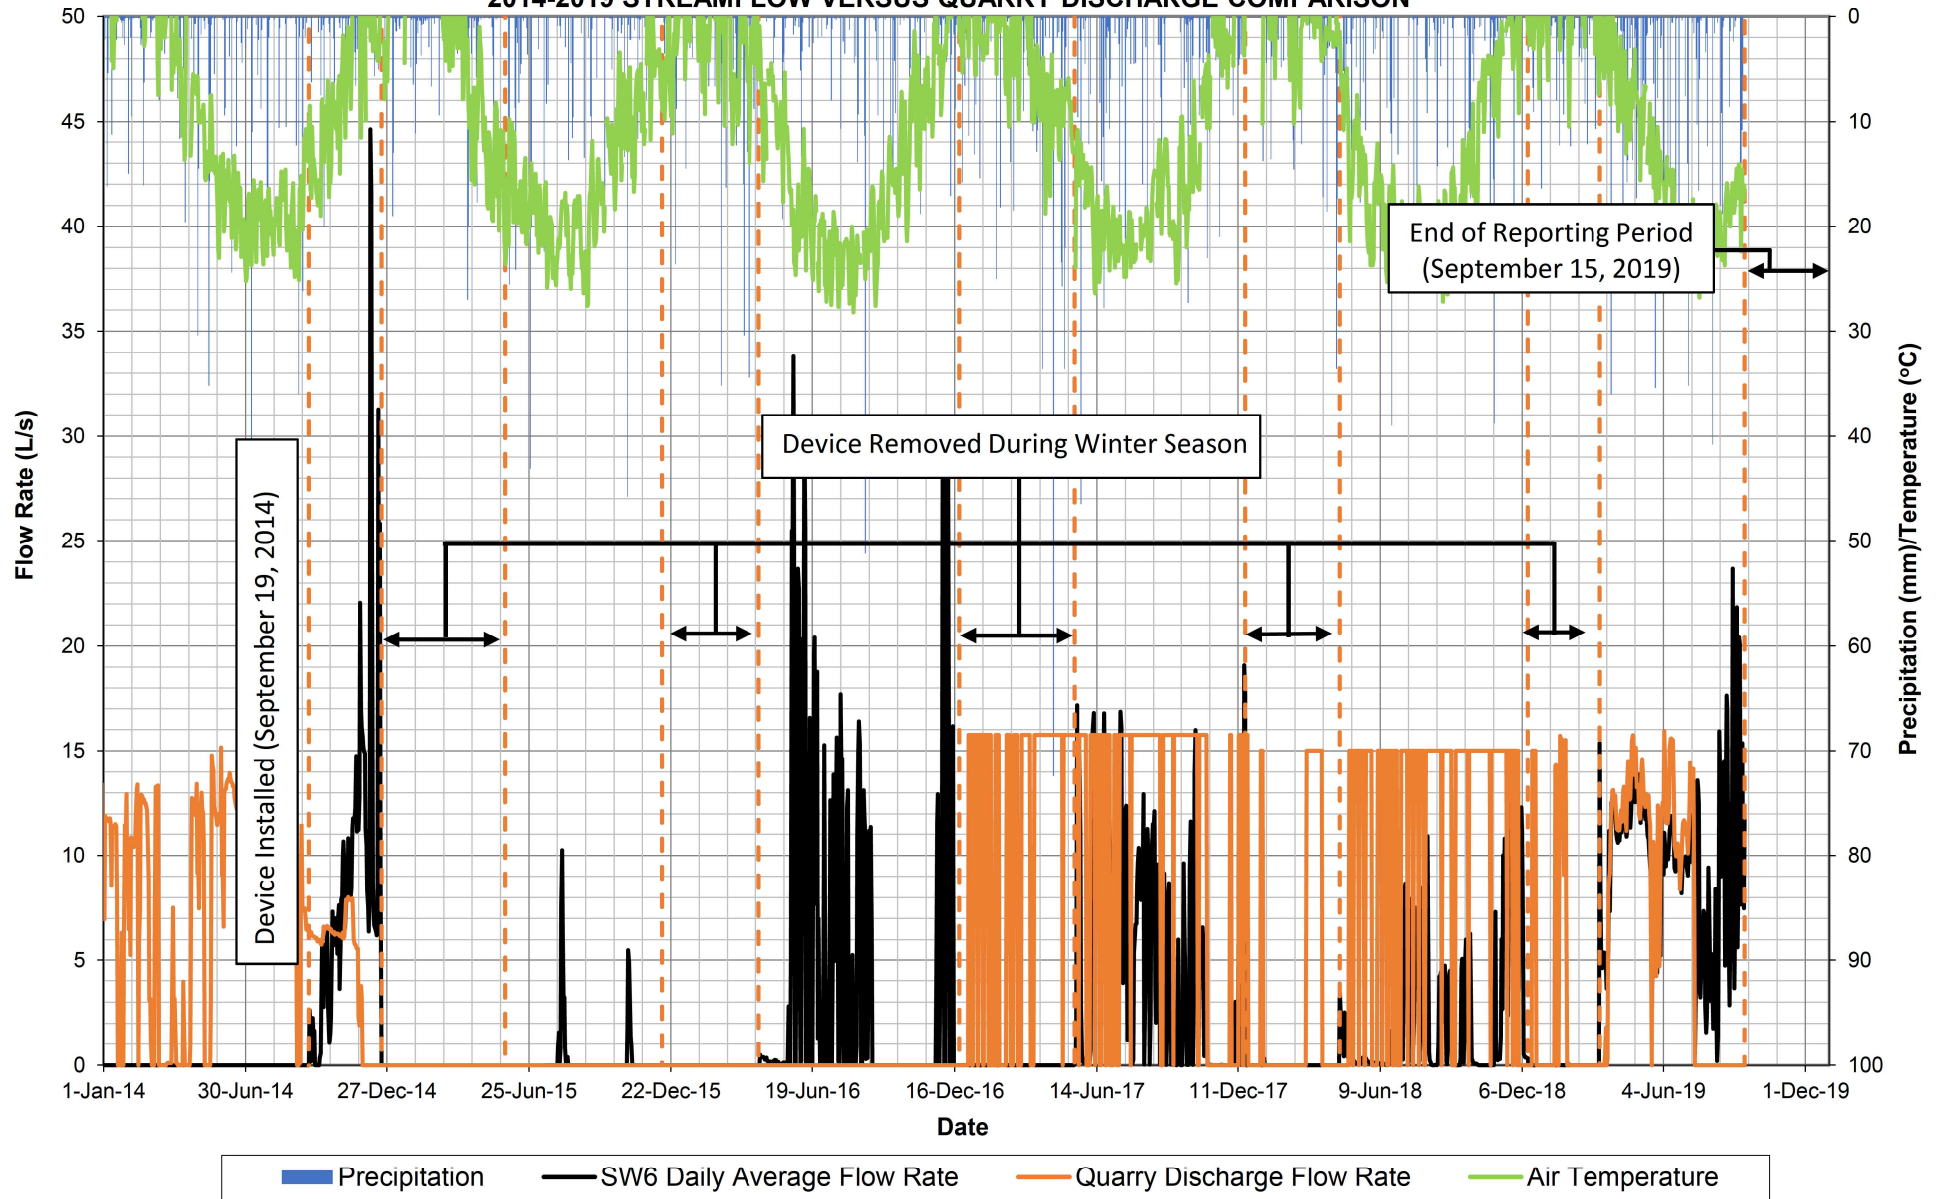
BURLINGTON QUARRY MONITORING LOCATION SW6 2014-2019 STREAMFLOW VERSUS QUARRY DISCHARGE COMPARISON

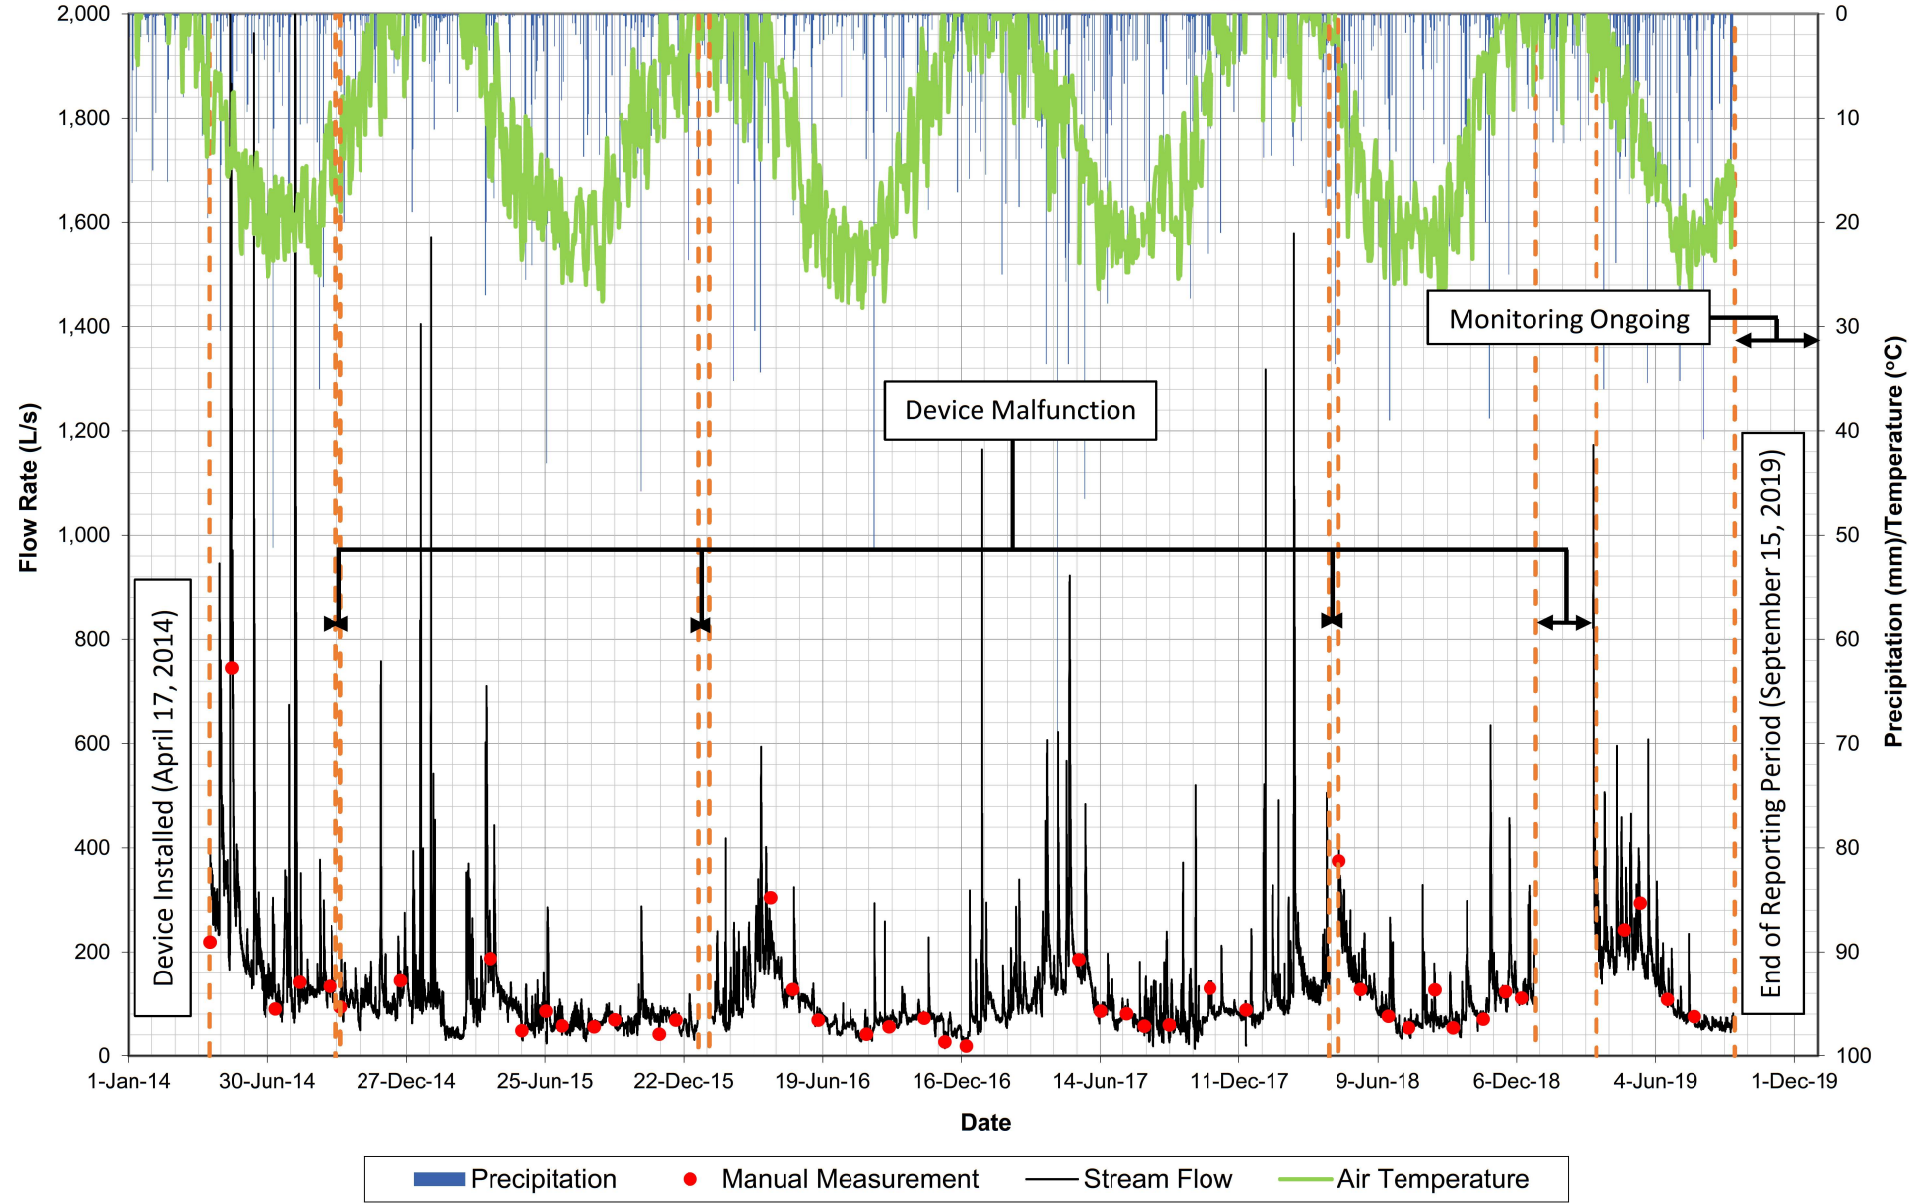
BURLINGTON QUARRY
MONITORING LOCATION SW2
STREAM FLOW MONITORING SUMMARY: 2014-2019

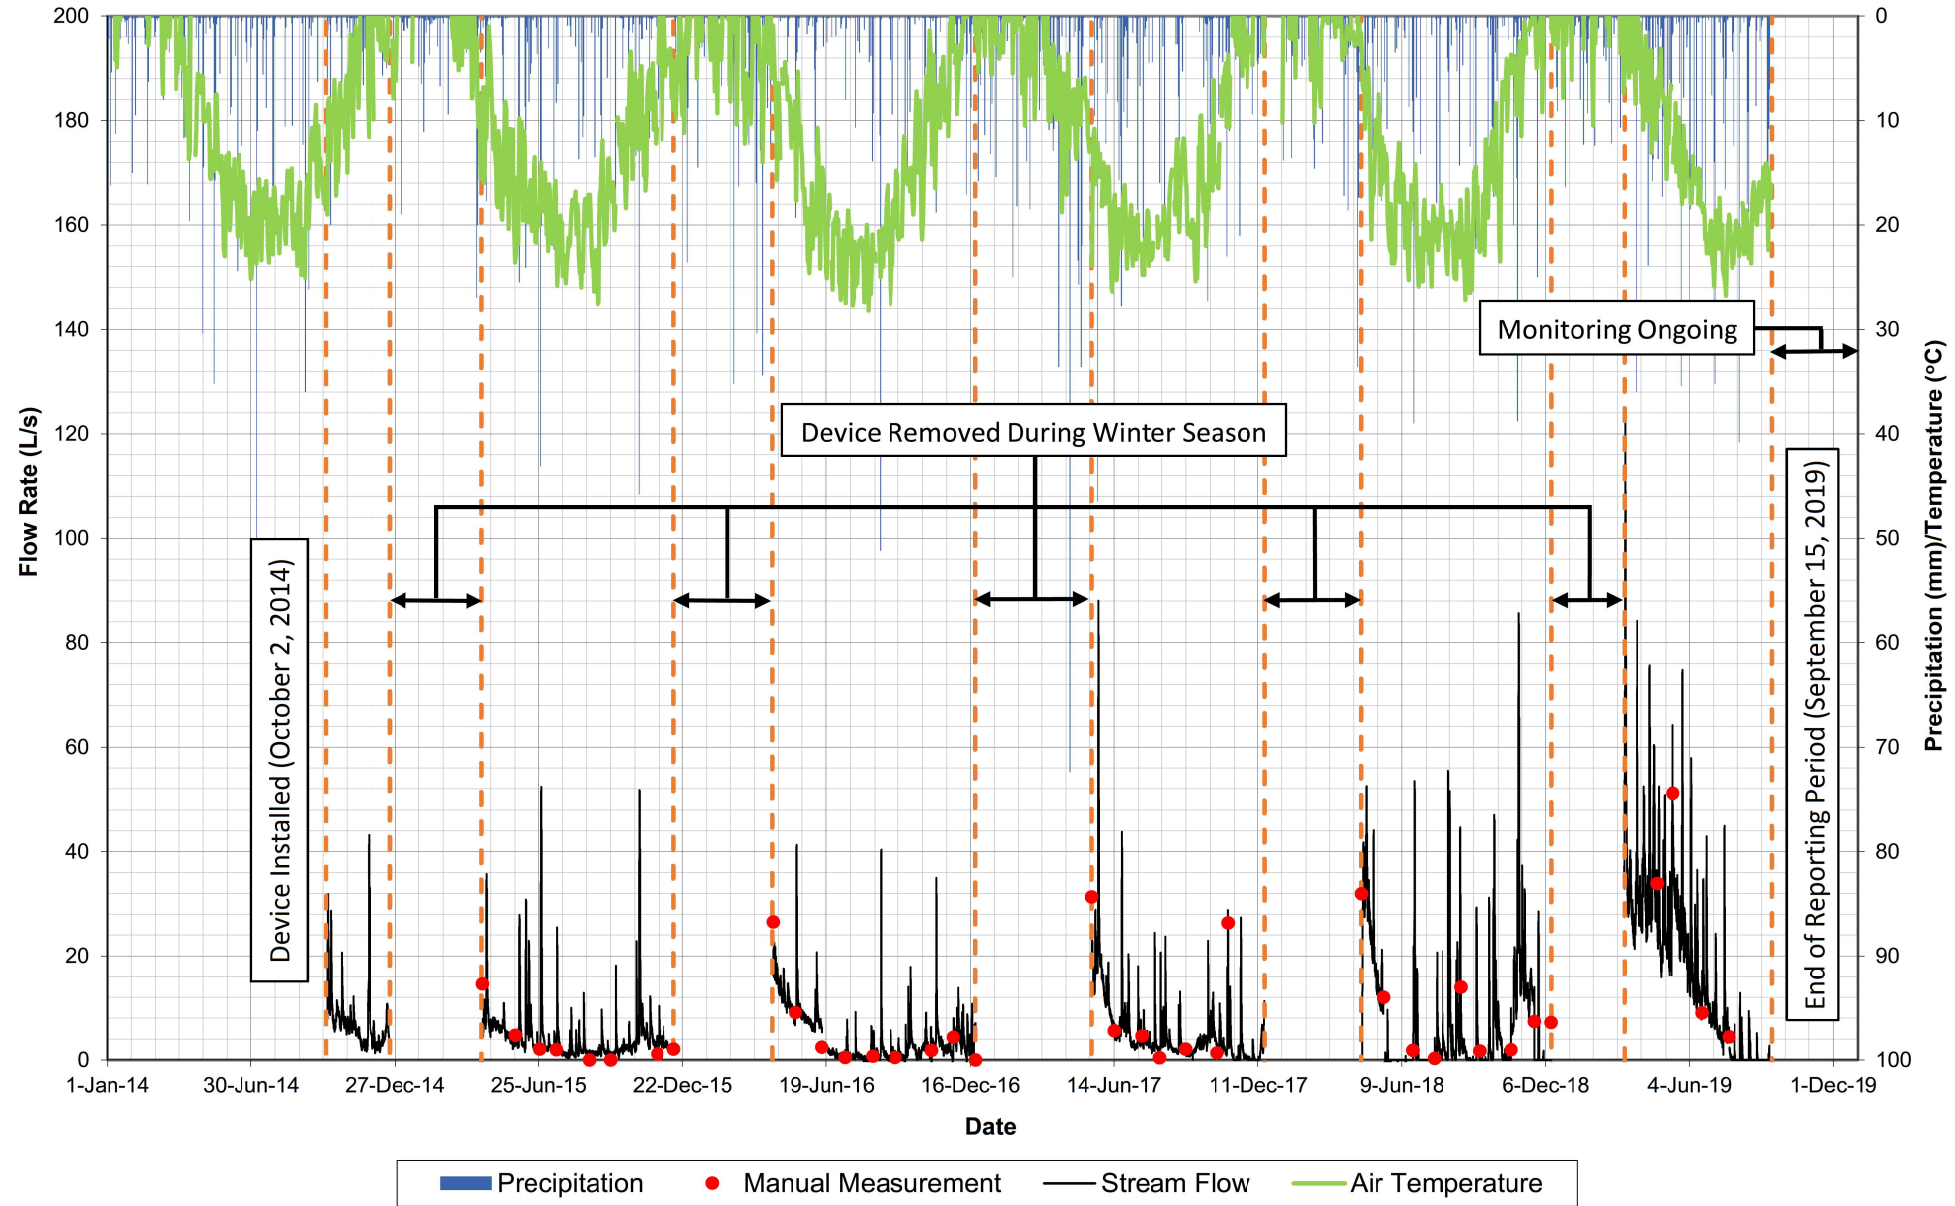
BURLINGTON QUARRY
MONITORING LOCATION SW14
STREAM FLOW MONITORING SUMMARY: 2014-2019

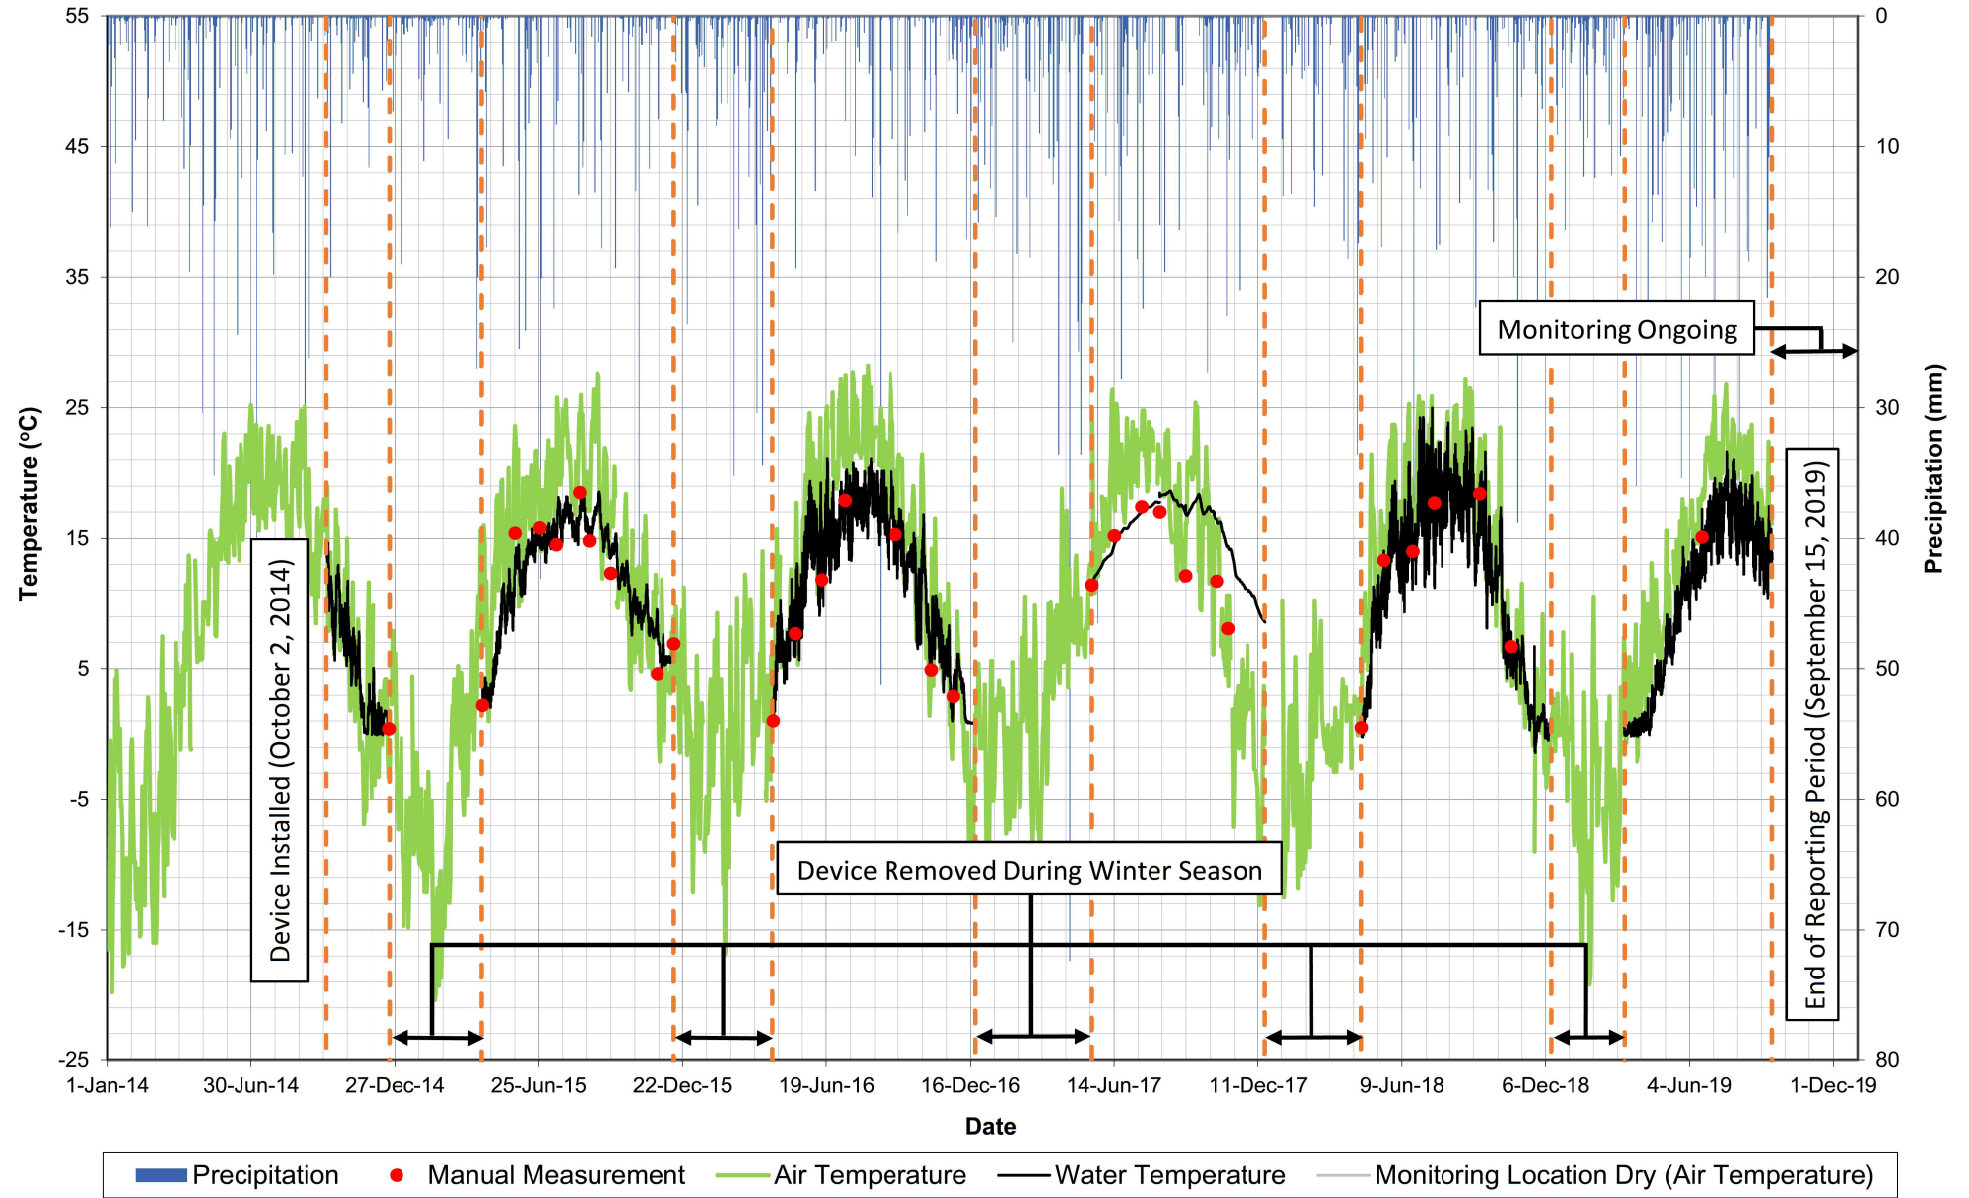
BURLINGTON QUARRY
MONITORING LOCATION SW14
STREAM TEMPERATURE MONITORING SUMMARY: 2014-2019
