# Cultural Heritage Report: Existing Conditions and Preliminary Impact Assessment

## Regional Road 25 – North Halton Coordinated Municipal Class Environmental Assessment

### Halton Region, Ontario

#### Final Report

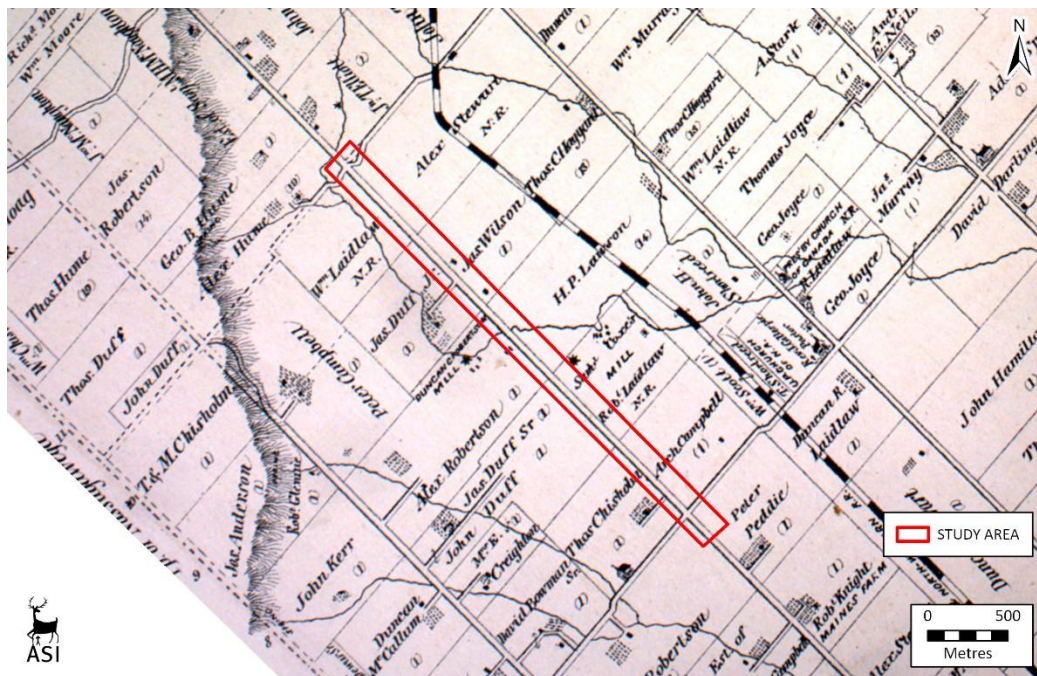
Figure 3: The study area overlaid on the 1877 Historical Atlas of the County of Halton (Base Map: Pope, 1877a).

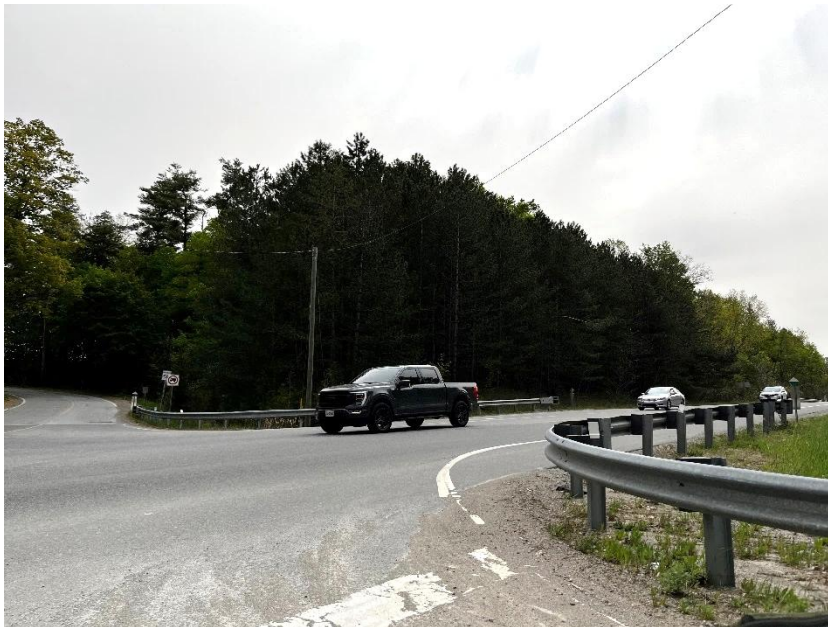
Plate 1: R.R. 25, looking east from the south side of 10 Side Road (A.S.I., 2023).

R.R. 25 at the intersection with 10 Side Road is a two-lane road. There are metal barriers at the corners of the intersection and stop signs on 10 Side Road. 10 Side Road, on the east side, is a two-lane road with gravel shoulders. On the west side, 10 Side Road is a gravel roadway with “No Exit” signs near the entrance and a communal mailbox (Plate 1). South of 10 Side Road, R.R. 25 continues as a two-lane agricultural roadway with hydro lines on both sides and streetlights on the west side. In this section of road, R.R. 25 is generally bound on both sides by mature wooded areas with occasional access roads/driveways to rural residential properties and small farms (Plate 2).

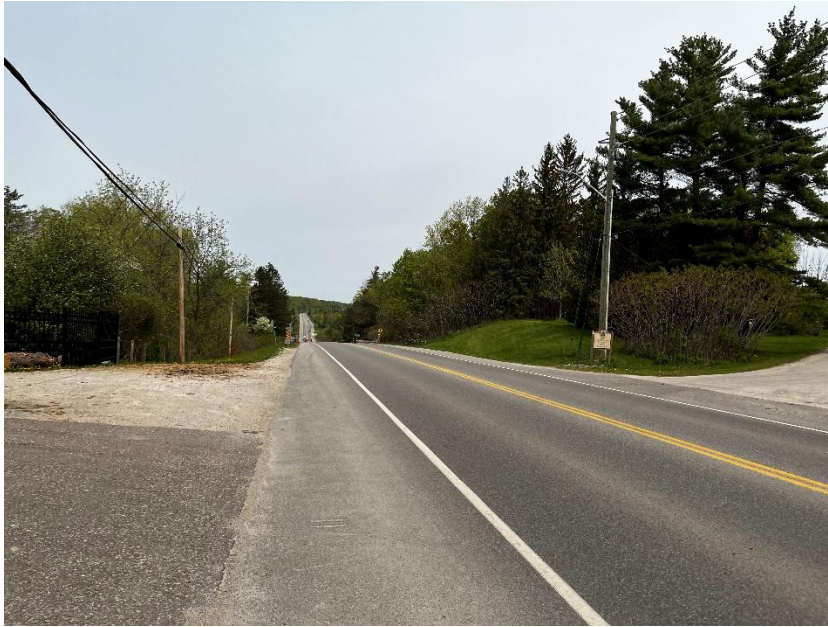
Plate 2: R.R. 25, looking northwest toward the intersection with 10 Side Road (A.S.I., 2023).

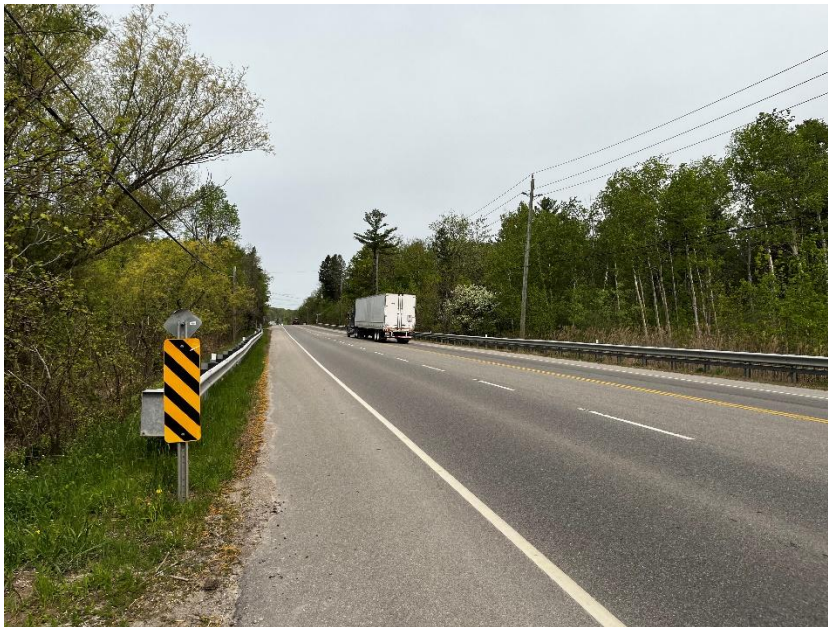
Plate 3: R.R. 25, looking northwest from just north of the entrance to the Glen Cairn Golf Club (A.S.I., 2023).

North of the entrance to Glen Cairn Golf Club, R.R. 25 widens to provide a turning lane from both the north and south to allow turning movements into the golf course (Plate 3). The golf course occupies the east side of the road north and south of the golf club driveway. It is obscured from the road by landscaping and mature trees. South of the golf course, the roadway narrows again to two-lanes. In this section, R.R. 25 is generally bound by mature wooded areas and agricultural fields with occasional access roads/driveways to rural residential properties and small farms (Plate 4).

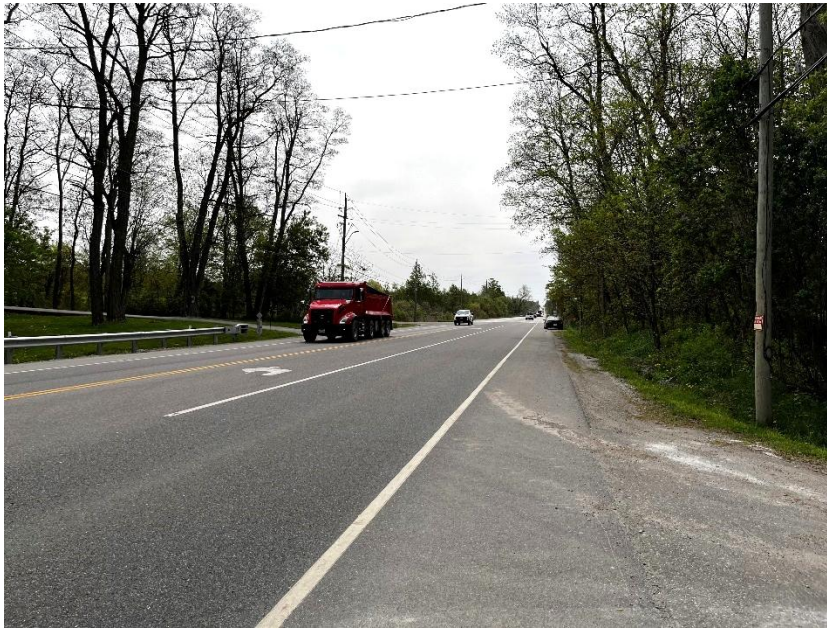
Plate 4: R.R. 25, looking southwest toward the entrance to the Glen Cairn Golf Club visible left of centre (A.S.I., 2023).

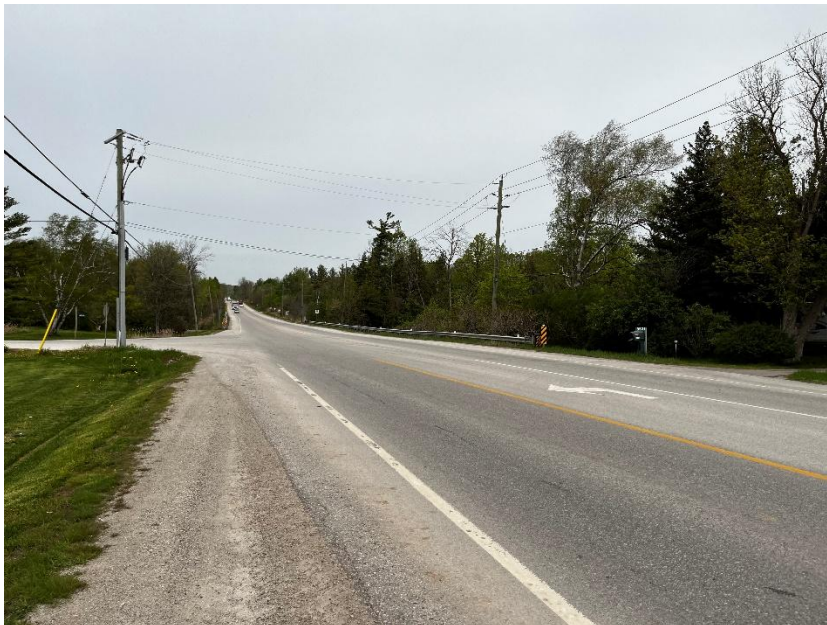
Plate 5: R.R. 25, looking northwest. The entrance to the Chudleigh Entertainment Farm parking area is on the left (A.S.I., 2023).

Near the north end of the Chudleigh’s Entertainment Farm property on the west side of R.R. 25, the road widens again to accommodate a northbound left turning lane to Northern Spy Way and Red Delicious Lane where the Chudleigh’s parking area is located (Plate 5). Opposite Chudleigh’s Entertainment farm is a row of residential properties with detached homes.

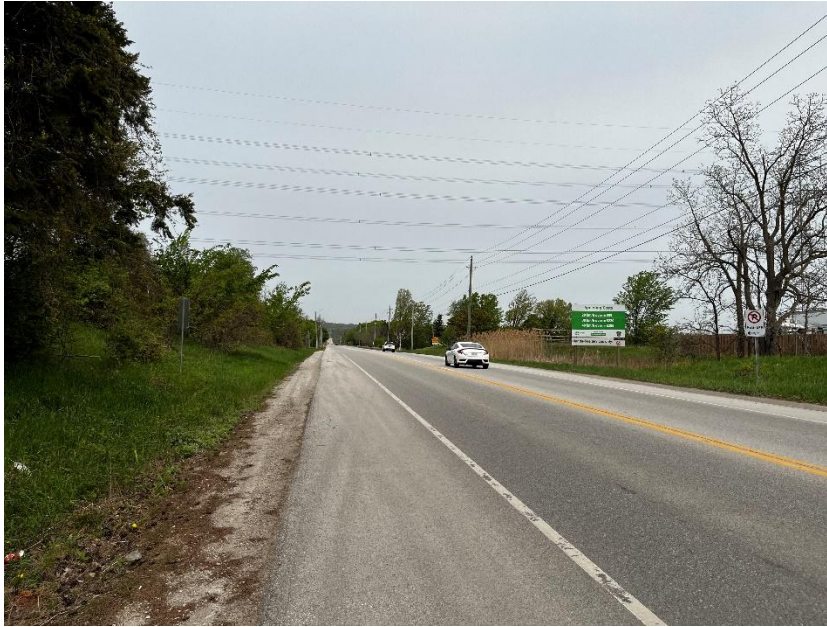
Plate 6: R.R. 25, looking northwest toward St. Matthews Mar Thoma Church where the road begins to widen for a turning lane (A.S.I., 2023).

South of the Chudleigh’s property to St. Matthews Mar Thoma Church, R.R. 25 continues as a two-lane roadway bound on both sides by a mixture of agricultural fields and residential properties. South of the driveway to St. Matthews Mar Thoma Church, the roadway widens to accommodate a northbound left turning lane to the church driveway and parking lot (Plate 6).

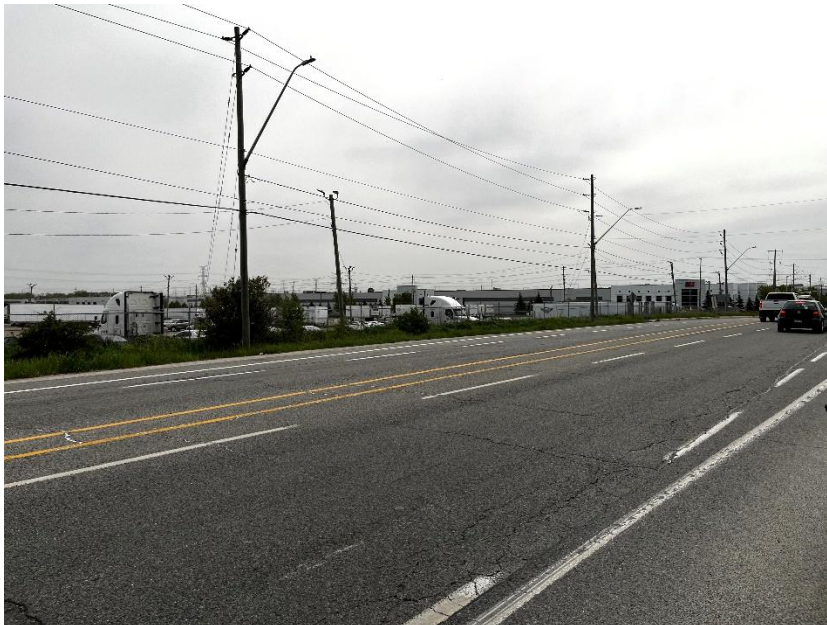
Plate 7: The industrial park on the east side of R.R. 25 near the intersection with 5 Side Road (A.S.I., 2023).

occupied by a mixture of agricultural fields and residential properties with mature trees (Plate 7 and Plate 8).

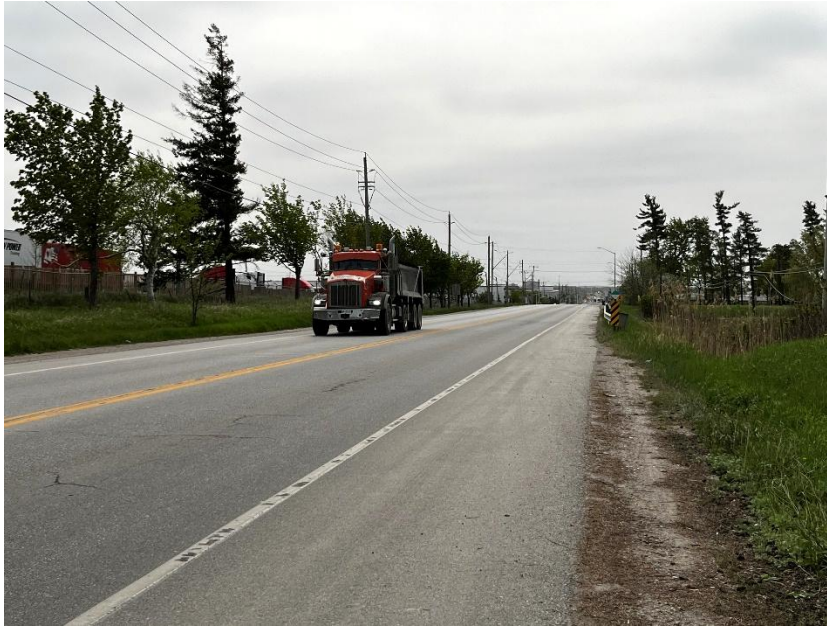
Plate 8: R.R. 25, looking southeast toward 5 Side Road (A.S.I., 2023).

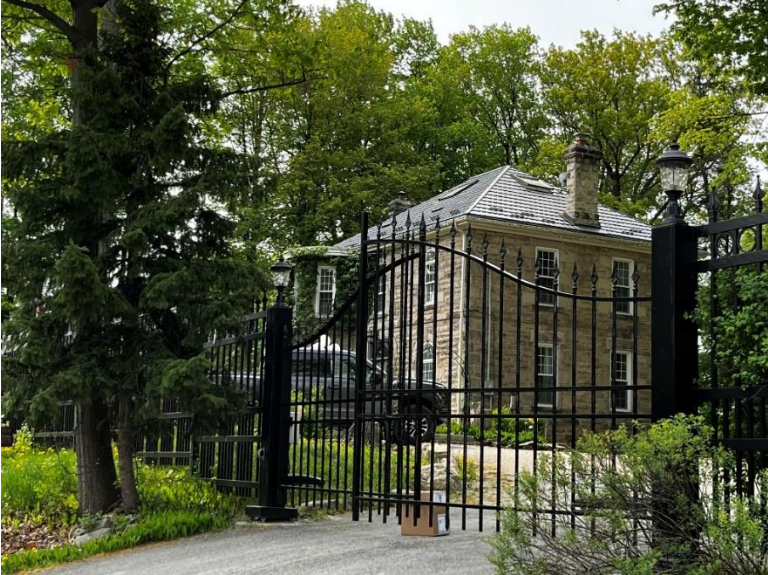
| Feature I.D. | Type of Property | Address or Location | Heritage Status and Recognition | Description of Property and Known or Potential C.H.V.I. | Photographs/ Digital Image |
|---|---|---|---|---|---|
| B.H.R. 1 | Residence | 9920 Regional Road 25 | Known B.H.R. - Designated under Part IV of the Ontario Heritage Act <sup>3</sup> | <p>This B.H.R. is located on the west side of R.R. 25 south of 10 Side Road.</p> <p>The B.H.R. is a two-storey, vernacular, cut-stone, residence constructed by the Bates family who operated a stone quarry. The residence has elements of the Queen Anne and Romanesque Revival architectural styles and includes many decorative elements, including quoining, string courses, and a corner tower. Known heritage attributes for the structure overall include the setback, location, and orientation of the residence along R.R. 25; its scale, form, and massing; hipped roof with dual stone chimneys; stone foundation; and construction materials, including the cut limestone walls, detailing, and horizontal string course. Heritage attributes for the front (northeastern) elevation include the flat-headed entrance and stone surround; round-arched window openings on the first and second storeys with stone keystones in stone hoodmoulds, and detailed stone surrounds; and the two-storey, stone, projecting bay with flat-headed window openings on the first and second storey. Heritage attributes for the sides (northwest and southeast) elevations include the flat-headed window openings on the first and second storeys, symmetrically placed on the elevation with stone sills, lintels, and surrounds (Town of Halton Hills, 2023).</p> | <p>Plate 10: The residence at 9920 Regional Road 25 (A.S.I., 2023).</p> |

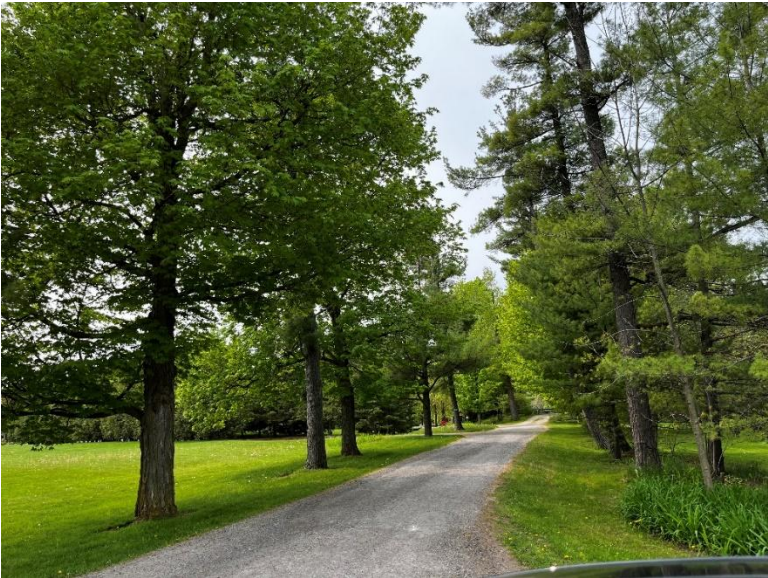
| Feature I.D. | Type of Property | Address or Location | Heritage Status and Recognition | Description of Property and Known or Potential C.H.V.I. | Photographs/ Digital Image |
|---|---|---|---|---|---|
| B.H.R. 2 | Residence | 9690 Regional Road 25 | Known B.H.R. - Designated under Part IV of the Ontario Heritage Act <sup>4</sup> ; Included in Register of Canada's Historic Places | <p>This B.H.R. is located on the west side of R.R. 25, just north of Chudleigh’s Entertainment Farm. The residence was not visible from the public right-of-way.</p> <p>The B.H.R. is a two-storey residence built by the Duff family in the 1870s. The residence is constructed of stone with limestone lintels, quoins, and sills and has gable dormers and Gothic windows. It is constructed in the Gothic Revival architectural style. The designation by-law also notes that the interior of the residence has been “painstakingly restored” and “only slightly altered”. Known heritage attributes include the structure’s massing; Gothic Revival architecture; stone construction; limestone lintels, quoins, and sills; gable dormers; Gothic windows; restored interiors; and its associations with Esquesing Township’s agricultural history (Town of Halton Hills, 2024b).</p> | <p>Plate 11: The driveway to 9690 Regional Road 25. The residence was not visible from the public right-of-way at the time of field review (A.S.I., 2023).</p> |

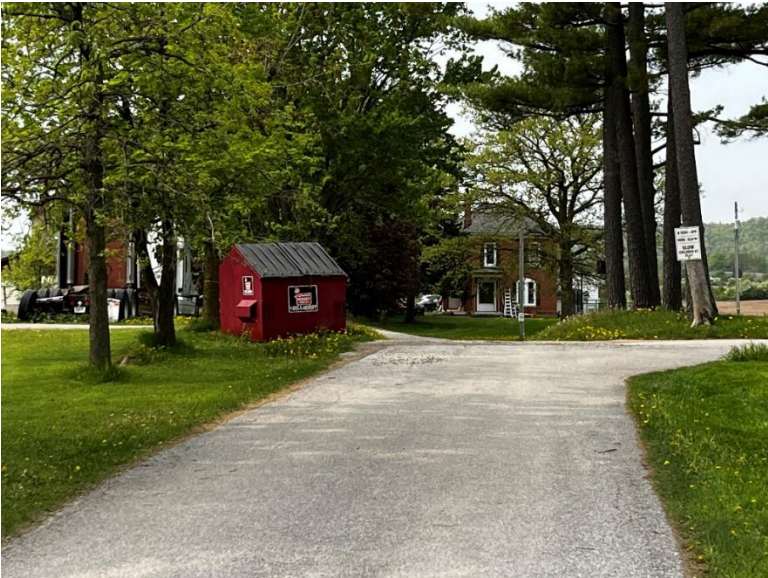
| Feature I.D. | Type of Property | Address or Location | Heritage Status and Recognition | Description of Property and Known or Potential C.H.V.I. | Photographs/ Digital Image |
|---|---|---|---|---|---|
| B.H.R. 3 | Residence | 9094 Regional Road 25 | Known B.H.R. - Designated under Part IV of the Ontario Heritage Act <sup>5</sup> | <p>This B.H.R. is on the west side of R.R. 25, north of 5 Side Road.</p> <p>The B.H.R. is a two-storey residence owned by the Chisholm family. The residence has an L-shaped plan and is constructed of brick with a stone foundation and hipped roof. Known heritage attributes include the structure’s setback, location, and orientation of the residence along R.R. 25; the tree-lined drive connecting the residence to R.R. 25; the coniferous windrow to the north of the residence; the residence’s scale, form, and massing; stone foundation; shallow hipped roof with bracketed eaves and brick chimney; and the materials, including the brick exterior and detailing, sills, and wooden bracketed eaves. Heritage attributes for the front (northeast elevation) include the segmentally arched former door opening, with round-arched window opening adjacent to the door opening on the first storey; the one-storey, covered, wooden porch over the former entrance; and the segmentally arched window openings with brick hood moulds on the second storey. Heritage attributes for the side (southeast) elevation include the one-storey, covered porch along the side elevation; segmentally arched door openings with glass transoms and window openings on the first and second storey with brick hood moulds; and the round-arched double window openings with brick hood moulds and sills towards the rear of the elevation. Heritage attributes for the rear (southwest) and side (northwest) elevation include the segmentally arched window openings with brick voussoirs on the first and second storeys (Town of Halton Hills, 2024a).</p> | <p>Plate 12: The residence at 9094 Regional Road 25 (A.S.I., 2023).</p> |

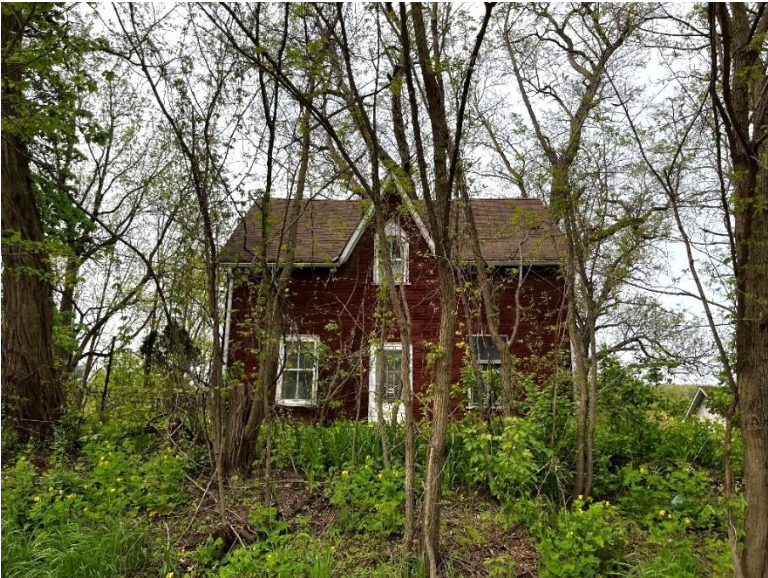
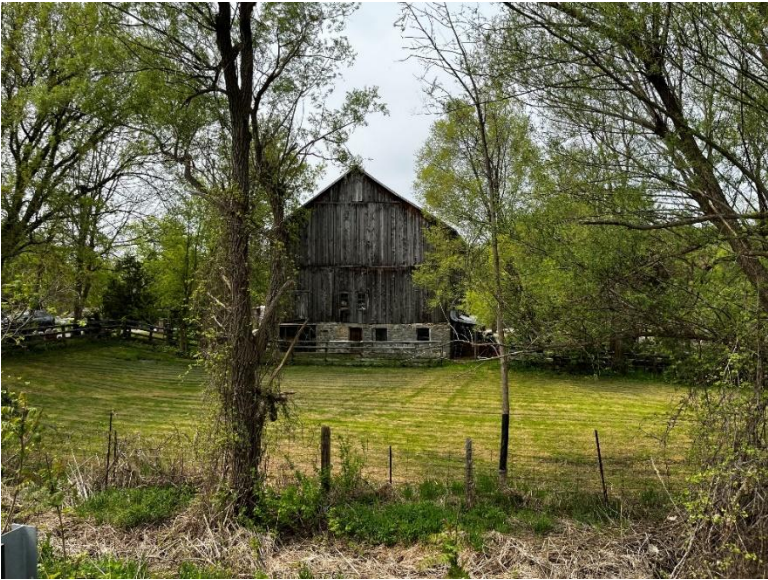
| Feature I.D. | Type of Property | Address or Location | Heritage Status and Recognition | Description of Property and Known or Potential C.H.V.I. | Photographs/ Digital Image |
|---|---|---|---|---|---|
| C.H.L. 1 | Farmscape | 9826 Regional Road 25 | Potential C.H.L. - Identified during background research and field review | <p>This C.H.L. is located on the west side of R.R. 25, north of the Glen Cairn Golf Club.</p> <p>The C.H.L. contains two residences, a barn, and outbuildings. Potential heritage attributes include the one-and-a-half-storey, Gothic Revival residence; gambrel roof barn with field stone foundations, outbuildings, and mature trees.</p> | <p>Plate 13: The Gothic Revival residence at 9826 Regional Road 25 (A.S.I., 2023).</p> <p>Plate 14: The barn at 9826 Regional Road 25 (A.S.I., 2023).</p> |

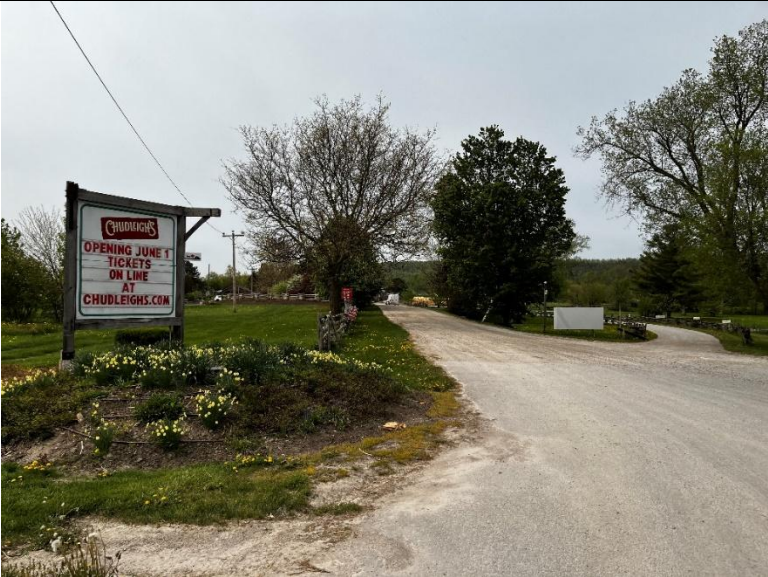
| Feature I.D. | Type of Property | Address or Location | Heritage Status and Recognition | Description of Property and Known or Potential C.H.V.I. | Photographs/ Digital Image |
|---|---|---|---|---|---|
| C.H.L. 2 | Farmscape | 9528 Regional Road 25 | Potential C.H.L. - Identified during background research and field review | <p>This C.H.L. is located on the west side of R.R. 25 approximately halfway between 5 and 10 Side Road.</p> <p>The C.H.L. contains the Chudleigh’s Entertainment Farm complex and associated orchards and farmlands. Potential heritage attributes include the farm buildings, entertainment and event structures, orchards, agricultural fields, landscaping, and mature trees.</p> | <div></div> <p>Plate 15: The entrance to Chudleigh’s Entertainment Farm (A.S.I., 2023)</p> |

| Feature I.D. | Location/Name | Heritage Status and Recognition | Type and Description of Potential/Anticipated Impact | Mitigation Strategies |
|---|---|---|---|---|
| C.H.L. 2 | 9528 Regional Road 25 | Potential C.H.L. - Identified during background research and field review | <p>Direct impacts to the C.H.L. are anticipated to include grading extending approximately four metres into a portion of the northeastern property line and the removal of mature trees at the property line. However, as the grading at the property line is minimal and will not encroach on any identified potential heritage attributes, these impacts are not considered to be adverse.</p> <p>No indirect impacts from construction-related vibration are anticipated as no structures are within 50 metres of the proposed work.</p> | <p>Where feasible, the proposed work should be designed in a manner that avoids all impacts to C.H.L. 2.</p> <p>Suitable mitigation measures including establishing no-go zones with fencing and issuing instructions to construction crews to avoid the C.H.L. should be considered to mitigate any impacts to the C.H.L.</p> <p>Where the proposed work cannot be revised to avoid impacts, the removal of trees and other features should be limited to the extent possible. Where removal cannot be avoided, post-construction rehabilitation with sympathetic plantings should be implemented.</p> |

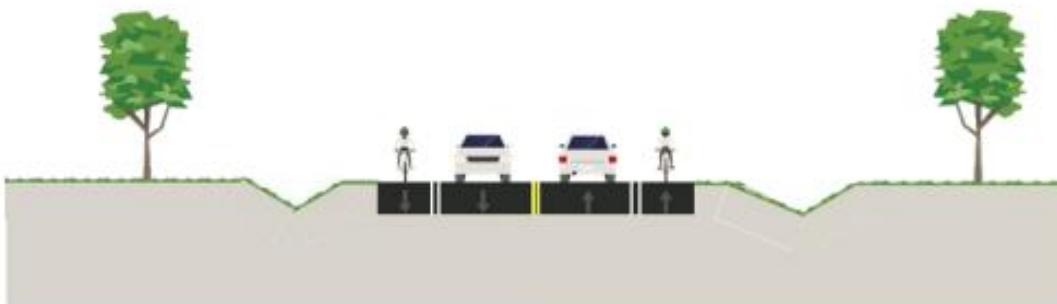
Figure 13: Preferred alternative cross-section for Segment 2 (Regional Municipality of Halton, 2024).

**Alternative A – Buffered paved shoulders  
on both sides**

The proposed cross-section for Segment 2 includes two 3.65-metre lanes bounded on both sides by three-metre wide paved shoulders (Figure 13).
