Appendix D

Sheldon Creek – East Branch Assessment Report

Regarding: Sheldon Creek East Branch Assessment, Burloak Water Purification plant Expansion (Phase 2) Environmental Assessment Support, Supporting Creek Assessment flows.

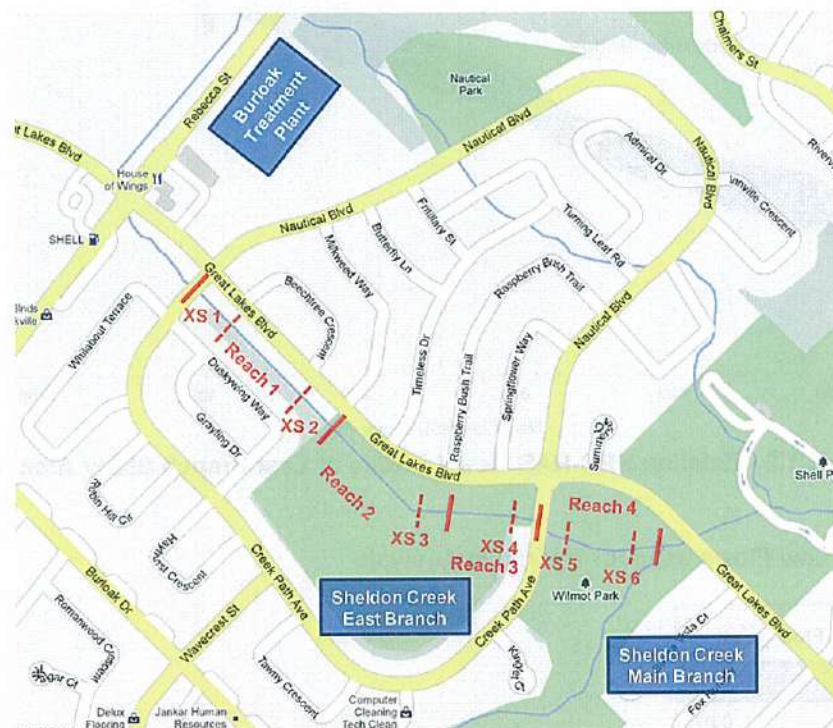
Figure 3.1.1 - Reach and Cross Section Locations in the Study Area

The existing hydraulic conditions for the East Branch of Sheldon Creek are characterized in the existing HEC-RAS hydraulic model provided by Conservation Halton. The section of creek evaluated in this study flows from Creek Path Ave., downstream of Rebecca St., to the confluence with the Main Branch of Sheldon Creek, upstream of Great Lakes Blvd. This section of creek has been divided into four reaches based on geomorphic characteristics (described in section 5). In addition, six cross-sections were surveyed for the geomorphic characterization; the hydraulic analysis provides results at locations close to these cross-sections (using existing HEC-RAS sections) to maintain consistency with other parts of this study. Figure 3.1.1 illustrates the hydraulic study area and cross-section locations established in the field.

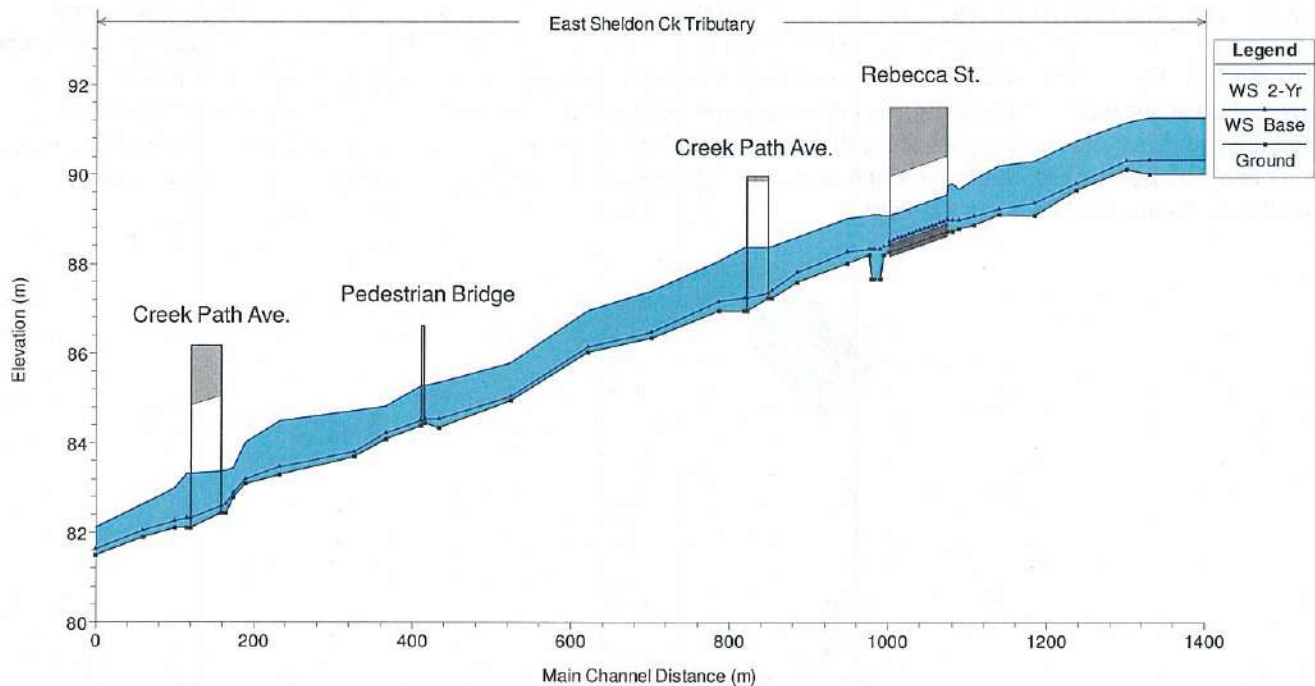
Figure 3.1.2 - Existing HEC-RAS Model Profile of East Branch Study Area

The HEC-RAS profile shown in Figure 3.1.2 shows that the creek has a relatively consistent bed gradient to the point of confluence with the main branch of Sheldon Creek at 0.69% with minor undulations at crossings. The 2 year event flow, also shown, is noted to pass below deck soffits at crossings. The HEC-RAS model data summary is included in Appendix B-1.

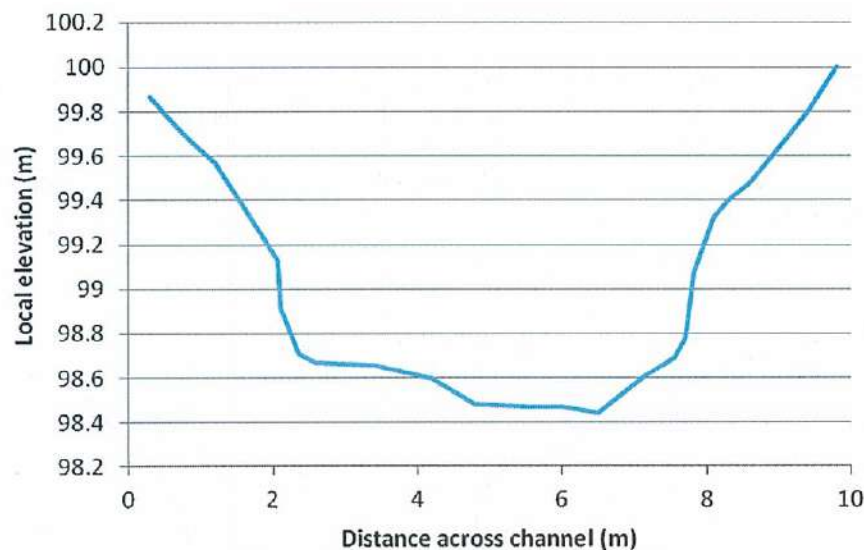
Figure 5.2.2.1 - Reach 2 cross-section

The channel cross-sectional configuration tended to be u-shaped, with asymmetry occurring along the more well-developed bends. Channel width was approximately 6 m and depth was ~ 0.70 m. Floodplain access appeared to be variable due to differences in bank height. Evidence of long term channel bed incision and migration across the floodplain were evident through terraces along the channel banks and evidence of a smaller channel set within a larger channel. A typical Reach 2 cross-section is shown in Figure 5.2.2.1.

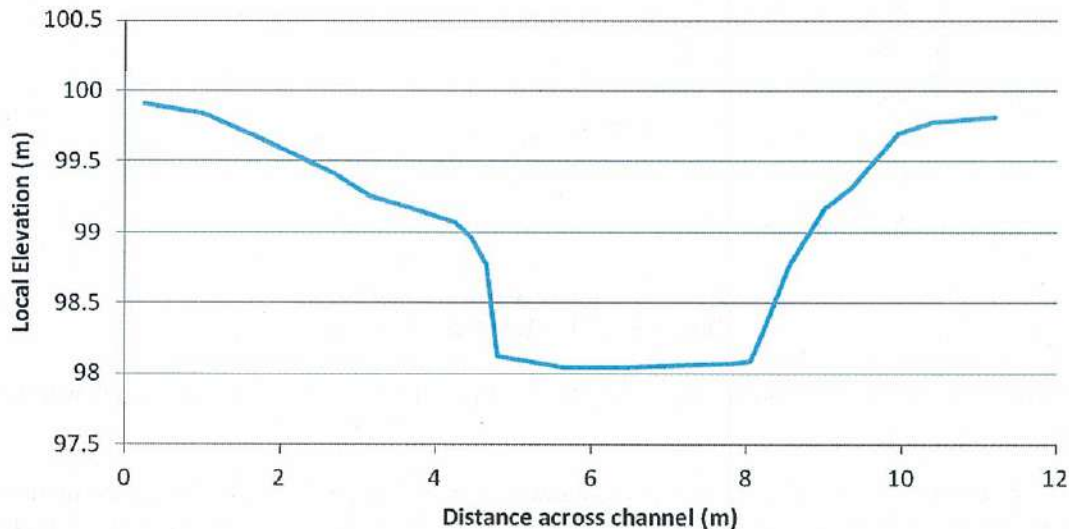
Figure 5.2.3.1 - Reach 3 cross-section

Similar to the upstream reaches, banks were typically near vertical but also were vegetated with shrubs, grasses, and trees. Tree trunks were bent and/or leaning, indicative of bank adjustment processes (Photo R3-4). The overall channel configuration appeared to have been straightened and the cross-section was u-shaped. The cross-section profile suggests that the active (bankfull) channel is set within a larger cross-section. A typical Reach 3 cross-section is shown in Figure 5.2.3.1.

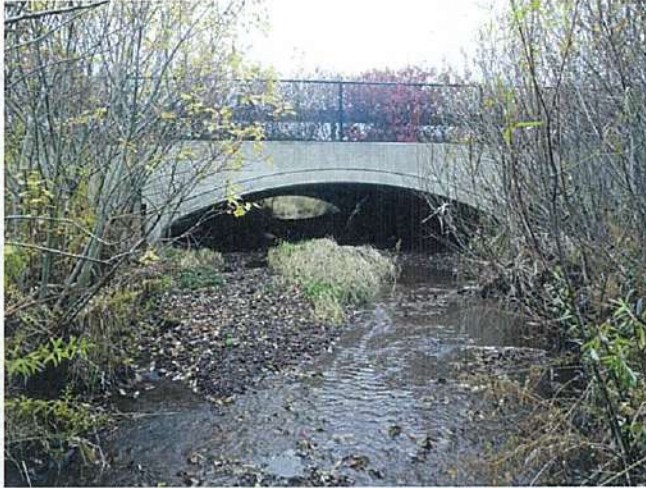
Photograph R1-1 ↑
Accumulation of shale fragments at Creek Path Avenue

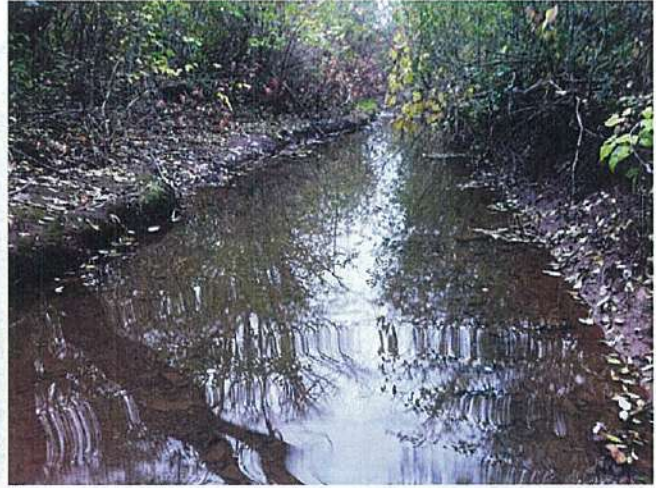
Photograph R1-2 ↑
Well vegetated channel banks in Reach 1

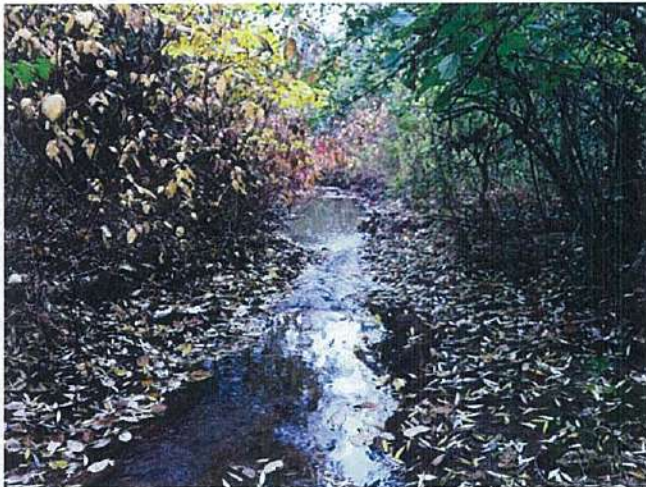
Photograph R1-3 ↑
Knick point formation in Reach 1

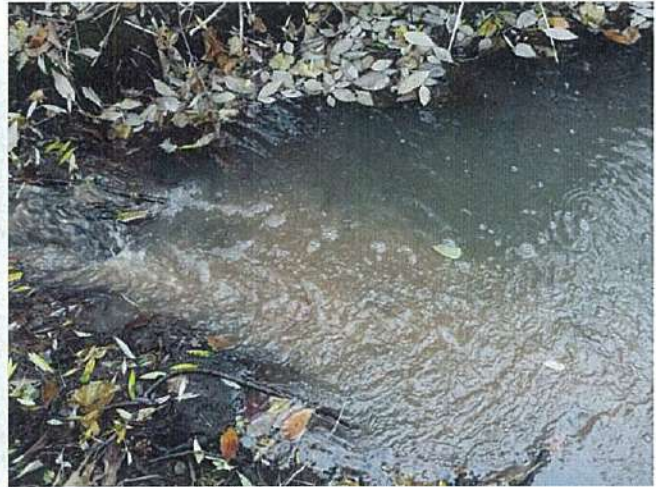
Photograph R1-4 ↑
Knick point formation in Reach 1

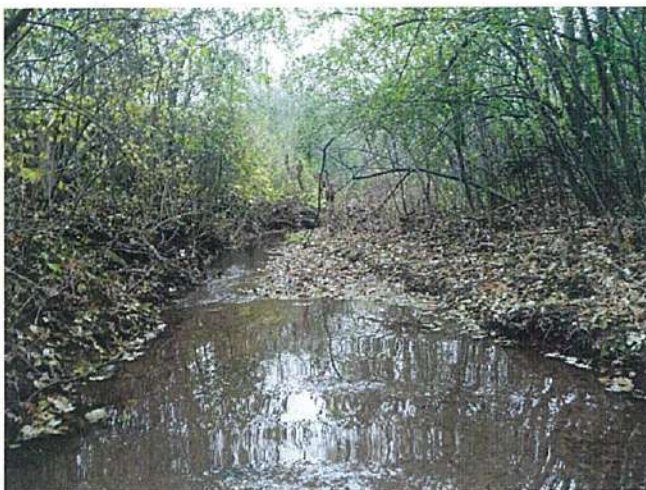
Photograph R1-5 ↑

The cross-section was typically u-shaped and some evidence of long term incision was evident in subtle or minor terracing along the channel banks (Photo R1-5) and/or as defined changes in cross-section profile (e.g., smaller channel set within a larger channel). Review of the cross-section configuration suggested that the channel would be able to access the floodplain during periods of high flow. Several dry overland flow swales were evident in the floodplain, directing flow into the channel. Two cross-section profiles were created in this reach, which revealed a 3.5 m wide channel set within a wider (~ 7 m) channel. Channel depth varied from 0.5 to 0.70 m. A typical Reach 1 cross section is illustrated in figure 5.2.1.1.

Minor terracing of channel banks in Reach 1

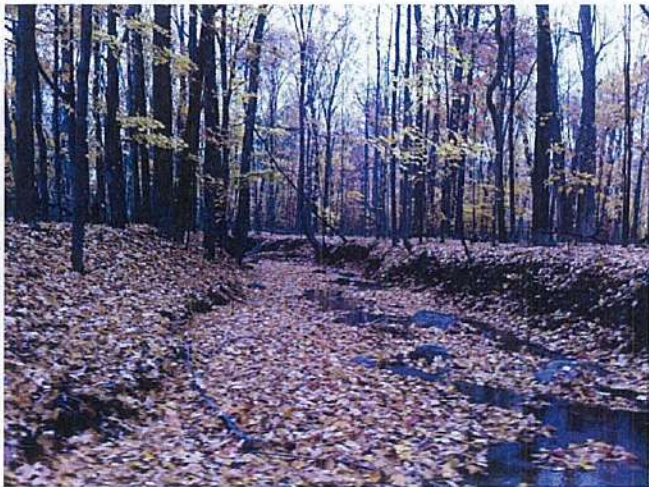
- Channel width was wider
- Overall, a more 'natural' channel form and surrounding condition
- Floodplain vegetation changed to a woodlot, including a less dense riparian cover (Photo R2-1)
- Increase in exposed shale on the channel bed
- Lateral bars of sediment were present along the banks
- A sinuous planform with developed meander bends was present, including erosion along outside meander bend

Photograph R2-1 ↑
Floodplain vegetation in Reach 2

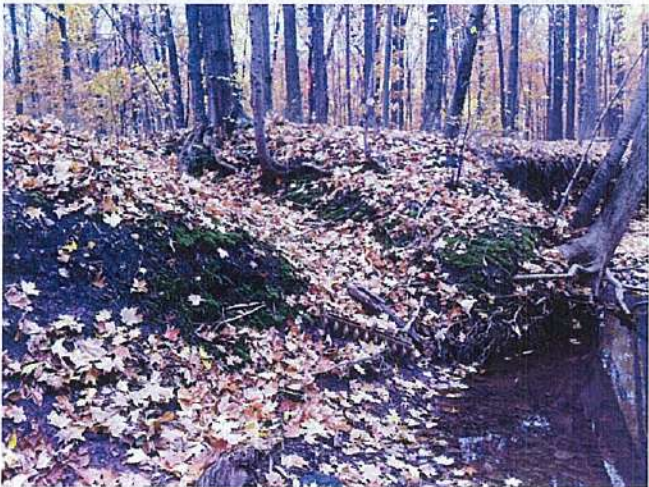
Several dry channels/swales were present in the floodplain, enabling a conveyance of overland flow to the channel (Photo R2-3).

Photograph R2-3 ↑
Overland flow channel in floodplain

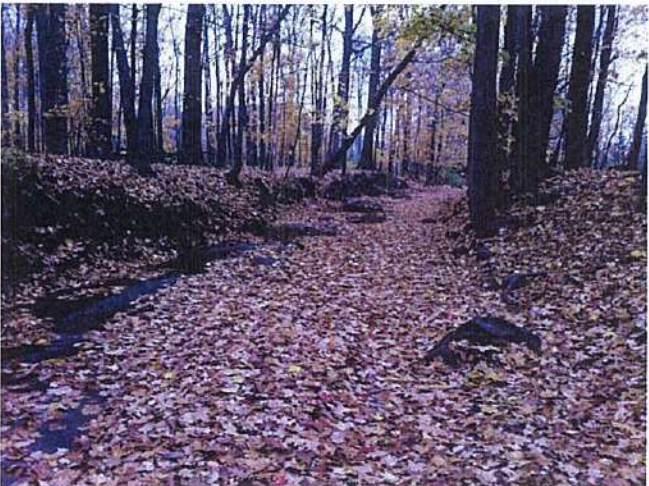
Bank vegetation consisted primarily of trees, of which tree roots were often exposed, indicative of channel widening. Fallen trees across or within the channel were also evident and noticeable (Photo R2-2). The banks were often characterized by a lower layer of exposed shale (broken, blocky materials) that was overlain by alluvial materials. Most banks were vertical and banks along the outside of meander bends were often undercut.

Photograph R2-2 ↑
Fallen trees across channel in Reach 2

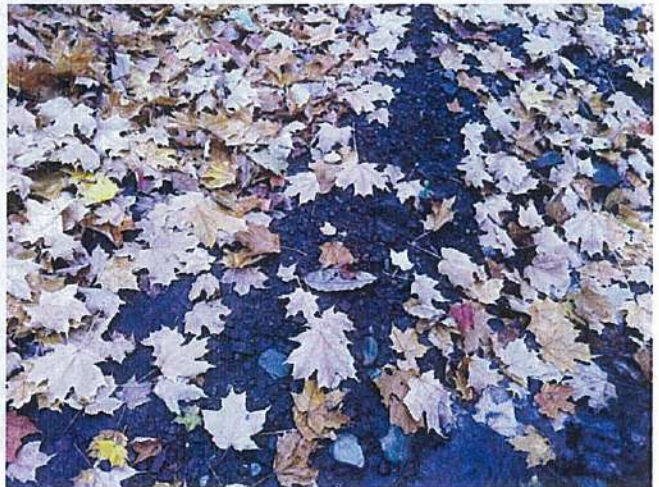
Photograph R2-4 ↑
Accumulation of sediment as lateral bars in channel

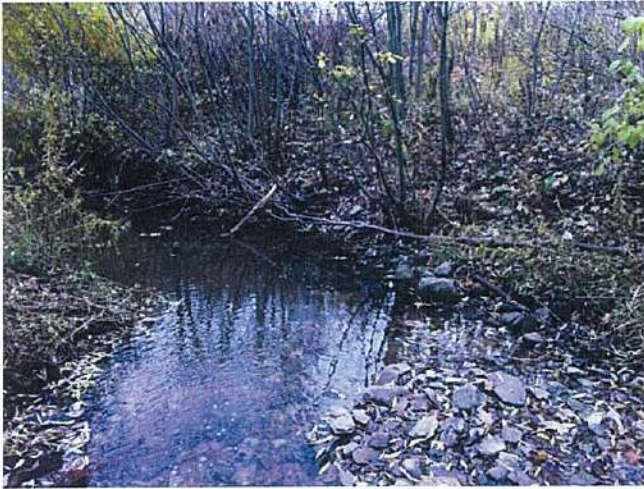
Photograph R3-1 ↑
Riparian vegetation in Reach 3

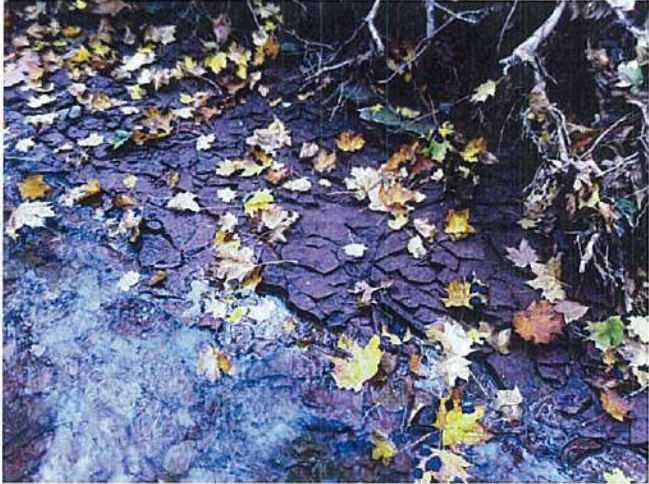
In addition to the increased shale exposure along the channel bed, shale was also exposed as ledges along the toe of bank, extending into the channel (Photo R3-5). The shale tended to be cracked, both on the channel bed and along the bank toe.

Photograph R2-5 ↑
Exposed shale along toe of bank in Reach 3

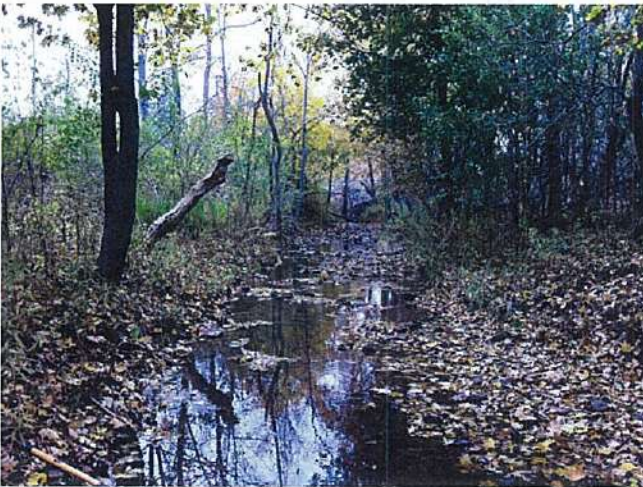
The channel planform in Reach 4 contained both straightened and meandering channel sections (Photo R4-1). Where meandering, active point bar development was evident, and terracing along the inside bend was observed. Terracing was also observed along straighter channel sections (Photo R4-2).

Photograph R4-1 ↑
Typical channel section in Reach 4

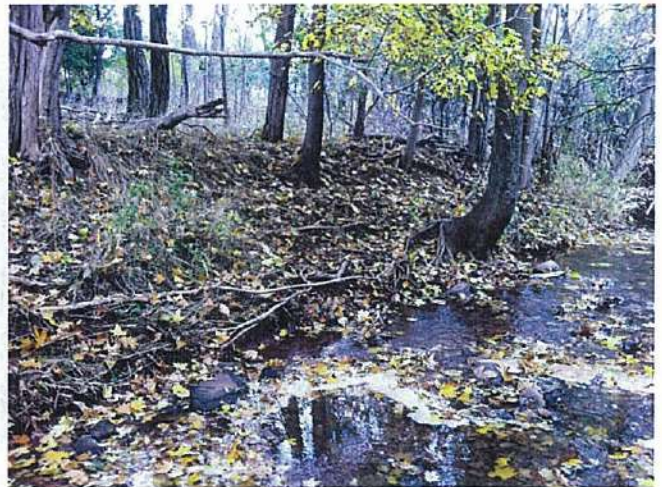
Photograph R4-2 ↑
Bank terracing noted in Reach 4

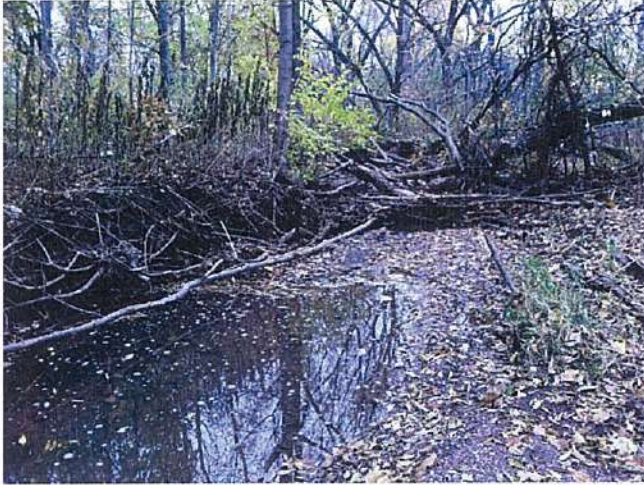
**Photograph R4-5 ↑
Debris jam in Reach 4**

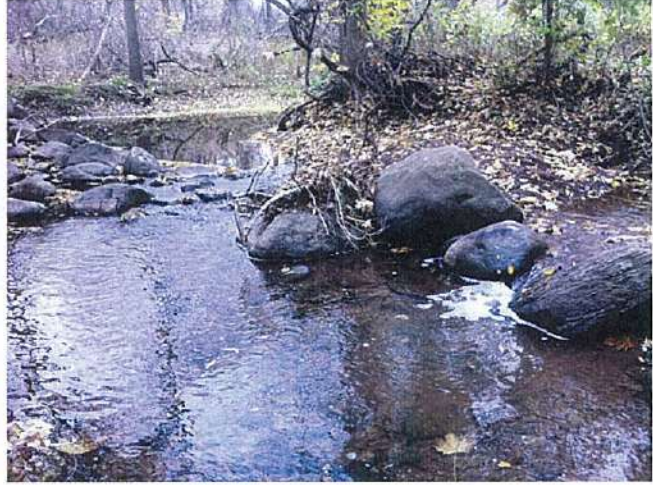
The outlet of the tributary into the main branch of Sheldon Creek was elevated ~ 10 cm above the bed of the main branch. Boulders situated at the outlet create a blockage and trap sediment, contributing to the elevated condition. Adjacent to the outlet, field observations suggest that high flows are reworking the mouth of the creek, which may eventually lead to a new location of the mouth (i.e., a few metres downstream). This would be accompanied by downcutting at the outlet, towards a similar elevation as the main branch of Sheldon Creek.

**Photograph R4-6 ↑
Boulders at confluence with main branch**

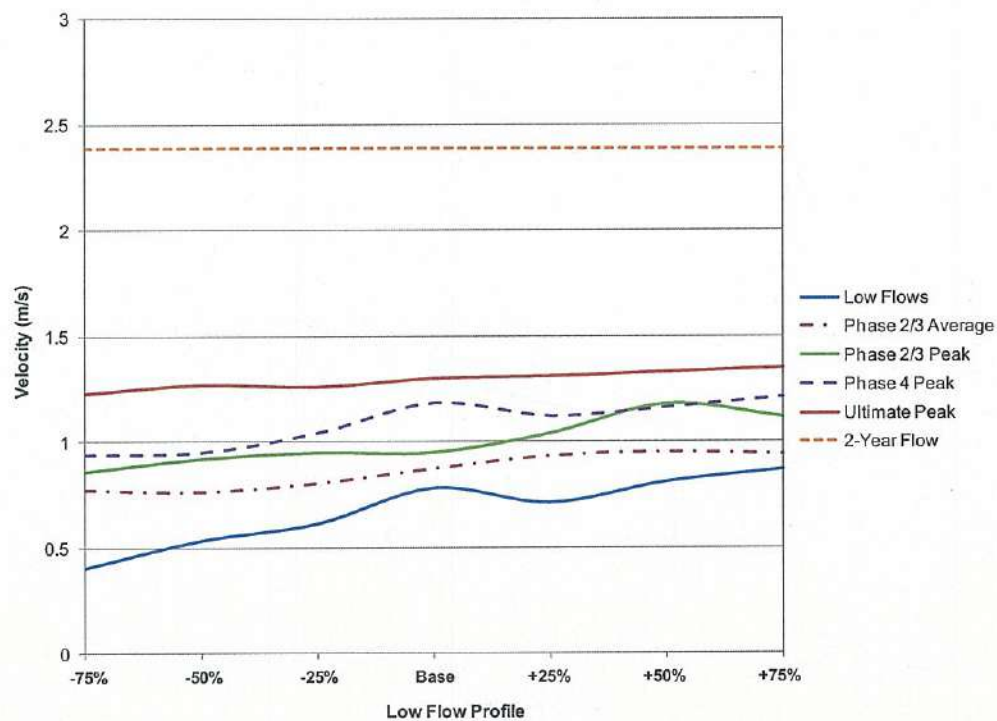
The first phase of plant expansion (Phase 2/3) that would result in discharge of water to the creek is expected to cause an average channel velocity increase of 0.12m/s in the study cross-sections. This would be expected to have a low impact on the creek hydraulic performance, but may have localized effects depending on bed and bank soil characteristics. At the ultimate plant capacity peak flows, the channel velocity increase over the average low flow is estimated to be an average of 0.41m/s. In comparison with the competent mean velocities determined in the Section 3.2, the increased velocities resulting from the discharge flow remain within the velocity thresholds provided in Table 3.2.1.

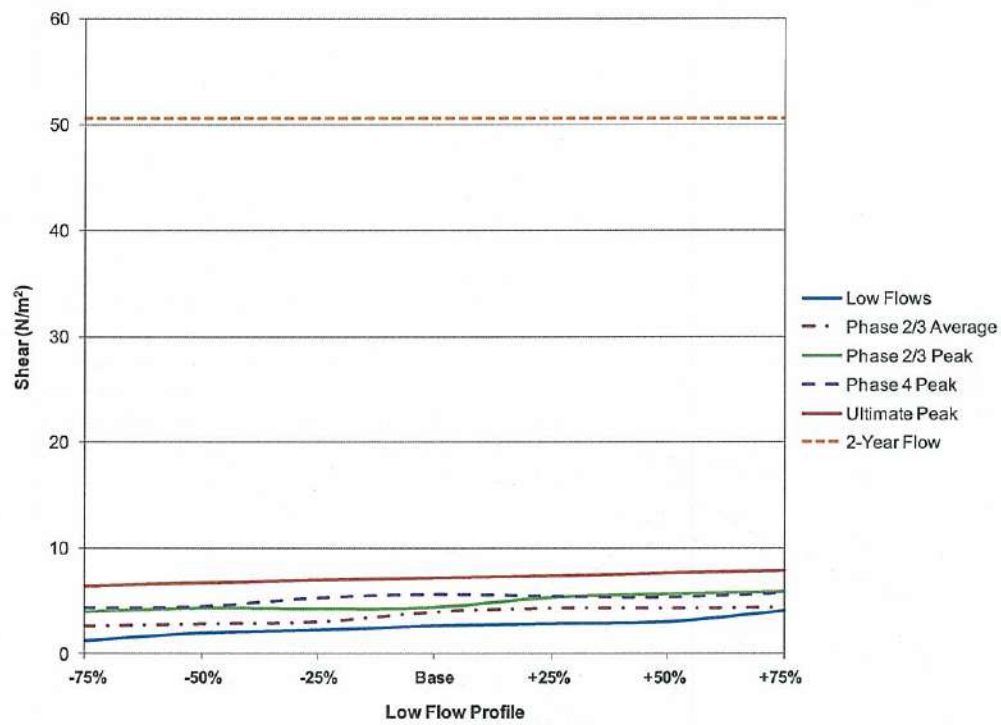
The first phase of plant expansion (Phase 2/3) that would result in discharge of water to the creek is expected to cause an average channel shear increase of 2.45N/m² in the study cross-sections. This would be expected to have a minimal impact on creek stability based on soil type. At the ultimate plant capacity peak flows, the channel shear increase over the average low flow is estimated to be an average of 10.48 N/m².
