4 Existing Conditions

Norval West Bypass Transportation Corridor Improvements—Heritage Impact Assessment: 16469
10 Side Road and 9948 Winston Churchill Boulevard, Halton Hills
4 Existing Conditions
November 19, 2025

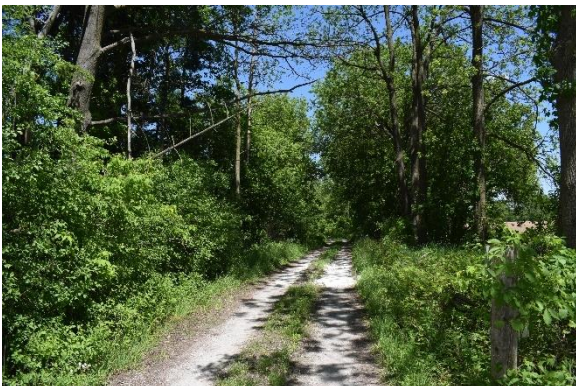
Photo 5 Gravel driveway, looking east

From Green Street, the property is also accessed from a one-lane gravel driveway (Photo 5). A wood sign with a brown background and yellow lettering notes the property is “The Russell Farm” and “No. 15” (Photo 6). The driveway proceeds approximately 320 metres to the west towards the residence. To the north of the driveway is a stand of mature eastern white pine trees known as Russell’s Hill of Pines and to the south of the driveway is a tree row of small, intermediate, and mature Manitoba maple and black walnut trees (Photo 7 and Photo 8).

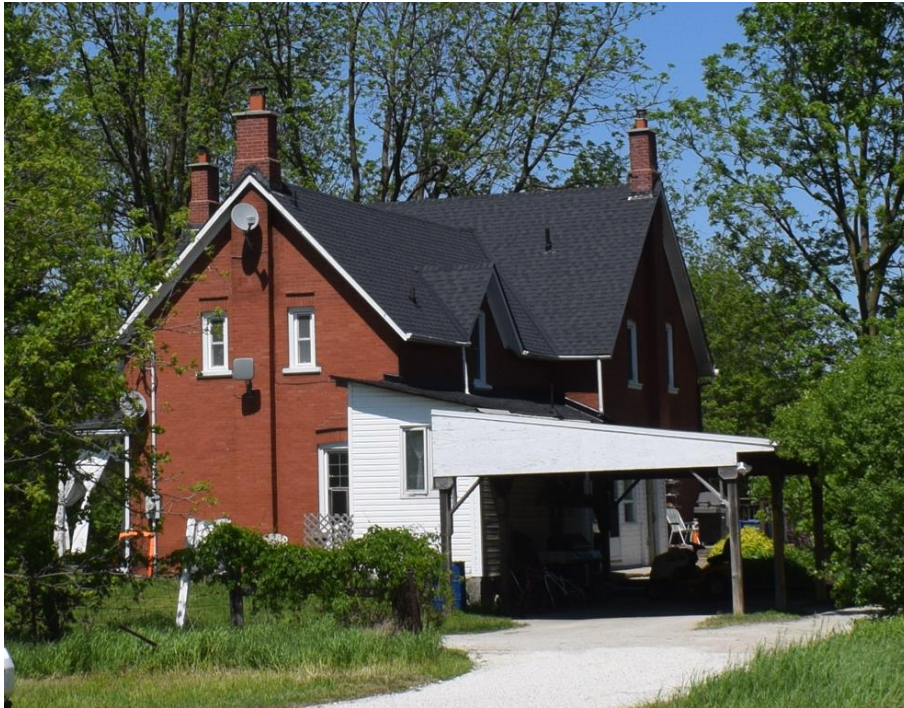
Photo 15 General view of residence showing massing, roof, and exterior, looking east

The residence is a one- and one-half storey structure with a steeply pitched cross gable roof clad in asphalt shingles with three red brick (Photo 15). The exterior of the residence is red brick with a stretcher bond and the foundation is stone (Photo 16 and Photo 17).

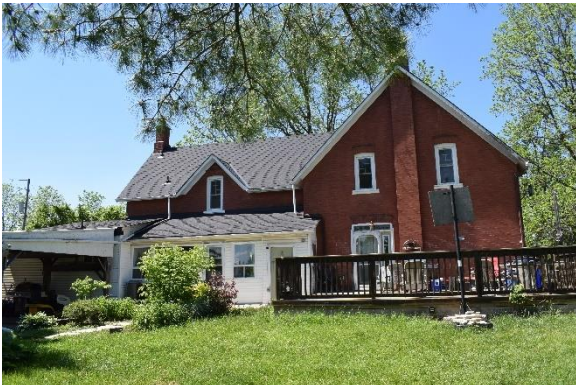
Photo 18 Front façade, looking north

The front (south) façade of the residence is asymmetrical in composition (Photo 18). The upper storey contains three 6/1 wood sash windows with segmental arch window openings with red brick voussoirs and painted sills (Photo 19). The westerly most window is set within a gable peak (Photo 20). The first storey contains the main entrance consisting of a replacement door and screen door with a replacement sidelight and narrow transom with wood sash. A red brick voussoir is located above the transom (Photo 21). A shed roof addition and car port are attached to the front façade. The addition is clad in vinyl or aluminum siding and contains vinyl sash windows and a composite door and screen door (Photo 22 and Photo 23).

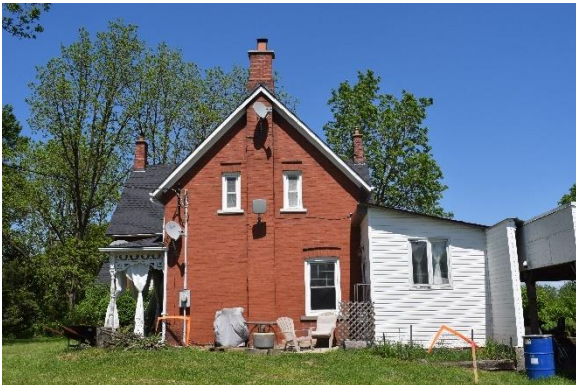
Photo 24 West façade, looking east

The west façade contains a second storey with two 1/1 wood sash windows with brick jack arches and painted sills. The first storey contains a 9/1 wood sash window with a red brick voussoir and stone or concrete sill (Photo 24).

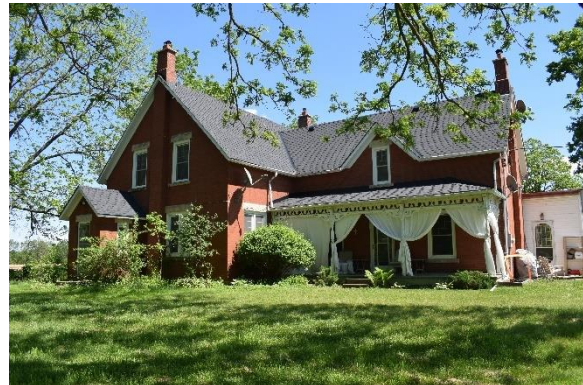
Photo 25 North façade, looking south

The north façade contains three second storey windows with 6/1 wood sash windows, rusticated stone lintels, and rusticated stone sills. The westerly most window is set in a gable peak. The first storey contains 6/1 and 9/1 wood sash windows with rusticated stone lintels and rusticated stone sills (Photo 25). This façade also contains a wood porch with wood decorative trim and wood porch supports. The porch contains two secondary entrances to the residence (Photo 26). To the east of the porch is an enclosed gable secondary entrance with a wood door and wood screen door. Above the doorway is a rusticated stone lintel (Photo 27).

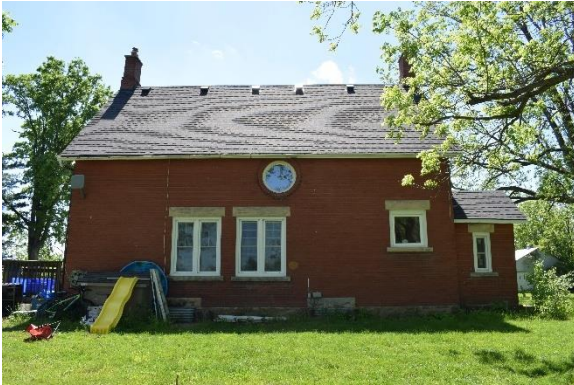
Photo 28 East façade, looking west

The east façade contains a second storey with a circular window with a wood sash and red brick surround. The first storey contains 6/1 and 1/1 wood sash windows with rusticated stone lintels and rusticated stone sills. This façade also contains a vinyl sash window to the north of the 6/1 windows. While the window has been replaced it retains a rusticated stone lintel and rusticated stone sill (Photo 28 and Photo 29).

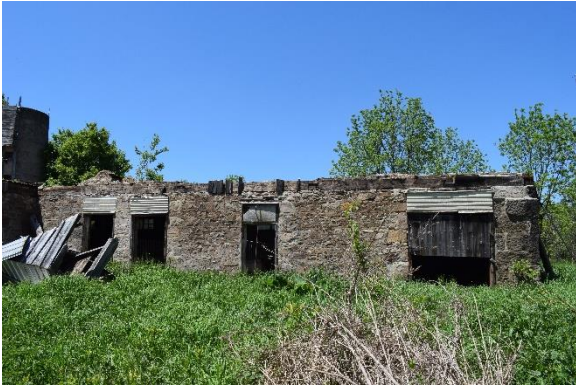
Photo 30 South façade of stone foundation, looking north

Based on the CHRA prepared by Wood in 2021, the barn was formerly a cross gable roof Central Ontario barn with wood cladding. Following a review of aerial photography, it was determined the hayloft portion of the barn collapsed or was demolished in 2023 or early 2024. Presently, only the foundation (stables) level remains. The foundation is constructed of fieldstone, except for cut stone quoins. Entrances to the stables are located on the west, south, and east facades. The former window openings to the stable level have been clad with metal (Photo 30 to Photo 32). The earth bank to the hayloft remains visible near the north façade of the barn and debris associated with the hayloft is present (Photo 33 to Photo 34). Some of the interior of the stables remain intact and based on a visual inspection from an open door consists of a mix of machine cut, and hand-hewn timber beams, with the additional of some metal supports (Photo 35).

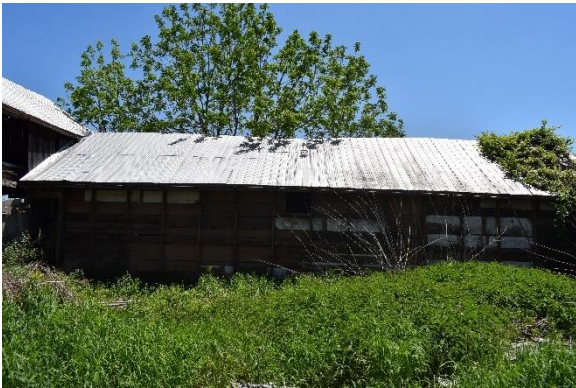
Photo 36 Outbuilding One, looking south

Outbuilding One: This outbuilding is a gable roof structure with metal roof cladding and a wood exterior. It is attached to Outbuilding Two at the east façade (Photo 36).

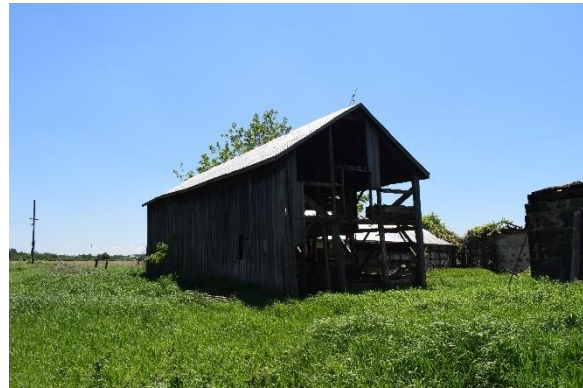
Photo 37 Outbuilding Two, looking south

Outbuilding Two: This outbuilding is a gable roof structure with metal roof cladding and a lightning rod. The exterior is clad in wood and several sections of the cladding are missing on the north and west façades. The missing cladding reveals a structure built with a mix of hand-hewn and machine cut wood. The structure is attached to Outbuilding One at the west façade. Together with the barn and Outbuilding One, these three structures form a small enclosure (Photo 37).

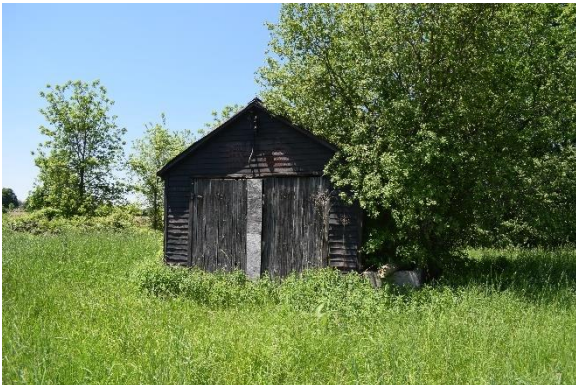
Photo 38 Outbuilding Three, looking north

Outbuilding Three: This outbuilding is a small gable roof structure clad in wood with wood doors and is located west of the barn. To the immediate east of the outbuilding is a concrete trough (Photo 38).

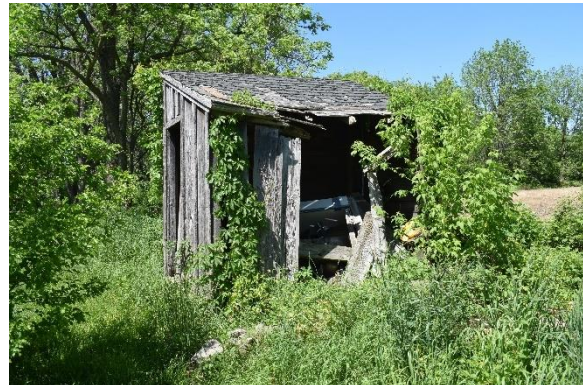
Photo 39 Outbuilding Four, looking north

Outbuilding Four: This outbuilding is a small shed roof structure with asphalt shingles and board and batten cladding and is located east of the residence. The south façade of this outbuilding has collapsed (Photo 39).

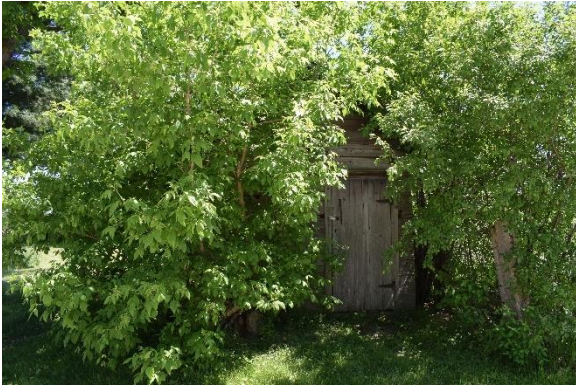
Photo 40 Outbuilding Five, looking south

Outbuilding Five: This outbuilding is a small gable roof structure with metal roof cladding. The exterior is wood and it contains a wood sash window and wood door. The structure is located west of the house and is surrounded by woody vegetation (Photo 40).

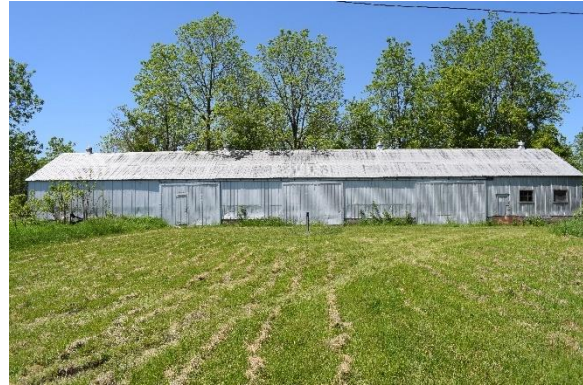
Photo 41 Outbuilding Six, looking north

Outbuilding Six: This outbuilding is a gable roof structure with ventilators, metal roof cladding, four entrances, wood sash windows, and a metal exterior with a concrete foundation. This outbuilding is located north of the residence and is the largest outbuilding on the property (Photo 41).

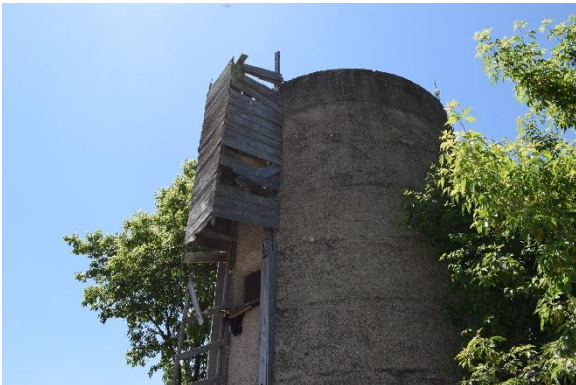
Photo 42 Silo, looking west

Other Outbuildings: The property also contains a concrete silo with a wood ladder adjacent to the north façade of the barn (Photo 42), a wood outhouse north of the barn (Photo 43), and a wood hunting blind within the wooded area (Photo 44).

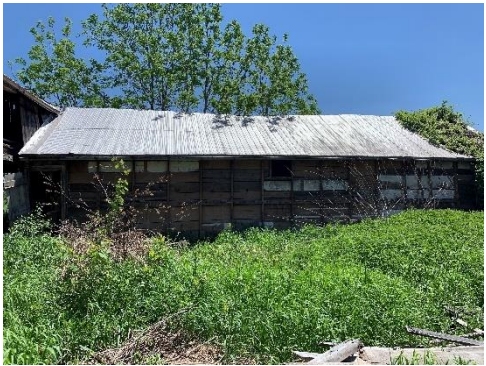
Outbuilding Two	Poor: Several sections of cladding missing

Given the partial demolition of the barn this is not a feasible mitigation option for that structure. In addition, Outbuilding One is in poor visual condition and Outbuilding Two and the silo are in fair visual condition. It is unlikely the outbuildings and silo could withstand relocation. Even if these structures were able to be relocated, the outbuildings and silo are utilitarian structures of limited design value. These types of structures were built throughout southern Ontario during the first half of the 20th century and remain relatively common in rural parts of the Region of Halton.

Given the visual condition and CHVI identified for the railway corridor, outbuildings, barn, and silo, documentation and salvage are an appropriate mitigation measure.

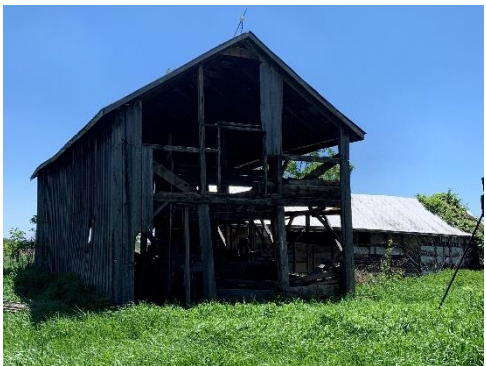
Structure or Landscape Element	Visual Condition and Notes	Photograph
Barn	Poor: The hayloft level has collapsed and only the stone foundation remains standing

To mitigate impacts to the barn, two outbuildings, silo, and former railway corridor, it is recommended that a *Documentation and Salvage Report* be completed for the property. This report is to be undertaken prior to changes made to the property. Documentation creates a public record of the structure and provides researchers and the general public with a historical context, construction details, and a photographic record of the resource. Through the select salvage of heritage attributes identified in the report, the CHVI of the structures and landscape can be partially retained, albeit in a different context.

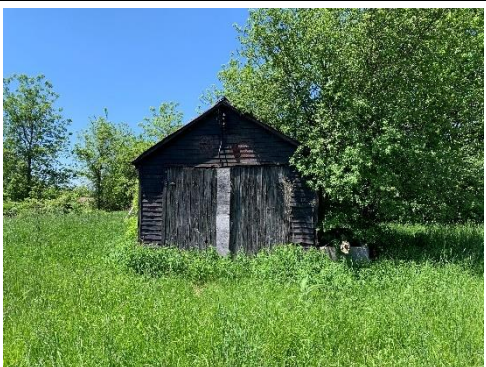
Structure or Landscape Element	Visual Condition and Notes	Photograph
Outhouse	Fair: While the roofing and cladding is intact, the building is leaning towards the south

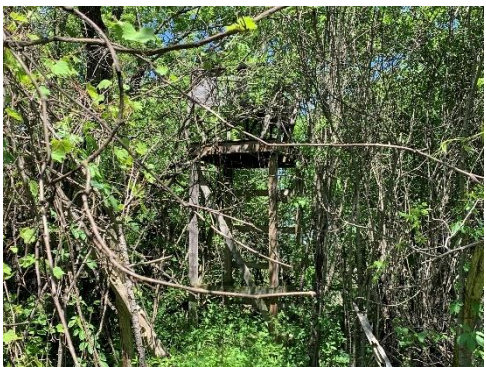
Hunting Blind	Good: Appears visually intact

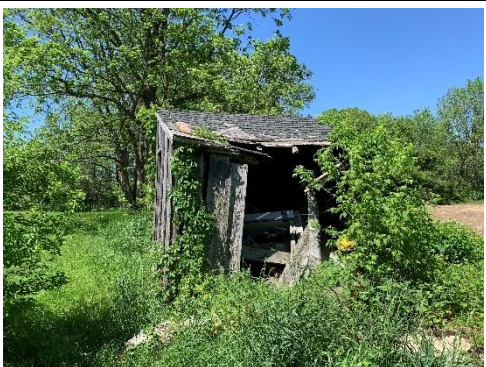
Structure or Landscape Element	Visual Condition and Notes	Photograph
Outbuilding Five	Good: Roofing and cladding appear visually intact

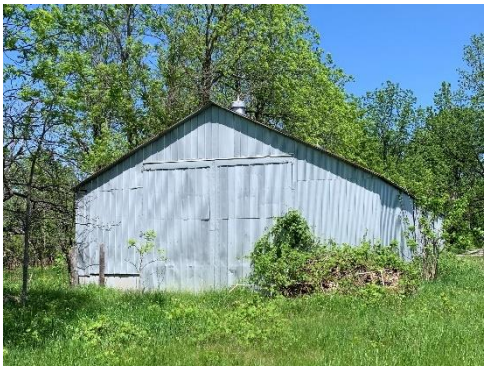
Outbuilding Six	Good: Roofing and cladding appear visually intact

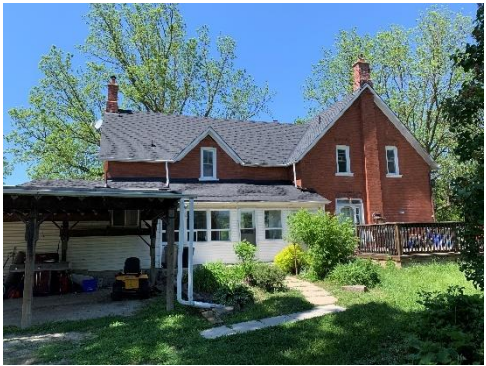
Structure or Landscape Element	Visual Condition and Notes	Photograph
Tree lines in vicinity of main residence	Fair: Mix of small, intermediate, and mature Manitoba maple and black walnut in various states of health

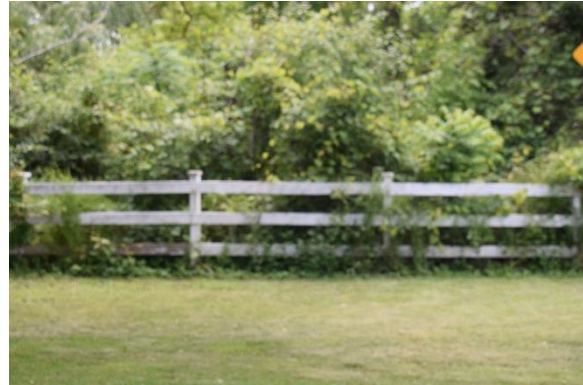
The property located at 9948 Winston Churchill Boulevard is accessed via two driveways located at the road bend of Winston Churchill Boulevard, just south of 10 Side Road. Although the character of this part of Winston Churchill Boulevard is predominantly rural, newly completed residential subdivisions are located approximately 700 metres to the west. As a result, the character of the area is mixed. Winston Churchill Boulevard is a two-lane asphalt paved road with no curbs or sidewalk (Photo 45). The property along Winston Churchill Boulevard is lined with a wooden fence painted white (Photo 46).

**Photo 45 Winston Churchill Blvd,
looking northeast**
