RE: Burlington Quarry Extension – Nelson Response to JART Transportation Comments
OUR FILE 9135D

Proposed Burlington Quarry Expansion
JART COMMENT SUMMARY TABLE – Transportation

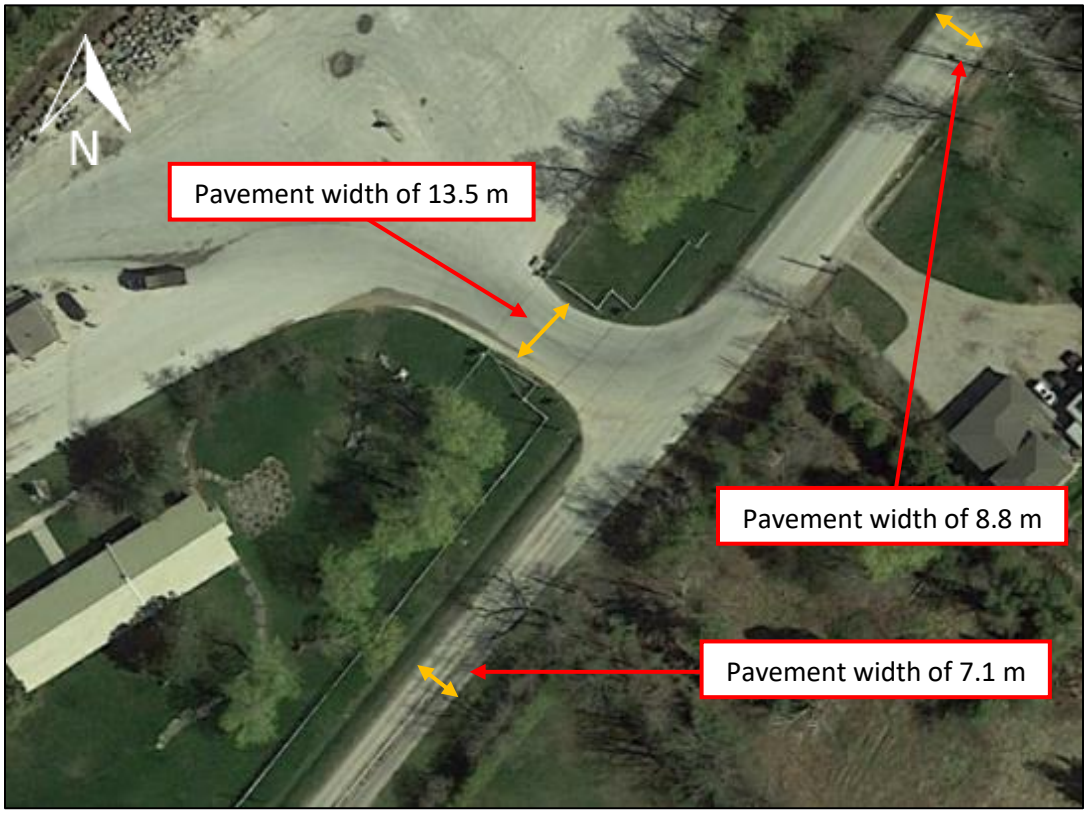
Figure 5: Pavement widths around the existing truck entrance (© Google, 2018)

The existing truck access is stop-controlled, with one lane per direction on all approaches. Pavement widths differ for each approach, as shown on **Figure 5**. The access also includes a large turning radius on the east side. The pavement on No 2 Side Road is also wider on the east side of the access, towards Guelph Line. **Figure 6** shows that southbound trucks turning left onto No 2 Side Road use the additional width provided on the east leg, as shown by sand accumulating on the south side of the road. **Figure 7** shows that even with the larger access pavement width at the edge of No 2 Side Road, some trucks encroach upon the northeast shoulder.

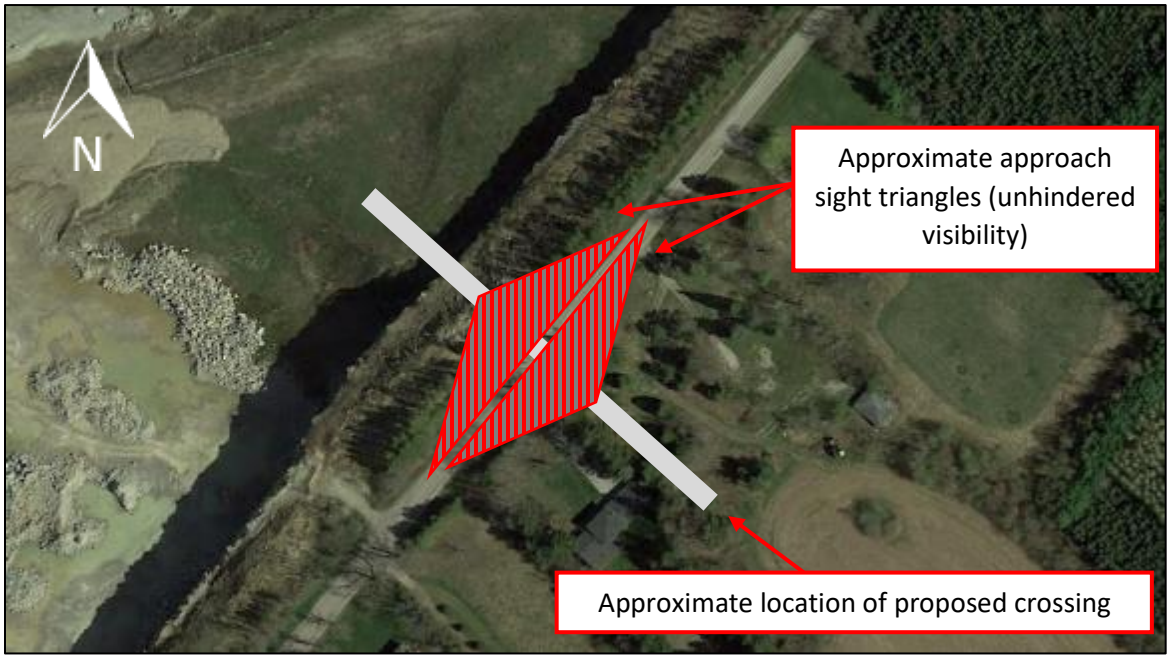
Figure 10: Approximate location of crossing and approach sight triangles (© Google, 2018)

The TAC Guide[12] recommends a minimum stopping sight distance of 105 m and a decision sight distance (stopping conditions) of 125 m for a rural roadway with a design speed of 70 km/h. The decision sight distance should be provided where feasible, and the stopping sight distance should be provided along any roadway to allow drivers to quickly come to a stop if necessary. Stopping sight distances to an object at a height of 0.38 m are available along No 2 Side Road, on both approaches to the proposed crossing. Decision sight distances are available in the eastbound direction to an object at a height of 0.38 m and in the westbound direction to an object at a height of 1.15 m.

- The proposed crossing location should be constructed and maintained to provide the appropriate approach sight triangles and departure sight distances for a 70 km/h design speed. Vegetation should be trimmed or removed as necessary during construction to provide the recommended approach sight triangles and departure sight distances in all four quadrants.

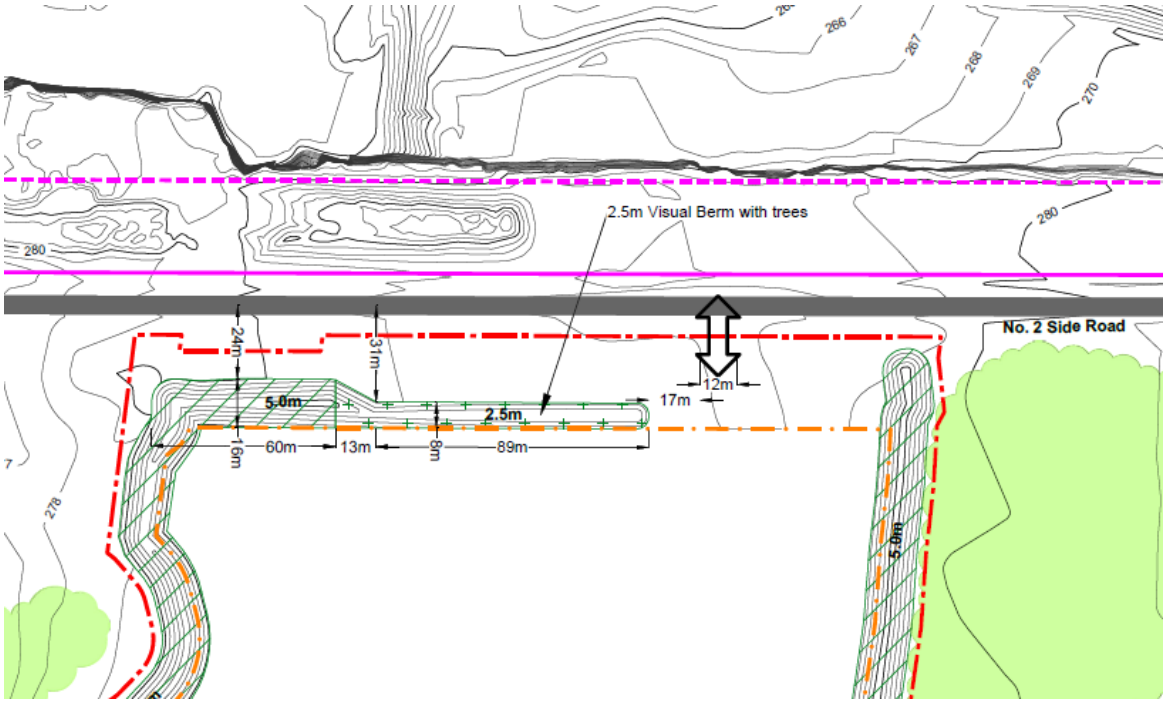
Figure 11: Location of proposed berms and crossing (MHBC)[13].

It should be noted that berms will be installed parallel to No 2 Side Road to the west of the crossing and perpendicular to No 2 Side Road to the east of the crossing, as shown on Figure 11. Based on their proposed locations, the presence of these berms is not expected to hinder the approach sight distances at the crossing.

It should be noted that berms will be installed parallel to No 2 Side Road to the west of the crossing and perpendicular to No 2 Side Road to the east of the crossing, as shown on Figure 11, above. Based on their proposed locations, the presence of these berms is not expected to hinder the departure sight distances at the crossing.
