DRAFT REPORT

# Black Creek Geomorphic and Erosion Hazard Limit Assessment

March 2011

Ref: 01-11-02

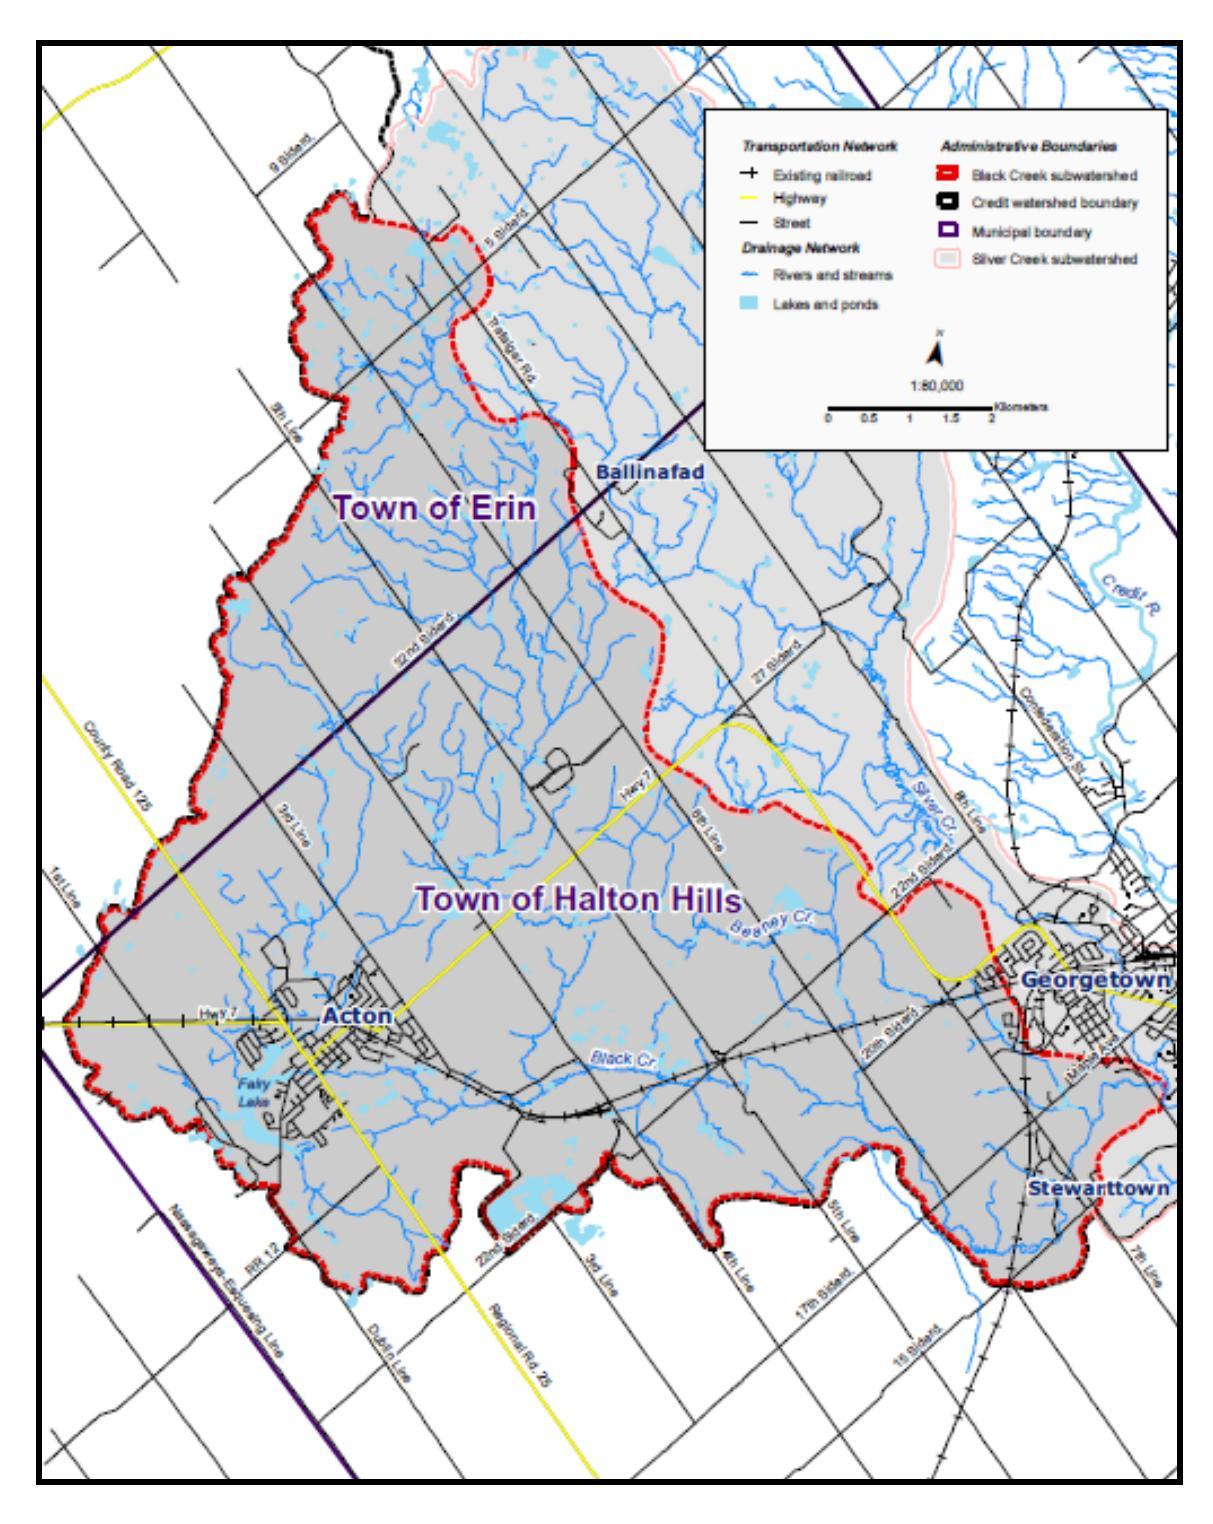
Figure 1. Black Creek subwatershed (image courtesy of CVC, 2009).

The Black Creek subwatershed is approximately 79.28 sq. km in area and is a major tributary of Silver Creek (**Figure 1**). The majority of land use within the subwatershed is agricultural, with areas of wetland and tracts of forest cover. Acton and Georgetown represent the two main zones of urbanization within the catchment. Within the study area, Black Creek Flows through till moraine, a sandy to silty till which is hummocky in nature. Underlying bedrock within the area is dominated by the Amabel/Lockport formation, a grey to medium blue-grey dolostone. This study area has been identified as the Black Creek at Acton Wetland Complex (CVC, 2009). This complex covers an area of 78.4 ha and straddles the Niagara Escarpment and horseshoe moraines to the northwest end. The wetland complex is largely a floodplain wetland. This wetland environment has been noted as providing habitat for brook trout and the provincially rare redside dace as well as habitat for many regionally rare plant species.

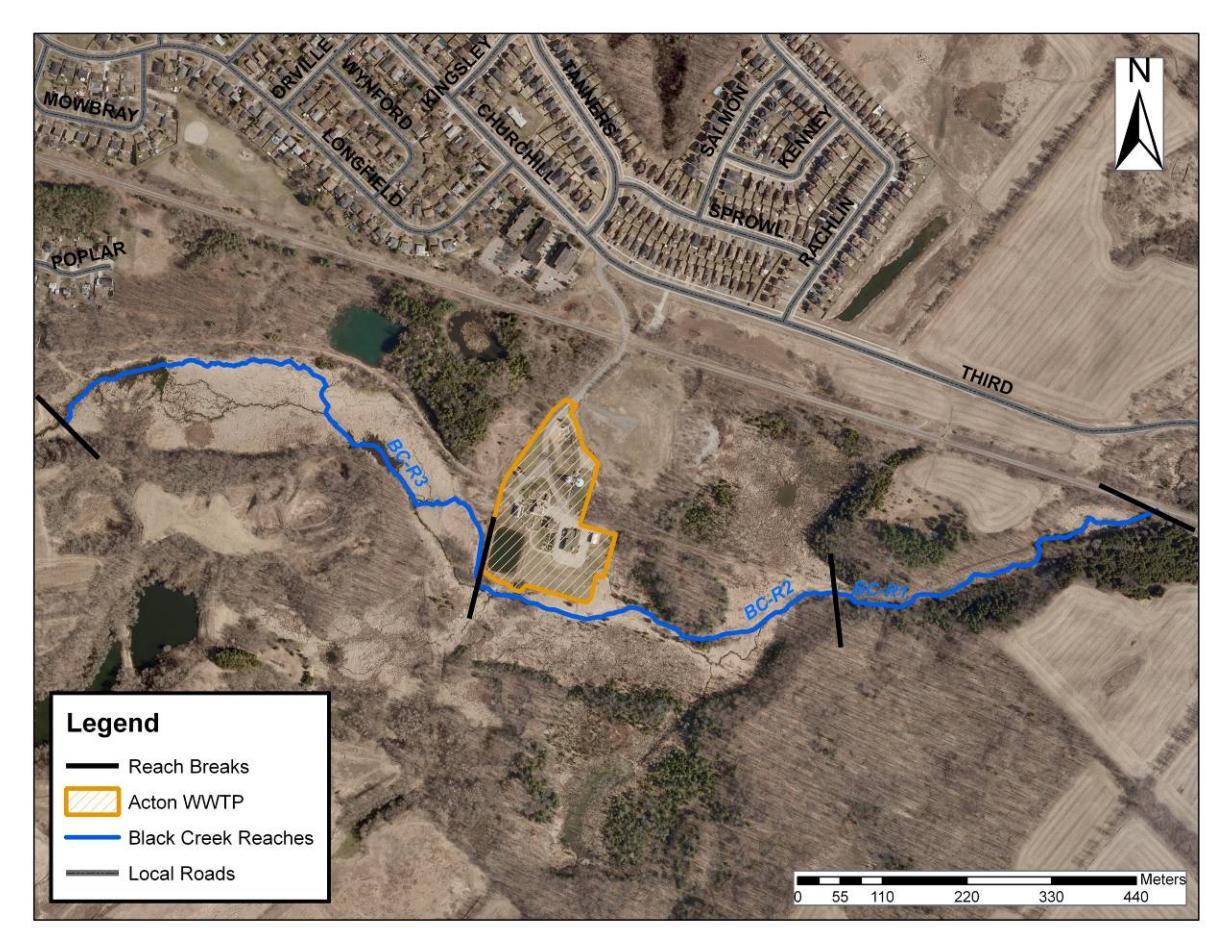
Figure 2. General study area (Acton WWTP highlighted).

The characteristics of the flow or channel materials can change along a creek or stream. In order to account for these changes, channels are separated into reaches – normally several hundred meters to several kilometers in length. A reach displays similarity with respect to its physical characteristics, such as channel form, function, and valley setting. Delineation of a reach considers sinuosity, gradient, hydrology, local geology, degree of valley confinement, and vegetative control using methods outlined in PARISH Geomorphic Ltd. (2001). Based primarily upon land-use, sinuosity, and topography, a total of three reaches were identified for Black Creek within the vicinity of the Acton WWTP (**Figure 2**). Reaches BC-R3, BC-R2, and BC-R1 measure 720, 480, and 460 meters, respectively. As illustrated in **Figure 2**, the broad floodplain conditions surrounding Black Creek within the study area contain a channel that displays multiple channels and standing water conditions typical of a wetland/marsh area. For the purposes of mapping, the main channel (preferrential flow route) has been identified.

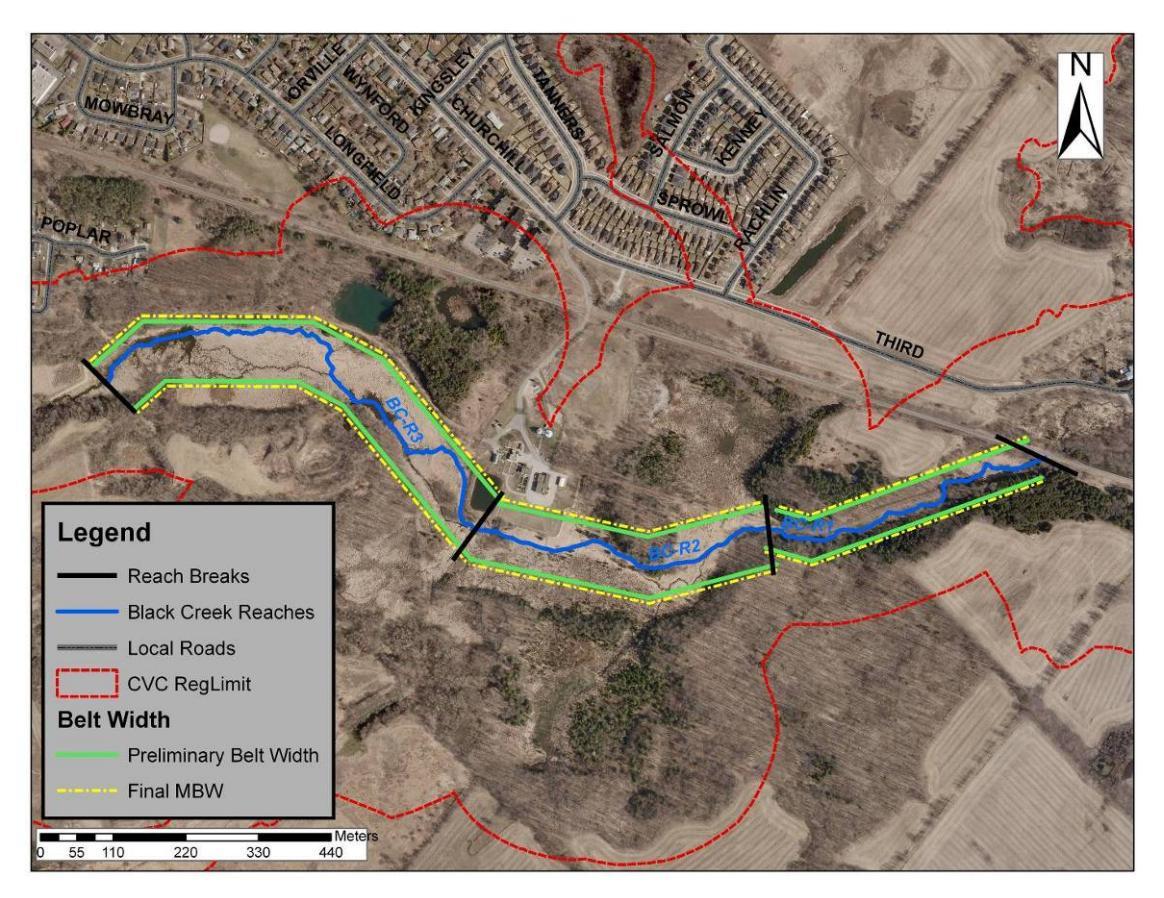
In support of the Provincial Policy Statement, the Toronto and Region Conservation Authority (TRCA) has produced a detailed document which outlines Belt Width Delineation Procedures (PARISH Geomorphic Ltd., 2004) for confined and unconfined systems. This document provides a process-based methodology for determining the meander belt width for watercourses within the jurisdiction of the TRCA based on background information, historic data (including aerial photography), degree of valley confinement and channel planform. Based on available mapping and digital aerial photography, a preliminary belt width was delineated for Black Creek in vicinity of the subject property on a reach basis. Due to the nature of wetland setting, the dimension of the meander belt width was largely driven by the dimension of the active floodplain in order to capture the multiple flow patterns associated with this section of Black Creek. This resulted in a preliminary belt width of 90 m for Reachs BC-R2 and BC-R3, and a preliminary belt width of 60 m for Reach BC-R1 which displayed a much more defined channel and flow pattern (**Figure 3**).

Figure 3. Geomorphic hazard limit delineation for expansion of the Acton WWTP.

As illustrated in **Figure 3**, a portion of the Acton WWTP property is located within the meander belt width. As such, following the letter of regulatory policy, this would characterize the Acton WWTP as being situated within hazard lands. However, the evaluation of geomorphic risk to this facility should also be cognizant of the extent of the regulatory limit also identified in Figure 3, and the low-energy wetland environment that typifies Black Creek within the study area. The WWTP property has been in existence since at least 1978. Based on aerial photography analysis, the property does not appear to show evidence of active erosion due to its proximity to Black Creek. The proposed WWTP expansion does not require an expansion of the original development footprint (**Figure 5**); therefore, the risk to this proposed development is no greater than to that of the original plant. With this in mind, the actual risk to the Acton WWTP in the form of channel migration or erosion was deemed minimal.

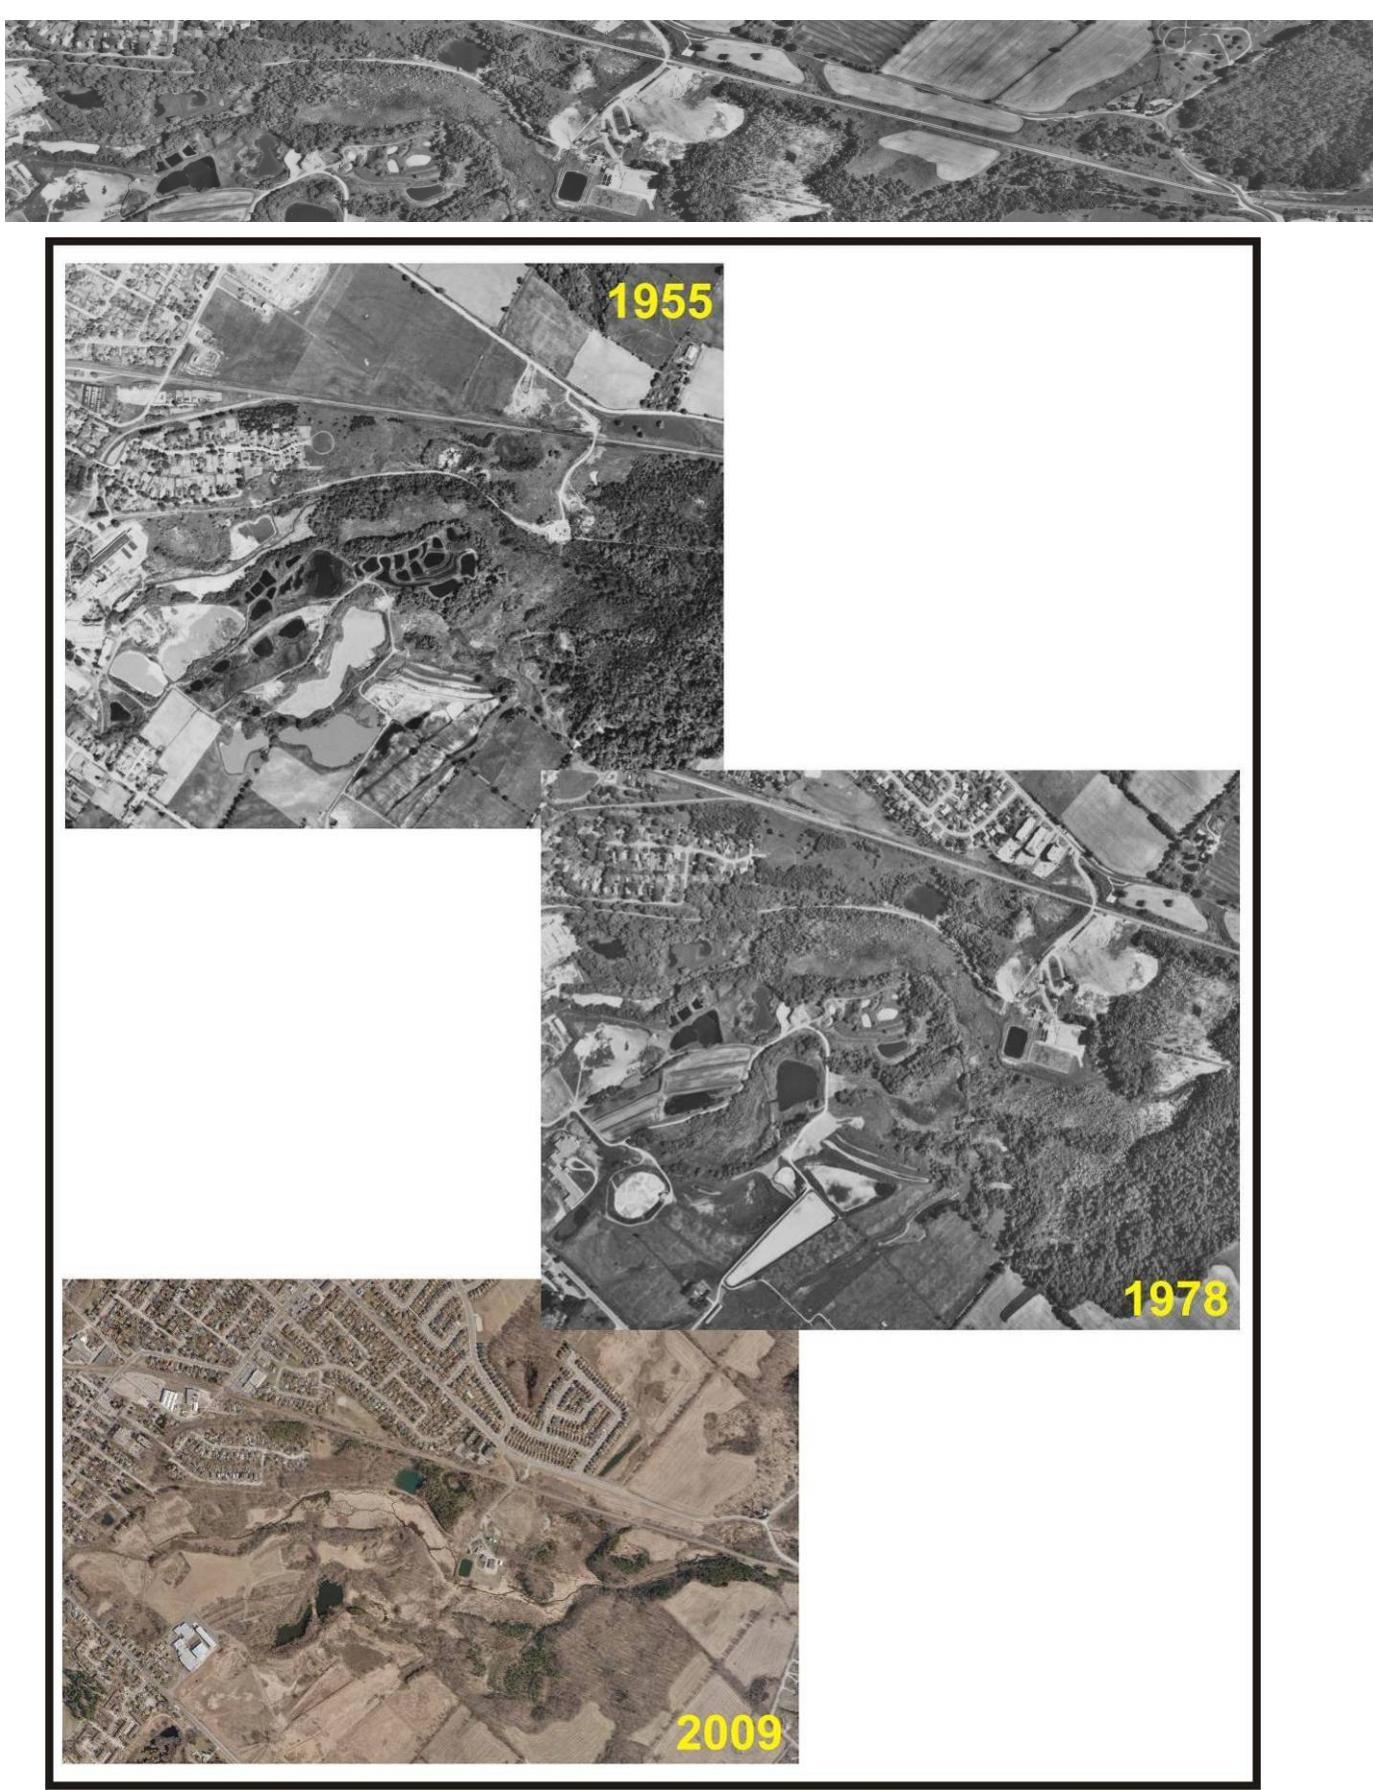
For the purposes of this study, historic aerial coverage of the general study area dating from 1955 and 1978 was compared to recent digital ortho imagery (2009) in order to document changes in land use and channel form over time (**Figure 4**). In 1955, the access road to the WWTP is evident off of Third Line. Residential development can also be observed, largely northwest of Highway 7. This development then expands east towards the WWTP between 1955 and 2009. The greatest observable change within the stream corridor is the modifications to the floodplain and wetland complex. In 1955, a series of ponds are visible just upstream of the general study area. By 2009, only two such ponds are visible. The footprint of the WWTP was established by 1978.

Figure 4. Historic air photo coverage of the general study area.

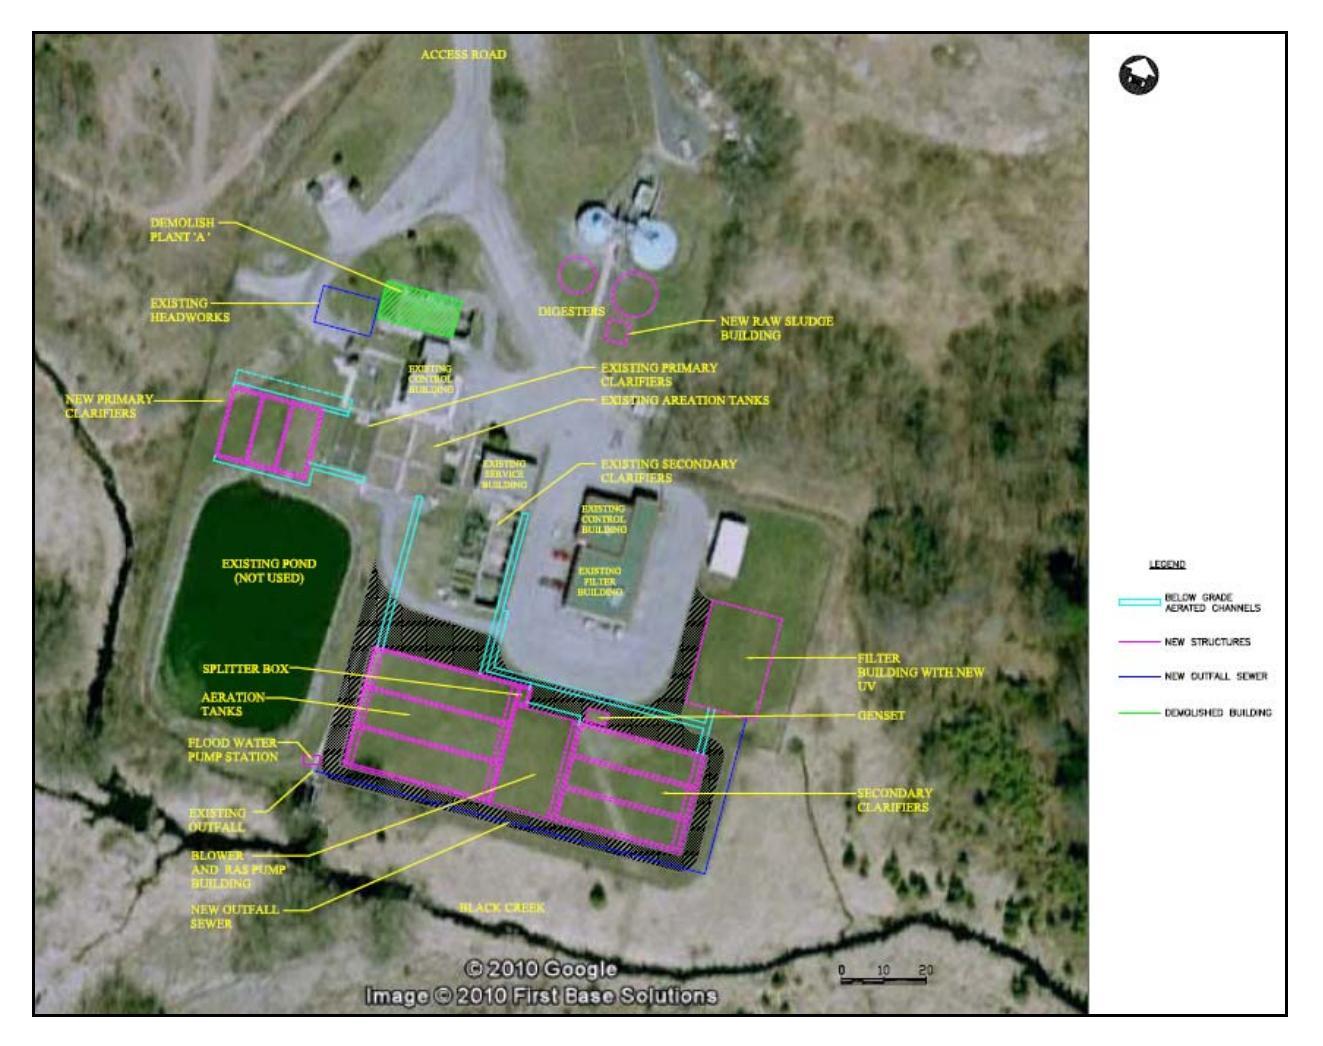
Figure 5. Proposed expansion of Acton WWTP (delineated in pink)

Option 1 (buried stone bank treatment) is best suited for the length of property located along the existing settling pond where the difference in grade is sufficient to allow the incorporation of a stone treatment into the bank/berm face. Along the portion of the property identified for the new secondary clarifiers and UV disinfection building, a buried trench approach (Option 2) is likely more appropriate as the property appears to be at sitting close to floodplain elevation. In both cases, the Class 1 riprap should be installed to a depth greater than that of the existing channel invert (by around 0.3 m). The width and location of the treatments were designed in such a way to avoid disturbance of the active channel, while also avoiding encroachment on the property limits. The width of the stone trench treatment will largely be driven by the depth of stone required and an optimal side slope greater than 1:1.

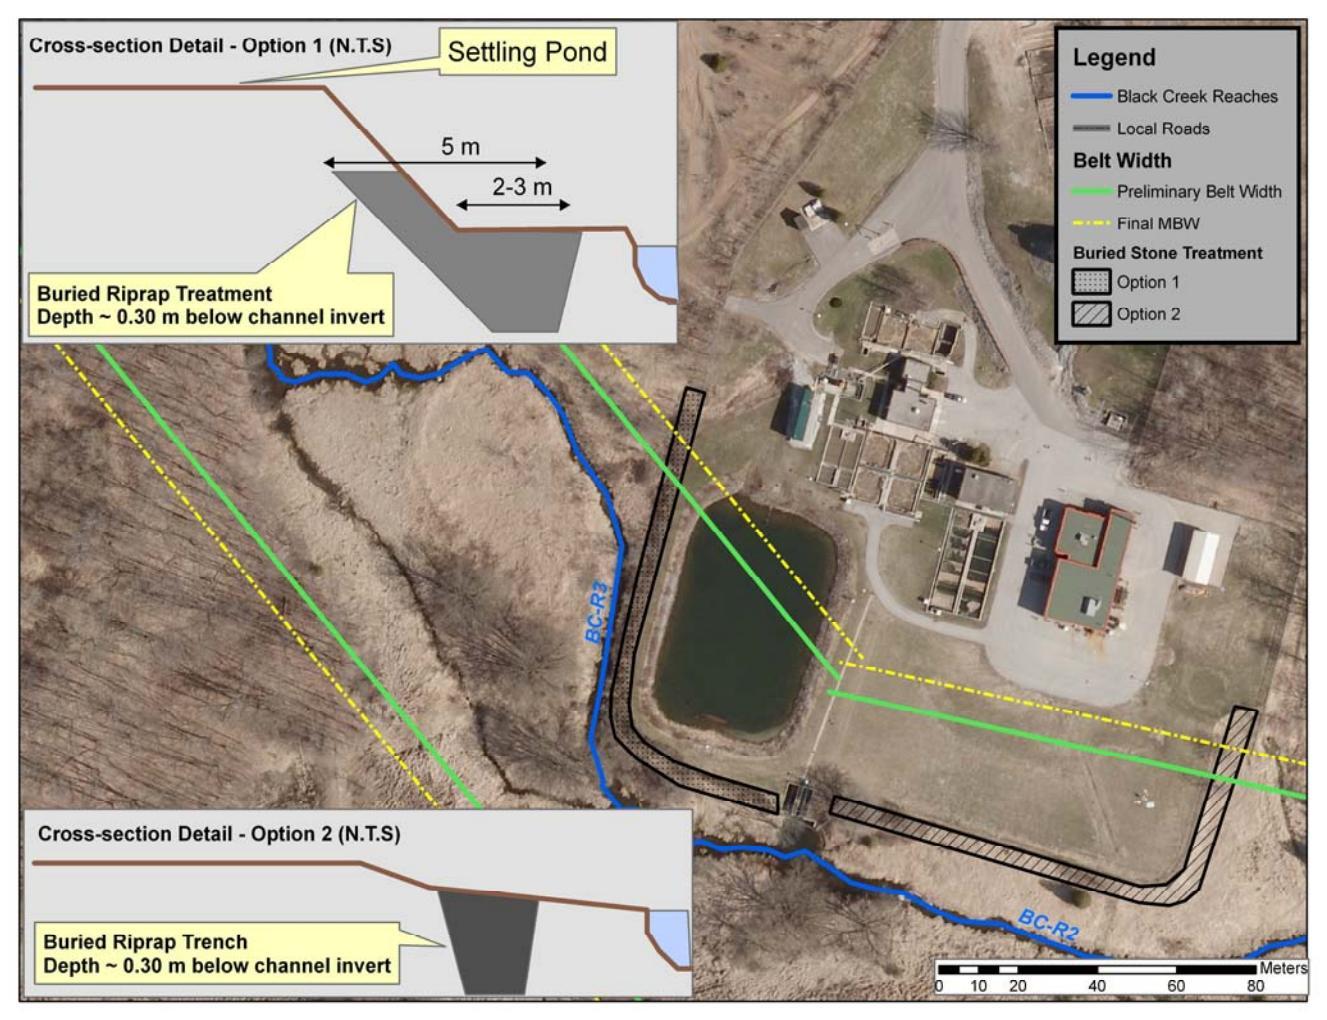
Figure 6. Potential erosion mitigation measures.

While the risk to the WWTP due to erosion was deemed minimal, the results of the field evaluation did identify evidence of active erosion (channel widening). With this in mind, two potential mitigation measures have been developed in order to provide an additional factor of safety against future bank erosion or channel migration. **Figure 6** illustrates a buried stone bank treatment (Option 1) and a buried stone trench treatment (Option 2). Both of these treatments incorporate the use of Class 1 rip rap (D50 of 30 cm). Rip rap is a special application of rock protection. It consists of rocks, broken rocks, angular stones or concrete debris placed together in a set and stable manner to a specified thickness for the protection of slopes and surfaces. It is used in areas where erosion is presently a problem or is an anticipated concern. While the size class associated with Class 1 rip rap may vary slightly

depending on the source of the aggregate materials, the general size range corresponds to 15-45 cm.

Given that the findings of the field investigation did indicate evidence of active erosion along the study reaches, however, potential mitigative measures were developed for the property. These measures entail the installation of buried stone treatment along the property limits that provide an additional factor of safety against bank erosion/channel migration. In support of the detailed design stage, some additional analyses would be required in order to ensure appropriate stone sizing and depth of treatment. This would entail the collection of detailed geomorphic field information within the study reach (sections, substrate/bank characterization and long profile). This data would then be processed in order to estimate a range of velocities and shear stresses for the active channel, as well as provide a context for scour potential along the bed. Detailed crosssectional information would also confirm the required depth of the stone treatment such that it achieves the minimum 0.30 m below the existing channel invert. The results of this work would support or refine the mitigation concepts presented in this report.

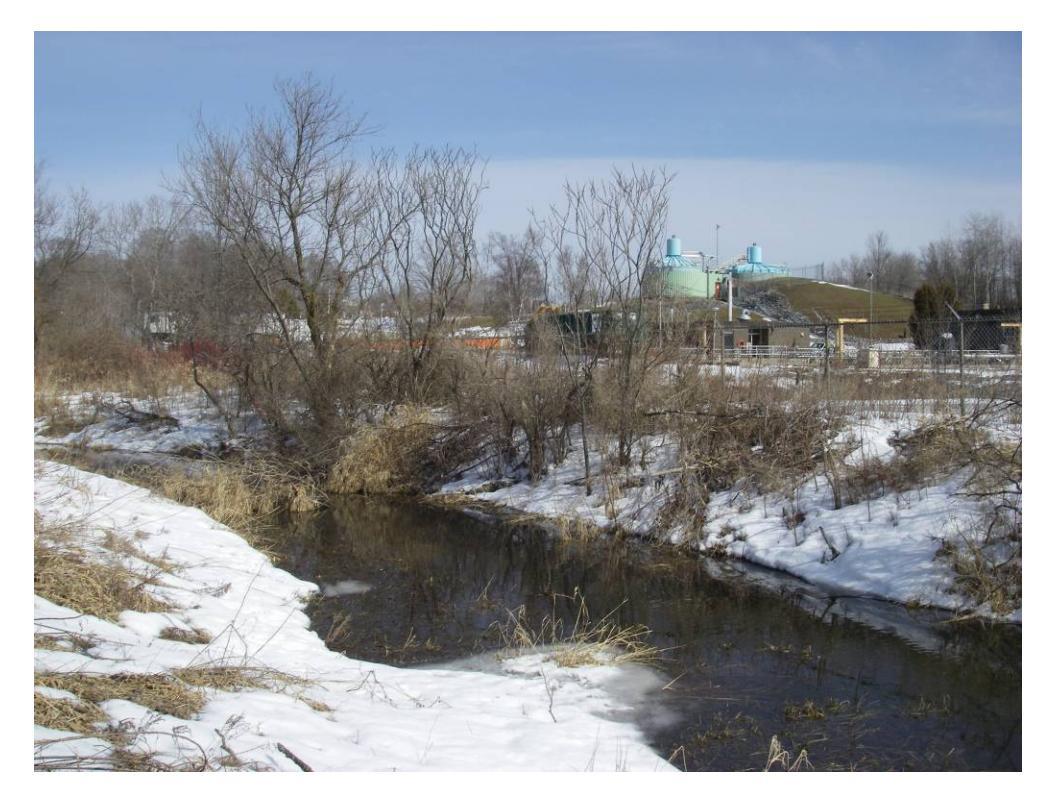
Photo 1. BC-R3 section of reach within vicinity of the WWTP.

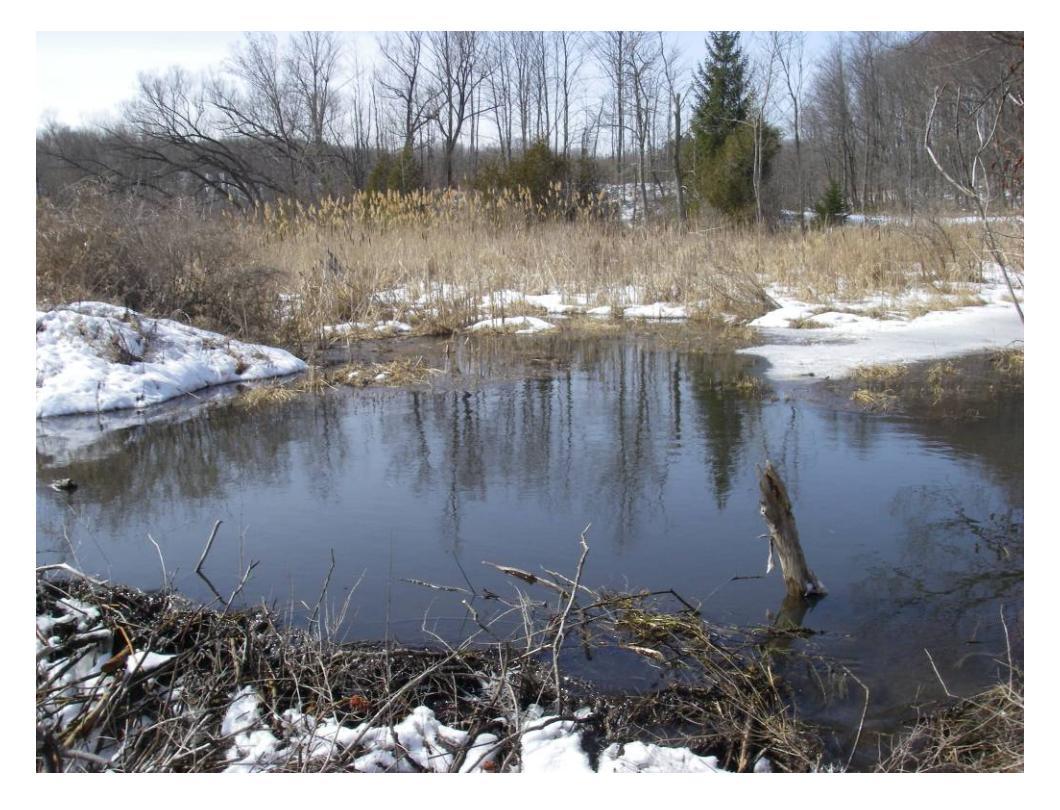
Reach BC-R3 primarily extends through a marsh area with a broad, open flood plain, and points of valley wall contact. Fallen trees, woody debris and beaver activity were prevalent throughout the reach, with a mid-reach beaver dam causing a considerable backwater zone of approximately 75.0 meters. Many of these features were associated with localized zones of scour and deposition. Bank material was comprised of silts and very fine sands, while bed substrate ranged from organic material and silt to very fine sands in pools and silt to gravel within the riffles. Bankfull dimensions were fairly consistent with widths ranging from 2.5 to 4.5 m and depths of 0.7 to 1.1 m. The RGA produced a score of 0.29, indicating a stressed or transitional state, which was primarily attributed to widening and aggradation. Widening was observed through fallen/leaning trees, occurrence of large organic debris and steep bank angles. Indicators of aggradation included siltation in pools, poor longitudinal sorting of bed materials, and a soft, unconsolidated channel bed.

Photo 2. BC-R3 backwatering due to beaver dam at downstream limit.

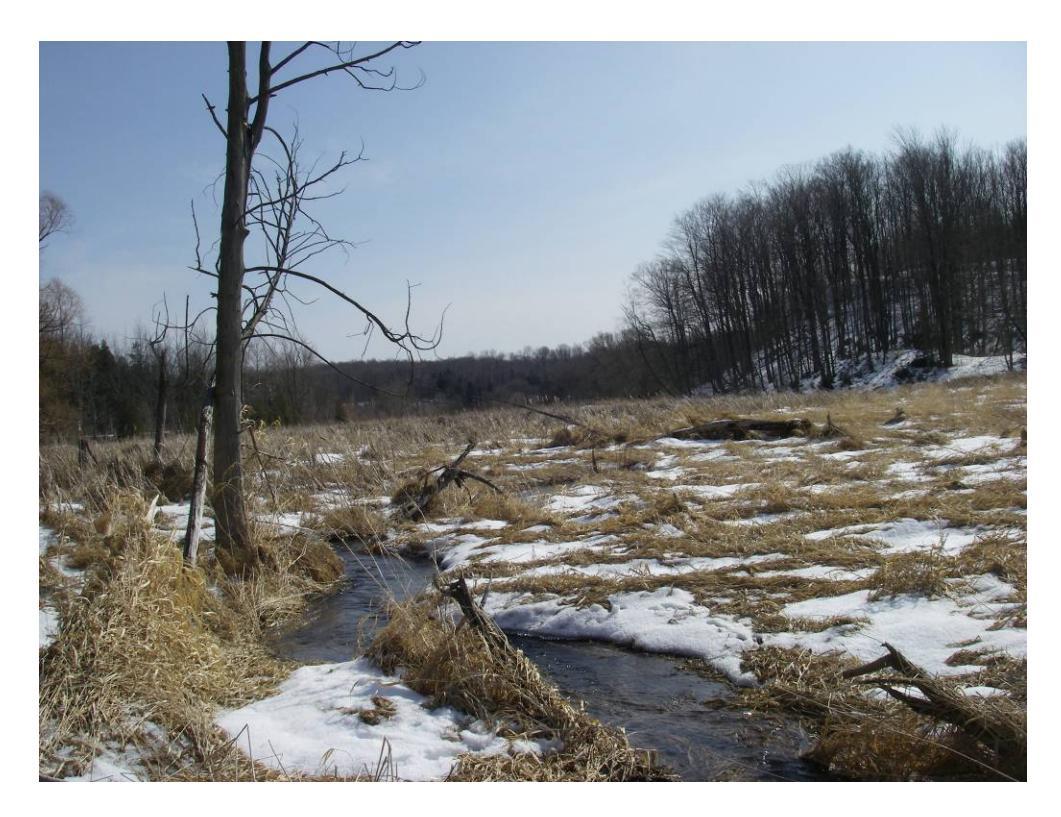
Photo 3. BC-R3 general lowland riparian conditions.

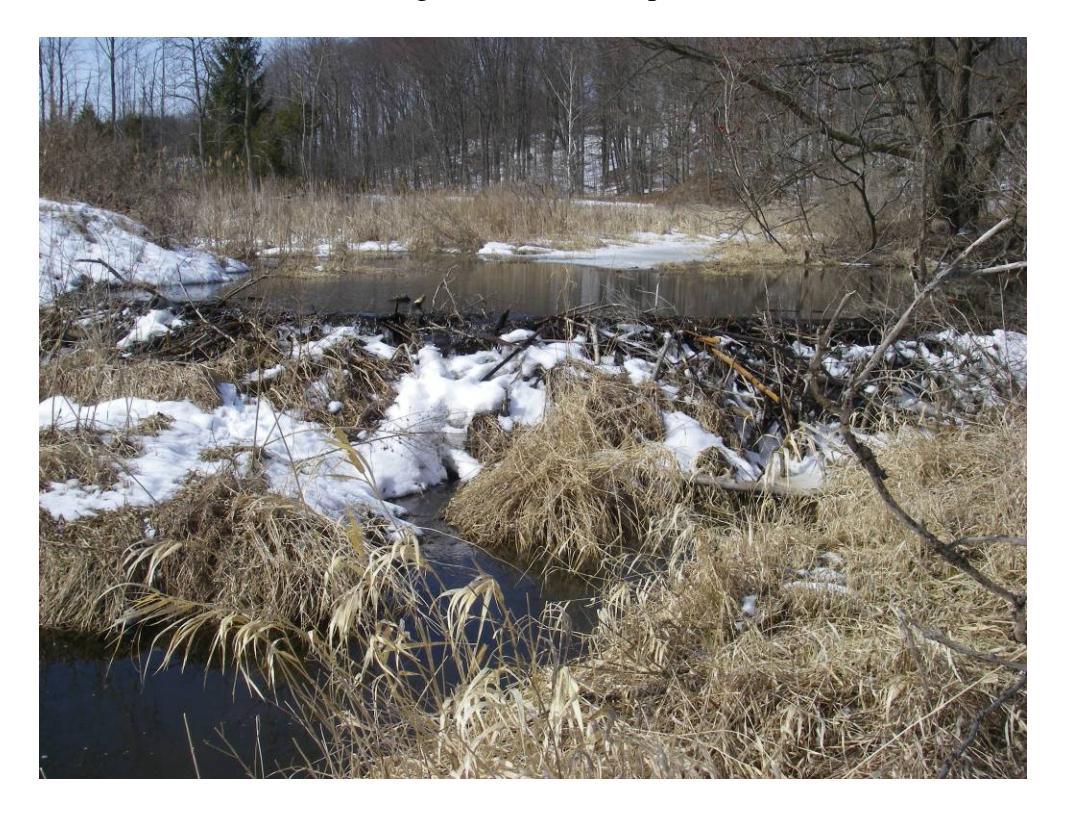
Photo 4. BC-R2 beaver dam at upstream limit.

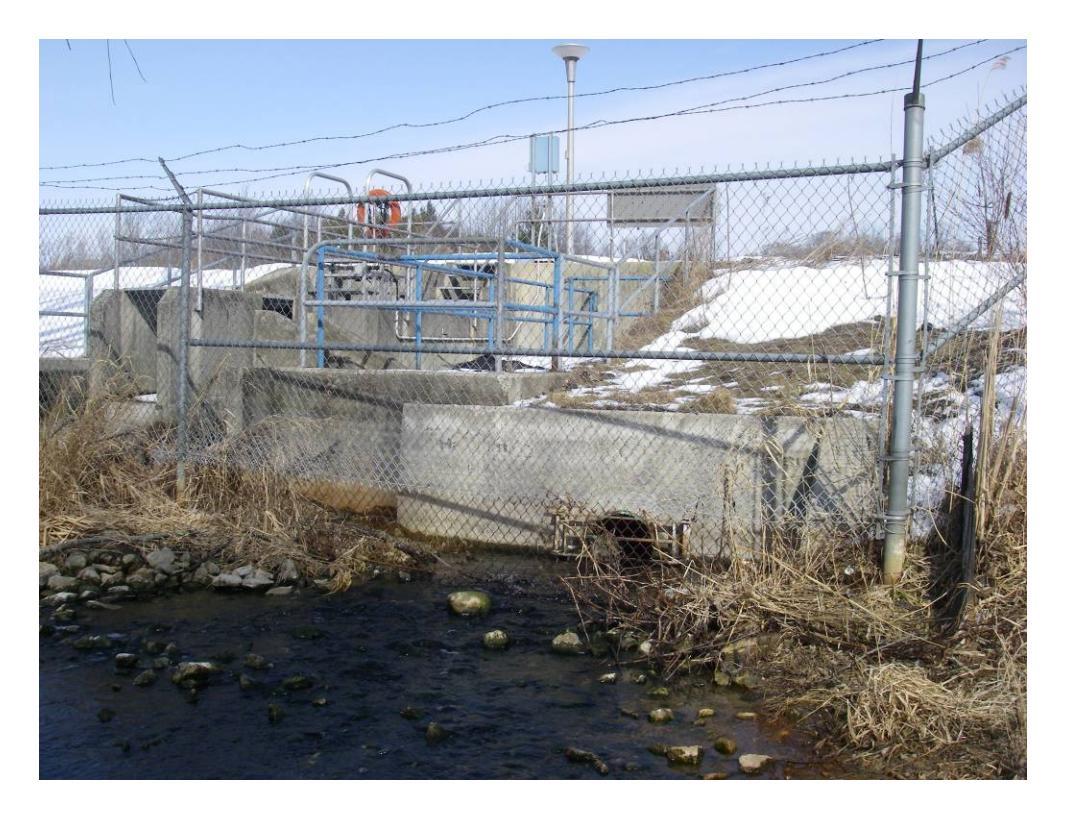
throughout, dominated by fine materials. Channel disturbances included beaver dams, debris jams and the outlet of the treatment plant. RGA results scored the reach as being in a stressed or transitional state (score of 0.39), with widening and degradation emerging as primary and secondary processes. Indicators of widening included steep bank angles, basal scour at inside meanders and exposed tree roots, among others. Degradation was observed through elevated tree roots above the channel bed, bank height increases, and the absence of depositional features.

Photo 5. BC-R2 at Acton WWTP outlet.

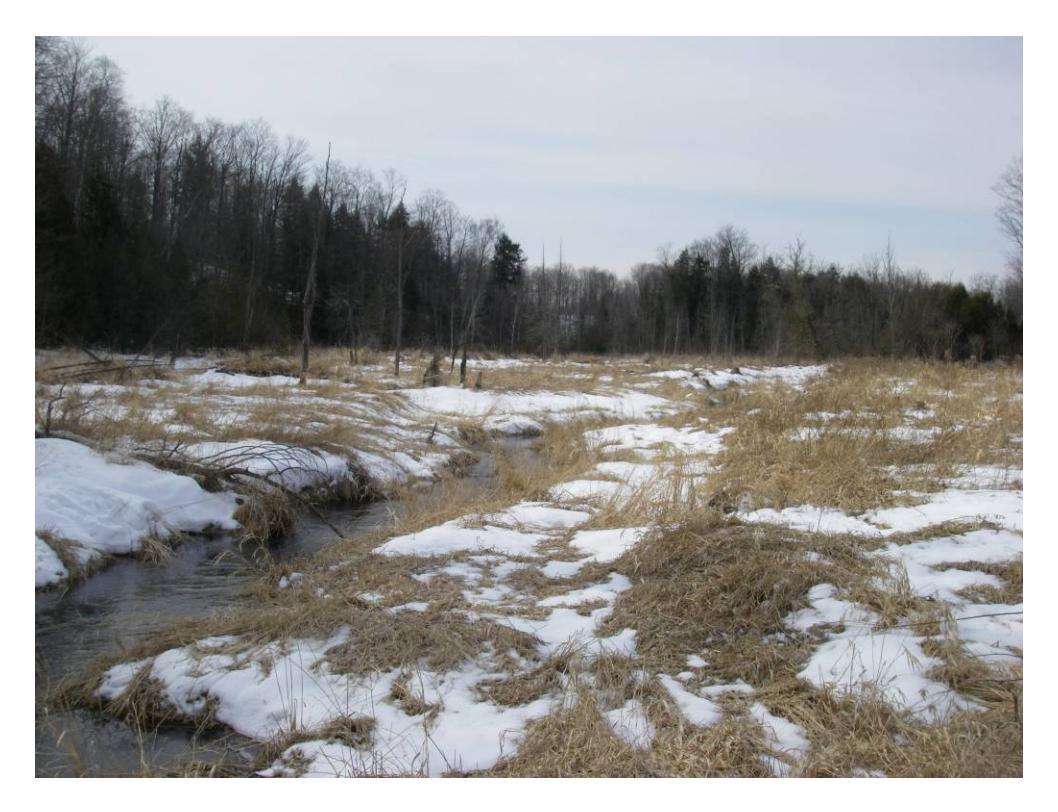
Photo 6. BC-R2 conditions at downstream reach limit.

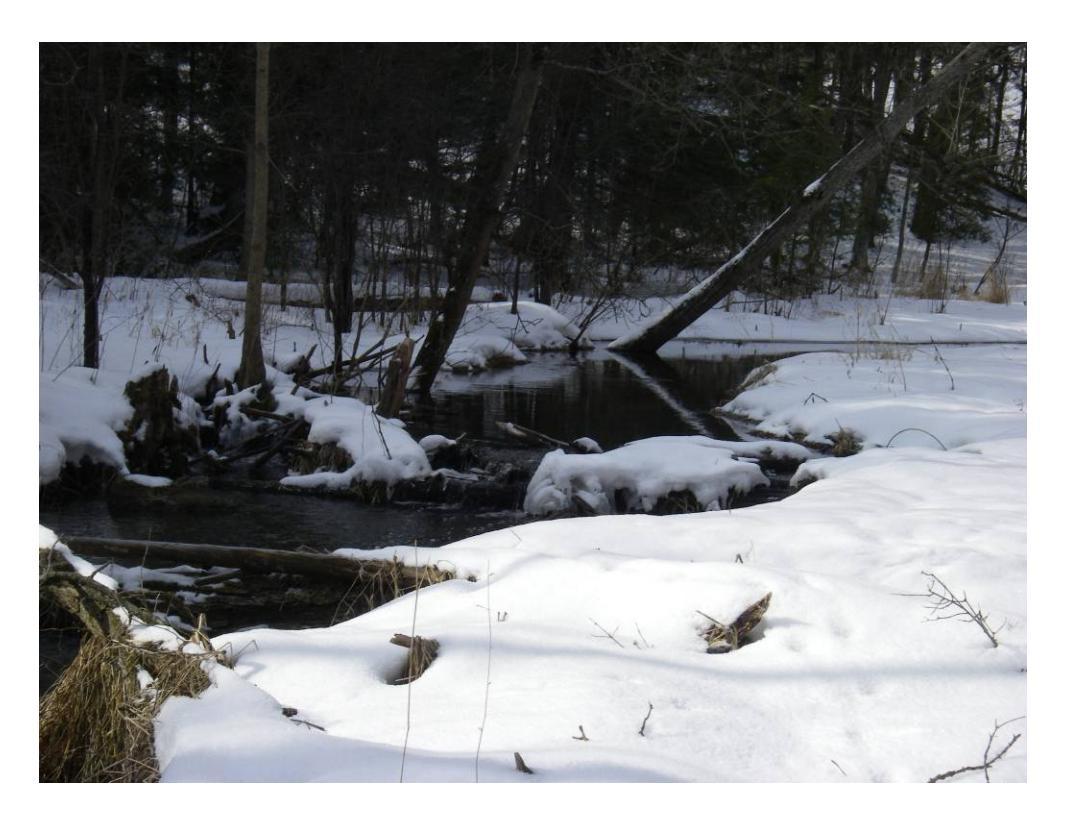
Reach BC-R1 flows through a valley setting vegetated by deciduous forest. Beaver activity was observed, with two dams located near the downstream end of the reach, each creating a considerable degree of backwater. Bankfull widths and depths ranged from 4.0-6.0 m and 0.6-1.3 m, respectively. Observed bank materials included silt and very fine to medium sands. Pool substrate was composed of organics and silt to fine sands, while riffles displayed material ranging from gravel to small cobble intermixed with coarse to very coarse sands. The RGA produced a score of 0.35, indicating that Reach BC-R1 was in a stressed or transitional state. Widening emerged as the dominant geomorphic process through indicators such as fallen/leaning trees, occurrence of large organic debris, exposed tree roots, basal scour on inside meanders and steep bank angles.

Photo 7. BC-R1 fallen/leaning trees.

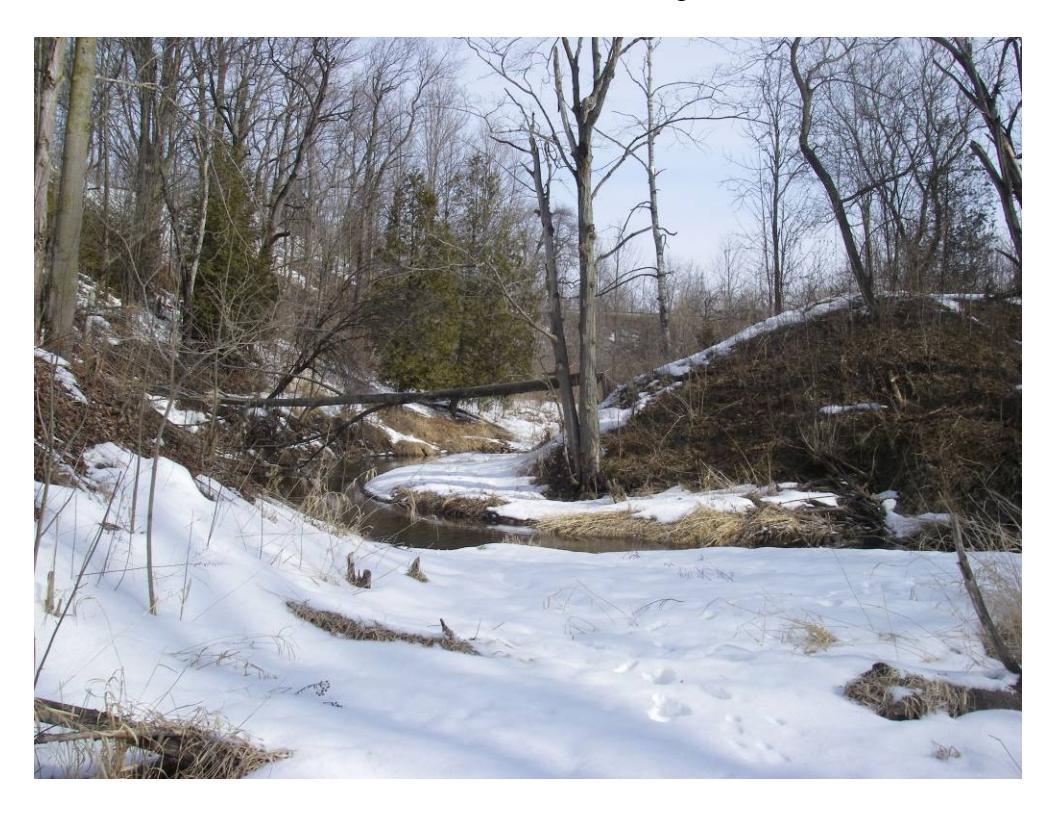
Photo 8. BC-R1 increased confinement and valley wall contact.

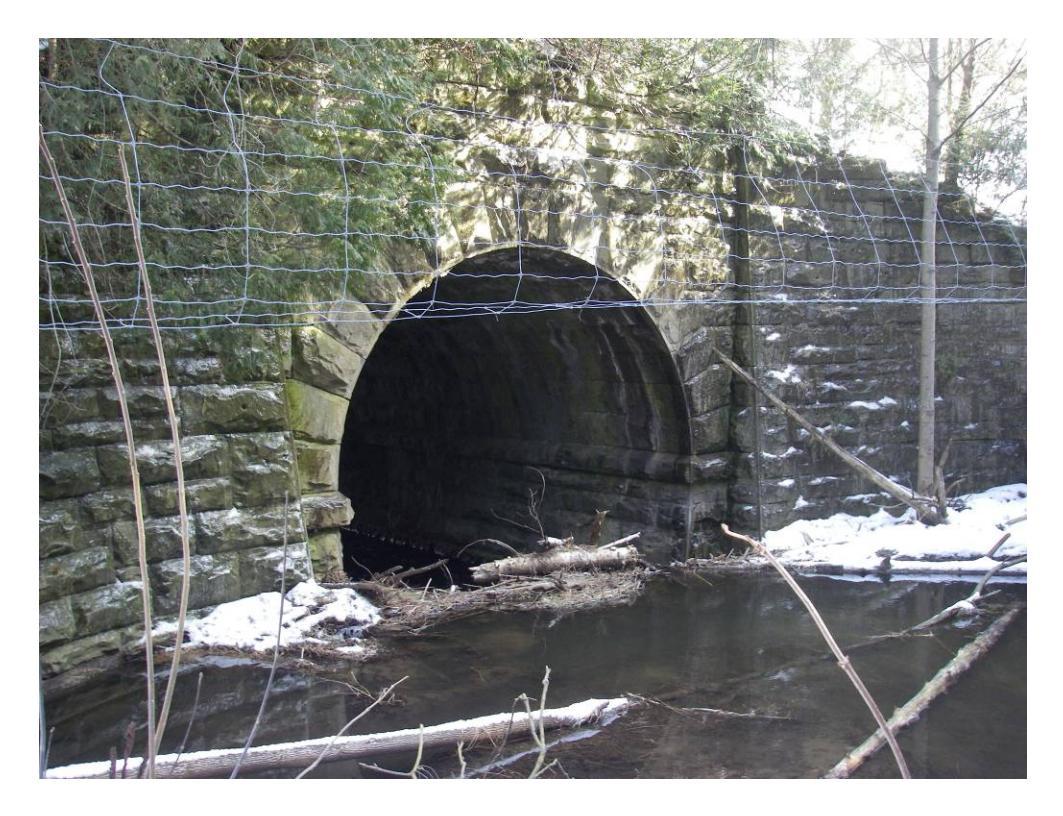
Photo 9. BC-R1 railway crossing and culvert at downstream limit
